Analysis and Preservation of Lime-Kilns in Corsica

Abstract—The aim of this paper is the analysis and preservation of lime kilns, focusing on the structure, construction, and functionality of vertical shaft lime kilns of the Cap Corse in Corsica. Plans and sections of two lime kilns are presented in detail, providing an overall picture of this specific industrial heritage. The potential damage areas are identified performing structural analysis of a lime kiln using the finite element method. A restoration and strengthening technique that satisfies the directions of the Charter of Venice is presented using post-tensioning tendons. Recommendations are given to preserve and promote these important historical structures integrating them into the custom footpath.

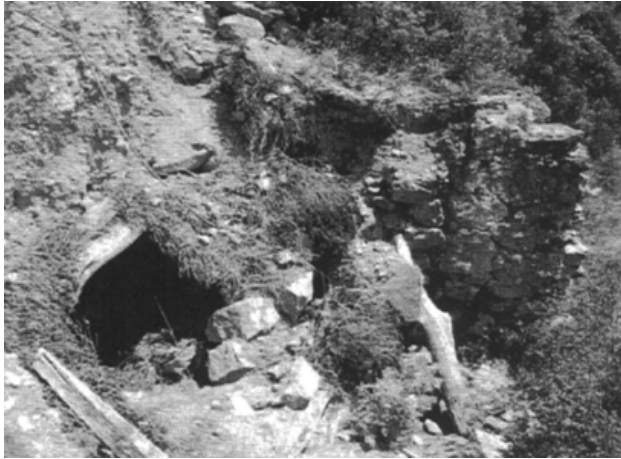
Fig. 6 Lime Kiln 2 as seen from the access path

Lime kiln 2 (Fig. 6) also belongs to the Community of Rogliano and is located next to lime kiln 1. This lime kiln is much smaller than lime kiln 1. The inside diameter of the kiln's shaft measures only 3.6 m, and is constant from bottom to top (Fig. 7). This structure has also been partly built into the hillside. The rest of the kiln form walls built with mortar of 1.15 m wide. An entrance foyer is still visible, but not so well maintained. The entrance width is about 3 m and the distance from the corridor to the firing door almost 4.5 m. The firing door is 0.72 m wide and 1.60 m tall and is better preserved than the previous one (Fig. 8). The firing door dimensions of these two lime kilns are similar, although the shaft's dimensions vary considerably. The shaft of this kiln is in good condition in contrast to the outside part of the foyer. The kiln's height is today approximately 5 m. Two wooden beams still exist at the firing door opening. Lime kiln 2 was probably using the same quarry as lime kiln 1. This kiln is also visible and easily reachable from the custom footpath although its outside part is completely covered by maquis.

Structural analysis was performed on a typical lime kiln using the finite element method. The dimensions used for the model are representative of the dimensions of the lime kilns of Corsica and are based on the dimensions of lime kiln 1. In the finite element model the soil underneath the kiln was considered to extend up to 4 m. The thickness of the soil was 1.5 m at the junction of the thick stone wall with the soil, 10 m in the middle and 4 m next to the entrance (Fig. 9(a)). Extended dimensions of the soil were considered so that the kiln's existence had small influence on the soil at the end of the model where the boundary was considered fixed. A masonry wall of 0.20 m thickness was attached to the soil inside the shaft. Based on observations of the soil and masonry walls of the lime kilns in Corsica, the following properties were used to represent appropriately the materials that compose the lime kilns: the soil's density was 1800 kg/m^3 , the modulus of elasticity 35 MPa, and the Poisson's ratio 0.24. The masonry's wall density was 2100 kg/m^3 , the modulus of elasticity 2500 MPa, the Poisson's ratio 0.24, the compressive strength 2.5 MPa, and the tensile strength 0.25 MPa. The materials were considered homogeneous and isotropic. Only dead load was considered. Static analysis was performed using the structural analysis software Ansys. The masonry and the soil were modeled using a 10 node, 3-D solid element. The results are presented in the form of contour plots of the first principal stress (in Pa). Fig. 9(b) shows that the masonry walls are the most stressed parts of the lime kiln. Most of these high stresses are due to the pressure that the existing soil exerts on the masonry structure. In particular, the most stressed areas are the area around the junction of the thick wall with the soil (extended to the thin wall inside the shaft), and the lower part of the thick masonry wall at the entrance. At these areas the stresses exceed the tensile strength of the wall. These results explain the damages appearing on the lime kilns not only in Corsica but elsewhere also (Fig. 6) where the stones have fallen inside the shaft and the entrance wall has been destroyed.

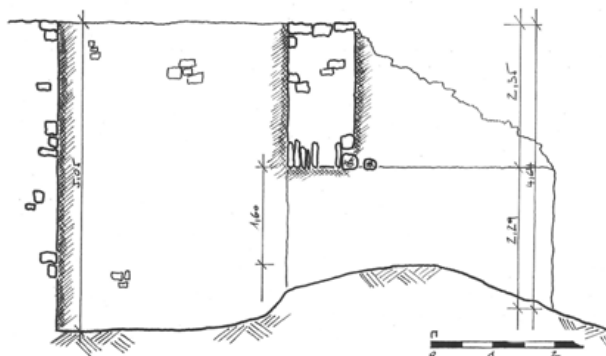
Fig. 8 Section of Lime Kiln 2
