# Analyzing the Historical Ayazma Bath within the Scope of Integrated Preservation and Specifying the Criteria for Reuse

Meryem Elif Çelebi Yakartepe, Ayşe Betül Gökarslan

In this work, the preservation of Ayazma Social Complex located in Ayazma Neighborhood of Üsküdar, one of the most important historical districts of İstanbul, with integrated preservation method has been discussed. In the conventional Turkish architecture, the social complex is a structure complex formed via constructing the public buildings required for the daily life of the people living in a settlement. Thus, the preservation of the social complexes within the scope of "integrated preservation" has gained importance. Ayazma Social Complex that forms the examination area of this work consists of a mosque in its center and structures around this mosque such as sultan mansion, time assignment center, primary school, stores, bath and water reservoirs. Mosque, sultan mansion and the water reservoirs survived to today as mostly preserved status. However, time assignment center, primary school and the stores didn't survive to today and new structures were built on their plots. The bath was mostly damaged and only t

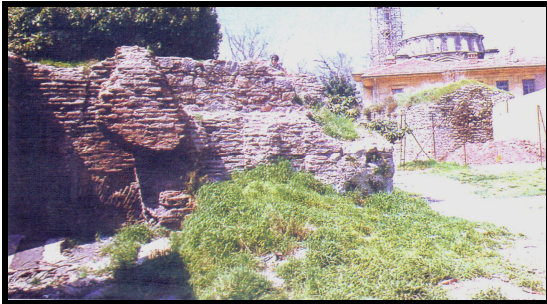
Fig. 5 Ayazma Bath's old photograph from 1987 [10]

The bath, which was abandoned for some time during World War I, started to serve again 1916. In a record dated September 17, 1769; it is claimed that the bath is used as a snuff workshop. Despite being a property of the foundation, it became a private property later with lawful resolution. The date until the bath served under the property of a person and its structural status is not precisely known. Nahide Şimşir (2004) states that the bath was in ruins in 1946 [12]. In 1974, the owner of the bath had stores built on the side of the bath facing Ögdül Street. In 1976, the bath is used as a dump [11] (Fig. 4). It is understood from a photo in the article of Sadi Bayram and Adnan Tüzen (1987) that the top cover of the bath was demolished in 1987 and that only the wall residue remained [10] (Fig. 5). Today, it is desolate.

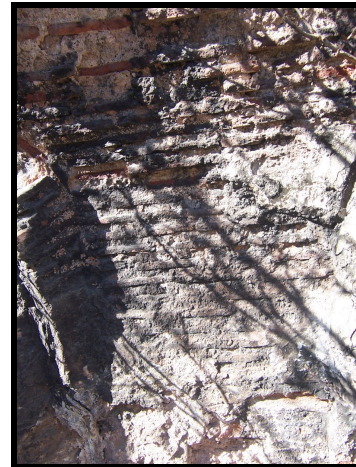
Fig. 7 Bath's material usage and construction technique

The first building of the bath was built out of rubble stones with masonry technique; however, the places added during the repair were made of thin bricks. It can be observed that the top sections of some walls were completed later with stone material (Fig. 7). There are no information concerning the top cover and interior arrangement which didn't live up today.

Considering the material losses, the wall residues of the bath should be integrated and should be put to its unique height. Since there isn't any data concerning the unique roof of the bath, the upper cover should be built with today's modern material steel and glass.

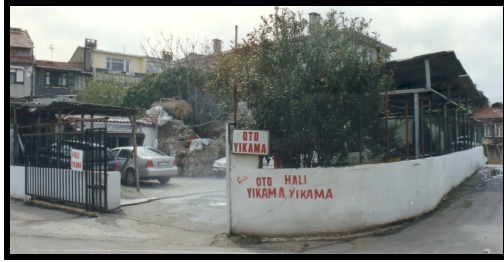
Fig. 8 Ayazma Bath, 2014

The structure is in ruins today. Its domes and furnace is completely destroyed, only the wall residues survived to today. A car and carpet wash service was built in its garden next to the bath. The residues of the structure and its surroundings were closed by new premises built by this enterprise. Water reservoirs were put inside the structure. The water and chemical based leaks used by the enterprise caused

serious deteriorations on the bath. The bath is faced with the danger of collapsing today (Figs. 8, 9).

In order to preserve Ayazma Bath and hand it down to the next generations, it should be purified of the dense structuring surrounding it; it should be saved from the usage type that damages the structure; surveying, restitution and restoration projects should be prepared as soon as possible and the restoration applications should immediately commence.

Firstly, the new additions of the enterprise in the surrounding of Ayazma Bath and the trees and soil dump in the bath should be cleaned. After this, ground excavations should be made and the status of the foundations should be examined. Necessary foundations and the walls should be subjected to strengthening and consolidation works. If there is ground water problem, the water should be kept away from the

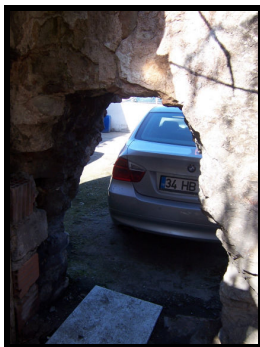
It is observed that an entrance gap was opened on the body wall by the Car Wash Service in order to be able to use the interior of the bath (Fig. 10).

Fig. 10 The gap opened on the body wall of the bath by the enterprise - 2014

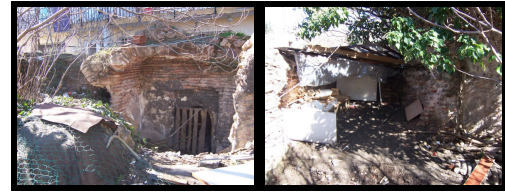
Fig. 12 Bath's interior views - 2014

The interior of the bath became the storage and dump of the Car Wash Service. It is observed that the trees in the interior part of the structure were randomly cut without considering its effects to the structure.

The complete destruction of the upper cover of the structure, the interior being in ruins, vegetation in the wall

residue, darkening and salinization effects, trees and soil dumps in the interior and wrong usage are the important deteriorations in the historical bath (Figs. 11, 12).

structure with drainage system. After the structural liberation, side liberation should be made. The plants, especially on the sides, should be removed from the structure with their roots. Next, the darkening and salinization should be cleaned.

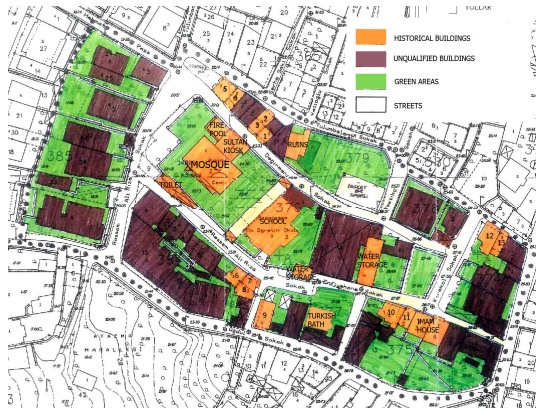
Fig. 13 Buildings at Ayazma Complex and its current situation analysis

Ayazma Complex's buildings have to conserve within the scope of integrated preservation. Firstly, the structures to be protected are determined by study of fabric analysis (Fig. 13).
