Assessing the Sheltering Response in the Middle East: Studying Syrian Camps in Jordan

Lara A. Alshawawreh, R. Sean Smith, John B. Wood

Abstract—This study focuses on the sheltering response in the Middle East, specifically through reviewing two Syrian refugee camps in Jordan, involving Zaatari and Azraq. Zaatari camp involved the rapid deployment of tents and shelters over a very short period of time and Azraq was purpose built and pre-planned over a longer period. At present, both camps collectively host more than 133,000 occupants. Field visits were taken to both camps and the main issues and problems in the sheltering response were highlighted through focus group discussions with camp occupants and inspection of shelter habitats. This provided both subjective and objective research data sources. While every case has its own significance and deployment to meet humanitarian needs, there are some common requirements irrespective of geographical region. The results suggest that there is a gap in the suitability of the required habitat needs and what has been provided. It is recommended that the global international response and support could be improved in relation to the habitat

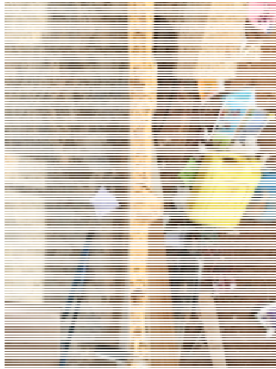
- **Walls and roofs:** The prefabricated shelters were made from polyurethane insulated sandwich panels. A section of the wall can be seen in Fig. 4, which was recycled from a shelter's wall and used as a side garden fence. The shelters' quality differs from one to another, but the majority have weaknesses in building fabric leading to air,

dust and water ingress. This is a contributing source towards health problems affecting camp residents.

Fig. 4 A section in the wall [13]

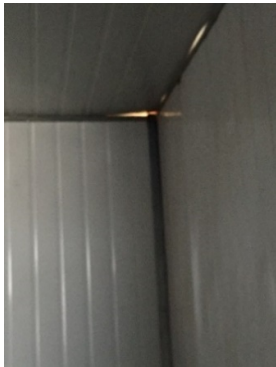
In an attempt to seal the shelters, especially the roof-wall junctions (Fig. 5), the residents covered the roofs using fabrics they had or bought them, if they could afford them. Some families also tried to expand their shelters by enclosing a space using corrugated sheets and then covered it with fabric,

Fig. 5 Gaps between junctions [13]

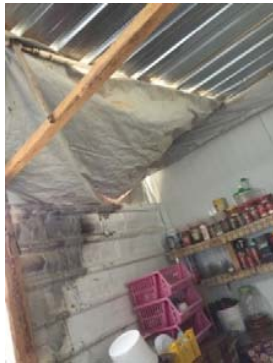
- **Facilities:** When the camp was first opened, the kitchens and toilets provided were communal. Problems occurred when using such communal facilities from both cultural and privacy/security perspectives. It was found that when residents could afford some materials, they adapted and self-built private facilities adjacent to their shelters. These adaptations included enclosing additional space with corrugated sheets, wood and canvas, if the residents were able to afford materials (Figs. 8 and 9).
- **Outdoor areas:** The courtyard is an important cultural feature in Syrian homes and enclosing an outdoor space

Fig. 9 Self-built kitchen [13]

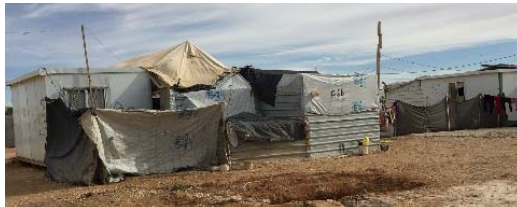
was found to be very important to the camp residents. They often enclosed a space next to their shelter or between two shelters with canvas or corrugated sheets, as shown in Fig. 10. One of the main benefits of such a private area was for women residents to have access to an outside space. This provided safety, privacy and aligned to their cultural needs.

Fig. 10 Private outdoor area [13]

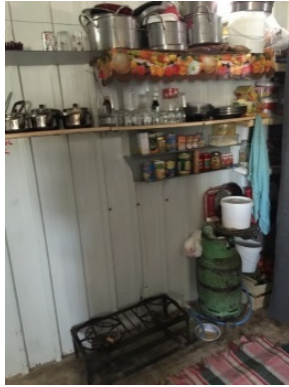
The residents were not provided with private or communal kitchens. Cooking equipment was given to residents to utilize in a corner of their shelters as a kitchen space. This included stoves and gas cylinders as shown in Fig. 20. Cooking inside the shelters was one of the causes behind the respiratory problems the residents had mentioned.

Fig. 20 Kitchen tools [15]

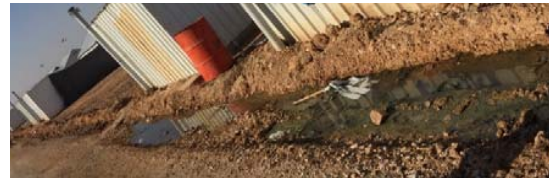
- **Drainage:** The absence of a drainage system is a problem in the Azraq camp. The residents formed ditches to outside pits and aligned different ditches to form a network of surface wastewater channels adjacent to the streets, as shown in Fig. 23. In addition to hygiene problems, it also leads to accessibility issues for people with special needs and elderly, trying to cross over the wastewater.

Fig. 23 Surface runoff wastewater [15]

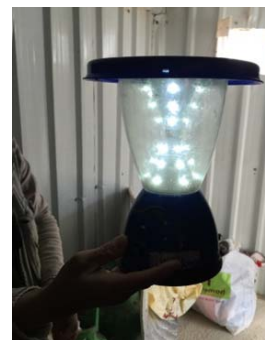
The only source for electricity in the Azraq camp is solar lamps (Fig. 25). Shelters have one or two lamps but no additional devices, other than mobile phones, can be operated by these lamps.

Fig. 25 Solar lamp [15]
