Assessment of Rehabilitation Possibilities in Case of Budapest Jewish Quarter Building Stock

Viktória Sugár, Attila Talamon, András Horkai, Michihiro Kita

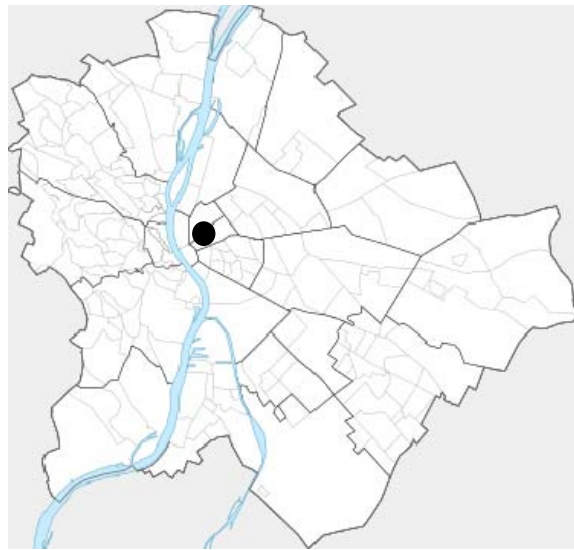
Fig. 1 The Old Jewish Quarter of Pest, in today’s District 7 of Budapest [3]

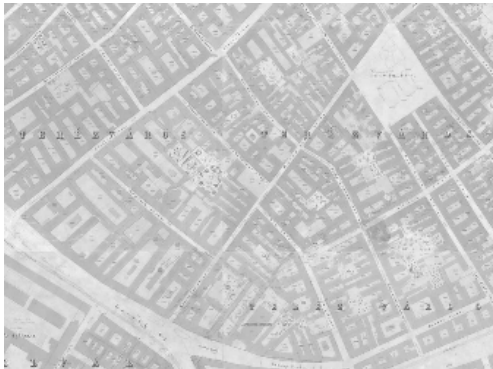
Fig. 2 Characteristic urban fabric of the turn of the 19th and 20th century in the district [4]

Until Joseph II, Emperor and King of Austro-Hungarian Empire, legislated the Patent of Toleration in 1783, Jews were prohibited to enter the walled Pest, and were also not allowed to settle until 1786. A law of 1840 at last permitted them to own real estate, until then, their praying rooms and apartments were also in rented houses. Naturally, the establishment started around the Jewish Market outside the city wall, alongside the main street of the area: Király Street (King Street, King of England Street at the time, Fig. 2) [2].

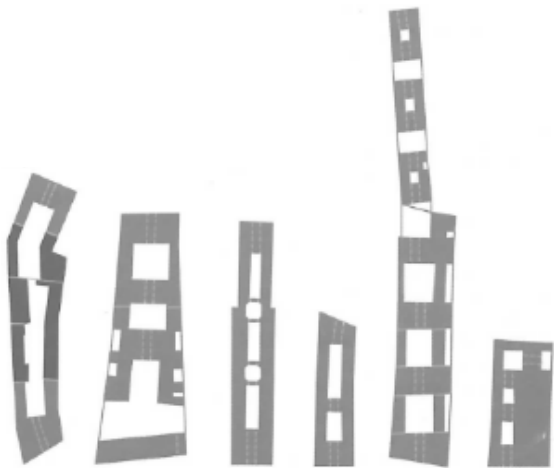
Fig. 3 Passage houses- chain layout connecting the streets and opening up the deep block for commercial life [2]

At the same time, the first passage houses (Fig. 3) and pedestrian crossings have developed through the deep blocks, later grown into a full system. The passage houses and crossings expanded the commercial life, at the same time

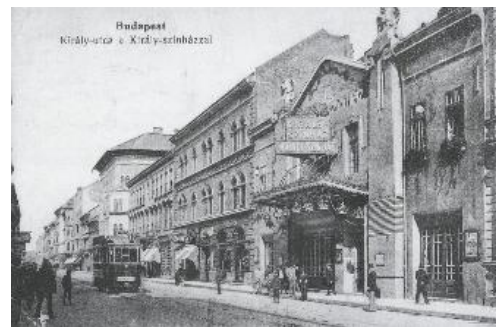
Fig. 5 Király Street, the main street of Jewish Quarter of Pest, archive photo [6]

The diversity of the houses is also increased by the combination of more and less ornate buildings (Fig. 5), as well as the mixture of apartments with and without the modern conveniences, resulting diverse social groups living side-by-side.

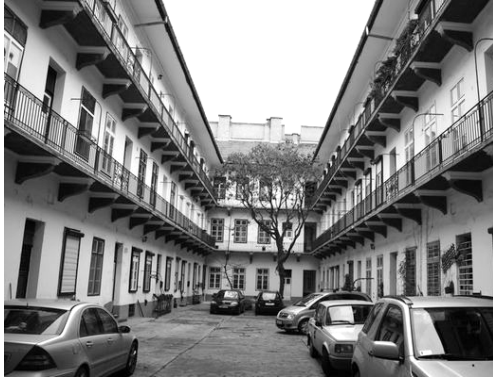
Fig. 7 Larger inner courtyard in the Jewish Quarter of Pest (Photo is courtesy of Kővári Csenge, Mészáros Mónika and Hegedűs Marcell – Ybl Miklós Faculty of Architecture)

In case of every architectural era, the enclosed geometry of the tenement houses with inner courtyard can be marked as characteristic. However, due to the higher ratio of early buildings, more L, U, or enclosed structure remained with spacious courtyard (Figs. 6, 7) – which is unique compared to the adjacent districts.

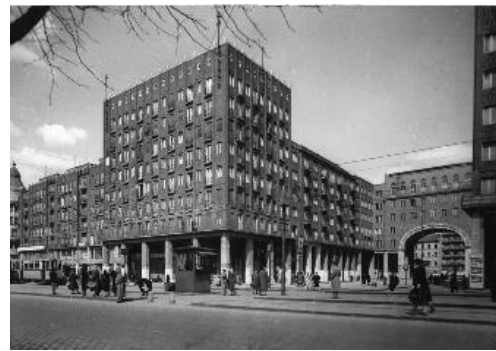
Fig. 8 Opening of Madách Boulevard the older buildings can still be seen through the gate motif [9]

The project of Madách Sugárút (Madách Boulevard) has been the most grandiose intervention in the mainly organic structure. The idea of the first so called Erzsébet (referring to Queen Elisabeth again) then later Madách Boulevard was first introduced in the beginning of the 20th century. The concept was to open a main road to rival the nearby Andrásy Boulevard, which is ever since its opening has been the most important avenue of the area. Several plans were created, from which in 1930’s, the complex of 11 interlocking buildings were built with a great gate motif to open up the densely built in inner parts. The plan however halted here, and only the beginning of the boulevard was built (Figs. 8, 9) [8].

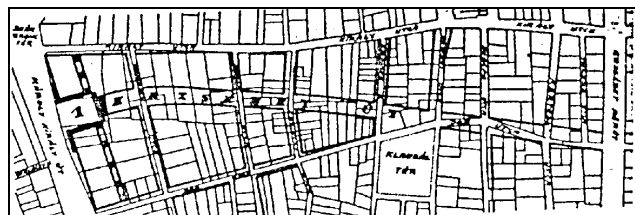
Fig. 9 Plan of Madách Boulevard – only the opening on the left part was finished [7]

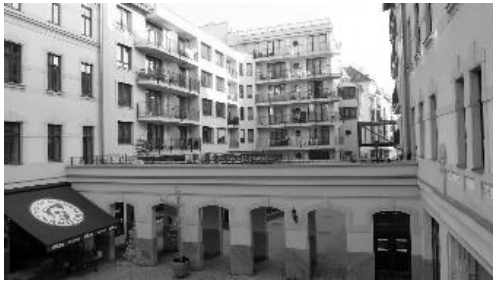
Fig.10 Contemporary buildings in the passage-section of the boulevard [10]

The Madách Promenade remained on topic ever since. The latest plans suggested the evolution of the boulevard to a promenade, then a passage [7], which is a more delicate intervention than its predecessors, reducing the Boulevard to a passage. The latest constructions have been created in this regard (Fig. 10). The investment undoubtedly increased the

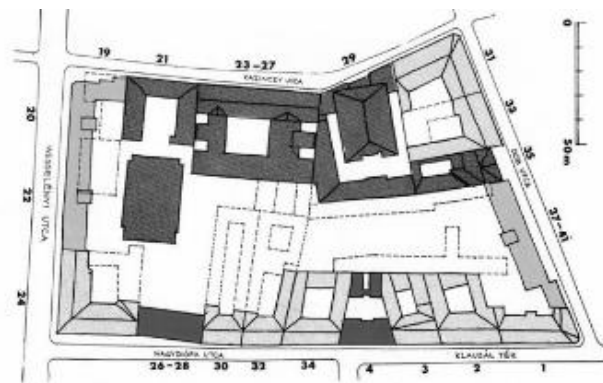
Fig. 11 Sample Block Nr. 15 after rehabilitation. The demolished wings are marked with dashed line [13]

The Erzsébetváros rehabilitation was started with the Sample Block Nr. 15 (Fig. 11).

The Sample Block Nr 15. contained a synagogue and other ecclesiastic buildings. Out of the existing 303 flats, 150 were

demolished, to build 170 in entirely new buildings. The average 49 m² floor space of the existing flats were enlarged averagely to 65 m². The inside of the blocks were rebuilt as parks and playgrounds. Between 1982 and 1985, the construction was finished. Above residential development, the public buildings (a university, a museum and offices) were renovated or given new buildings. Majority of the new residents were the same as before, or moved here from the adjacent blocks [11].

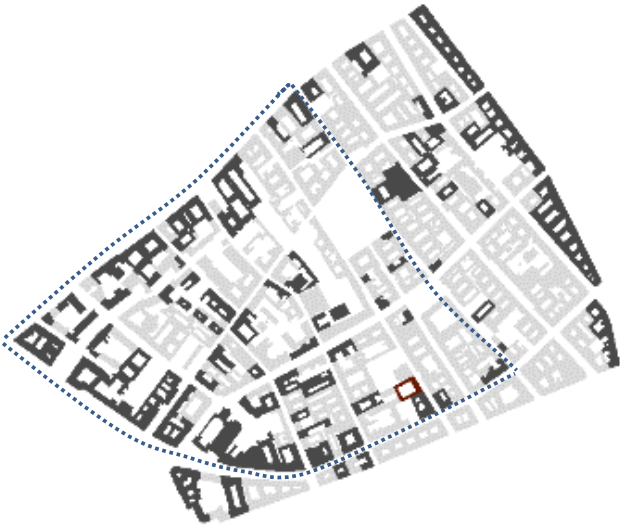
Fig. 12 Buildings under individual protection is shown with darker shade, the UNESCO buffer one area is marked by dotted line. It is also a conservation area. Based on [7]

As acknowledgement of its significance, it became part of the UNESCO World Heritage Area, which consist of the Buda Castle Hill, the Danube banks, the Andrassy Avenue (Fig. 12).
