# Assessment of the Number of Damaged Buildings from a Flood Event Using Remote Sensing Technique

**Abstract**—The heavy rainfall from 3<sup>rd</sup> to 22<sup>th</sup> January 2017 had swamped much area of Ranot district in southern Thailand. Due to heavy rainfall, the district was flooded which had a lot of effects on economy and social loss. The major objective of this study is to detect flooding extent using Sentinel-1A data and identify a number of damaged buildings over there. The data were collected in two stages as pre-flooding and during flood event. Calibration, speckle filtering, geometric correction, and histogram thresholding were performed with the data, based on intensity spectral values to classify thematic maps. The maps were used to identify flooding extent using change detection, along with the buildings digitized and collected on JOSM desktop. The numbers of damaged buildings were counted within the flooding extent with respect to building data. The total flooded areas were observed as 181.45 sq.km. These areas were mostly occurred at Ban khao, Ranot, Takhria, and Phang Yang sub-districts, respectively. The Ban khao sub-district had more occurrence than the oth

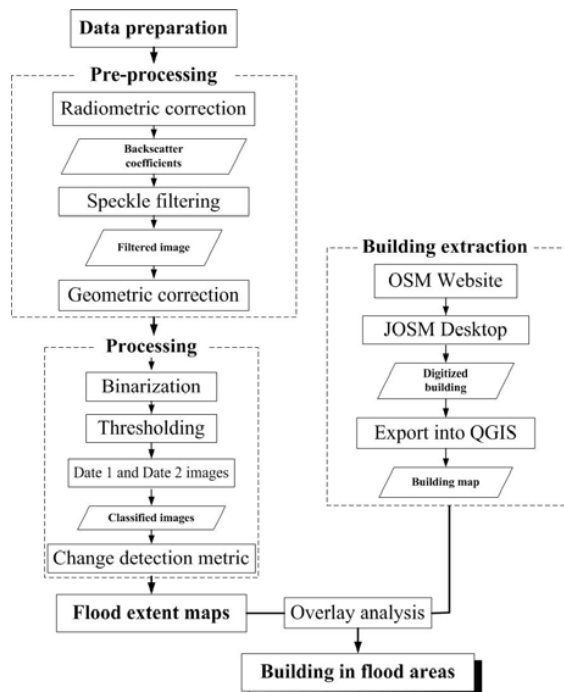
Fig. 2 Methodology

In this study, remote sensing techniques were applied to identify flooded areas and the damaged buildings. The workflow of this study is shown in Fig. 2.

Firstly, the pre-processing stage included calibration, speckle filtering, and geometric correction. These methods were conducted on the Application Platform (SNAP) version 4.0 software, and it is free software to process Sentinel data as well. The antenna pattern of the data was corrected to create new products with calibrated values of the backscatter of coefficient. Then, the improvements of new products were performed by Lee filter with widow 7x7 based on speckle filtering. The geometric correction was used to re-project coordinated system (Geography projection), and the image data were re-sampled to 8 m x 8 m (Fig. 3) [7], [5].

Secondly, the raw image data in different times (pre-flooding and during flood event) were used to identify flooded areas. In this study, the flooded areas were identified based on the Sigma0\_VV spectral values of image data with image threshold technique. This technique was used to extract flooded areas because it is effective in detecting water using spectral values [2], [17]. In the image thresholding, an image  $P(x, y)$  contains the objects on a dark background. An image was performed and then these objects are extracted by threshold technique. The formulation is as [18]:

Thirdly, the maps at different times (Date1 and Date2) were demonstrated to classify the pixel values. Then, the maps were overlaid together to identify land change using change detection method. This method can create decision change matrix presenting all the land change between dates across the flooded areas [9]. Thus, the flooded areas were extracted by pixel values of changing from land to water areas.

Finally, buildings were created from OSM website online and JOSM desktop. These are free open source software that most researchers can use to develop the project efficiently. This study digitized all buildings in Ranot district. Then, building data were exported to spatial data by QuickOSM plugins on QGIS software. Lastly, buildings (spatial data) were used to identify damages from flood event. This study identified damaged buildings by overlaying between all buildings with flooding extent and used Select by Location tool to select buildings over the flooded areas.

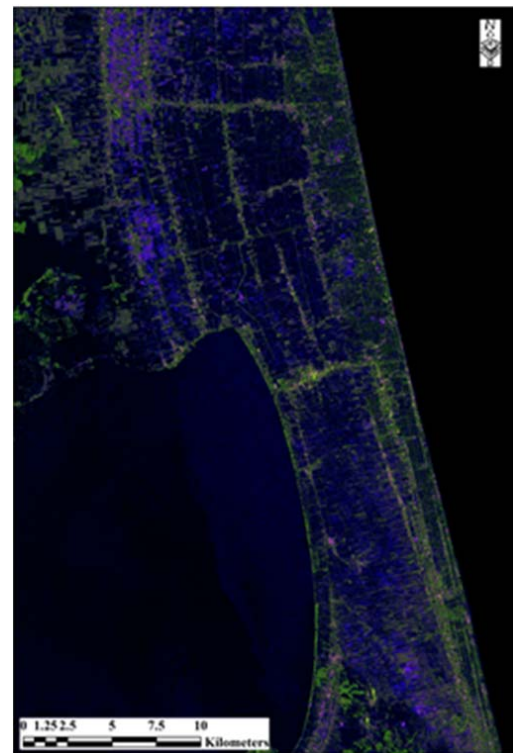
Fig. 3 (a) pre-flood is no flooded situation, and (b) during flood event is occurring

(a) Pre-flooding

(b) during flood event

The SAR-C data were classified by spectral values based on histogram thresholding. The results showed that the 1<sup>st</sup> image (28<sup>th</sup> December 2016) had 0-0.065 (water area) and 0.066 - 21.78 (land area), and 2<sup>nd</sup> image (9<sup>th</sup> January 2017) had 0-
