# Coastline Change at Koh Tao Island, Thailand

Cherdvong Saengsupavanich

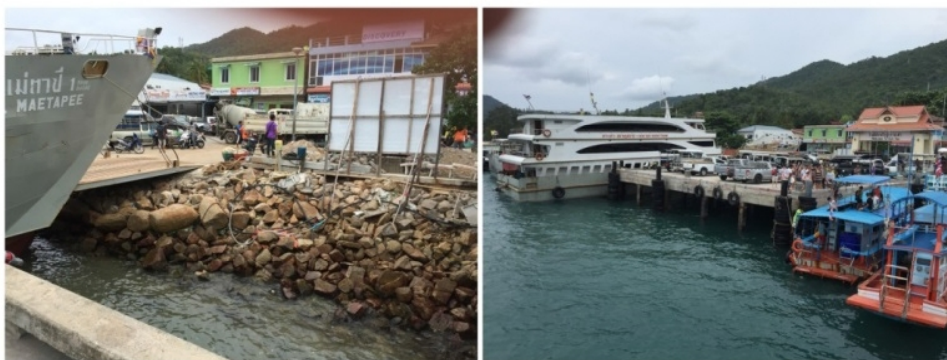
Fig. 2 Current situation at the west side of Koh Tao Island

The west side of Koh Tao Island is where tourism infrastructures, shopping area as well as restaurants are located. Piers and buildings are abundant (Fig. 2). However, this area also has a beautiful sandy beach which may be affected by tourism-generated pressure. The study, therefore, selected the west part of the island for the analysis since it was a good representative of how the shoreline responded to the tourism stress.
