# Concrete Sewer Pipe Corrosion Induced by Sulphuric Acid Environment

**Abstract**—Corrosion of concrete sewer pipes induced by sulphuric acid attack is a recognised problem worldwide, which is not only an attribute of countries with hot climate conditions as thought before. The significance of this problem is by far only realised when the pipe collapses causing surface flooding and other severe consequences. To change the existing post-reactive attitude of managing companies, easy to use and robust models are required to be developed which currently lack reliable data to be correctly calibrated. This paper focuses on laboratory experiments of establishing concrete pipe corrosion rate by submerging samples in to 0.5pH sulphuric acid solution for 56 days under 10°C, 20°C and 30°C temperature regimes. The result showed that at very early stage of the corrosion process the samples gained overall mass, at 30°C the corrosion progressed quicker than for other temperature regimes, however with time the corrosion level for 10°C and 20°C regimes tended towards those at 30°C. Overall, at these conditions the corrosion rates of 10 mm/year, 13,5 mm/year and 17 mm/year were observed.

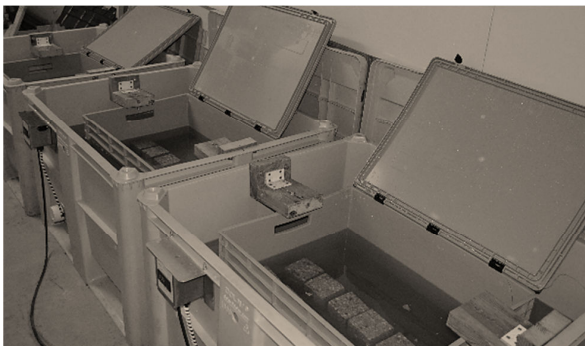
Fig. 1 Experimental set up of cubes being submerged into diluted sulphuric acid

A total number of 45 cubes, cut out from brand-new circular concrete pipe were used in these experiments. Each cube had a measurement of 100x100x100mm and was cut with diamond-blade rotating saw, however as the process of cutting a circular pipe is very challenging and labour consuming a tolerance of 10% in each side measurement of the cube was allowed for. A number of 15 cubes were fully submerged into 0.5 pH solution of sulphuric acid in each of the containers in Tanks 1, 2 and 3. Further they were extracted at different points in time and assessed using different techniques to account for the corrosion level. Fig. 1 demonstrates a setup of tanks, containers and cubes located in the environmental chamber.

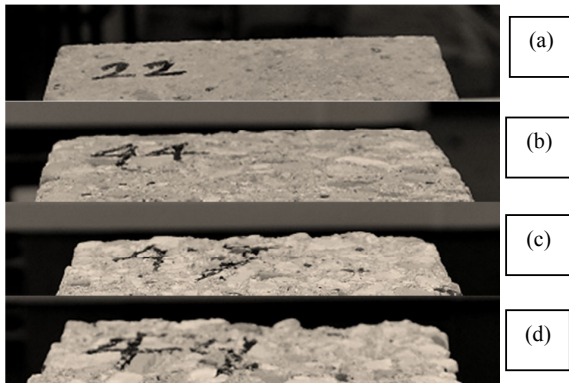
Fig. 2 Cube sample 22 before immersion (a), cube samples 44 after 28 days (b), cube sample 47 after 42 days (c) and cube sample 49 after 56 days of immersion (d)

The result of this study are summarised in Table I, where column 1 identifies the tank number (ABI are 'all cubes before immersion' and AAI are 'all cubes after immersion'), followed by the number of days the cube was submerged in the solution and associated cube numbers. Column 4 shows the average of three cube's mass after exposure into acid solution, followed by mass loss compared to original mass values and bulk density after exposure. Last column shows the corrosion level obtained from the digital photo-tests (Fig. 2 shows one cube side before immersion and three cubes ejected from acid solution at different days).

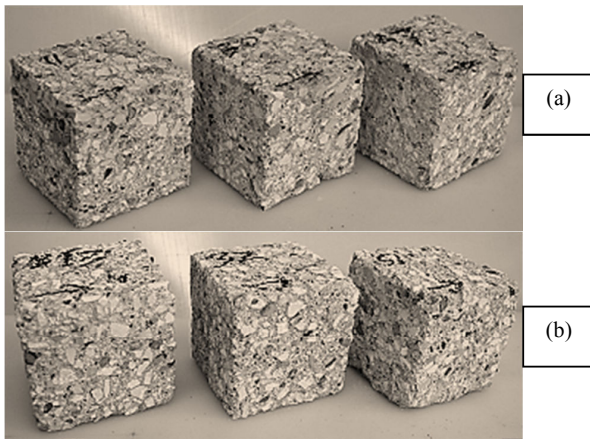
Fig. 5 Cube samples 11, 30 and 47 (left to right) after 42 days immersion into 0.5 pH sulphuric acid solution and temperatures of 10°C, 20°C and 30°C, respectively (a) and cube samples 13, 32 and 51 (left to right) after 56 days immersion into 0.5 pH sulphuric acid solution and temperatures of 10°C, 20°C and 30°C, respectively (b)

Interestingly that the leap between the cubes corrosion depth doubled in periods from 28 days to 42 days and then further between 42 days to 56 days which could be visibly assessed. Examples of such can we seen in Fig. 5.
