Effects of Corrosion on Reinforced Concrete Beams with Silica Fume and Polypropylene Fibre

S.Shanmugam, V.G. Srisanthi, and S.Ramachandran

Abstract—Reinforced concrete has good durability and excellent structural performance. But there are cases of early deterioration due to a number of factors, one prominent factor being corrosion of steel reinforcement. The process of corrosion sets in due to ingress of moisture, oxygen and other ingredients into the body of concrete, which is unsound, permeable and absorbent. Cracks due to structural and other causes such as creep, shrinkage, etc also allow ingress of moisture and other harmful ingredients and thus accelerate the rate of corrosion. There are several interactive factors both external and internal, which lead to corrosion of reinforcement and ultimately failure of structures.

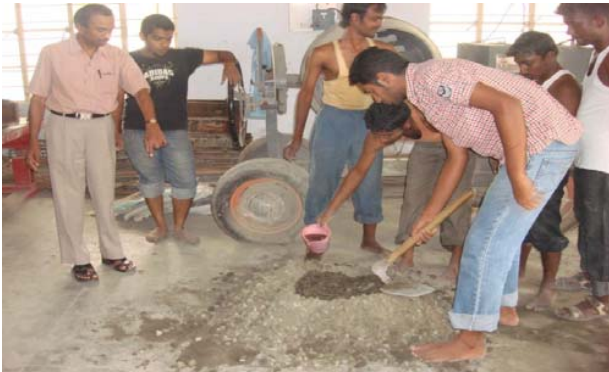
Fig. 1 Mixing of Concrete for Casting of Beam Specimens

1000 mm were selected. Bottom reinforcement of 2 numbers of 10 mm diameter, top reinforcement of 2 numbers of 8 mm diameter and shear reinforcement of 6 mm diameter two legged stirrups were used. The surface of rebars was derusted using wire brush and rust clear solution in order to remove any loose rust particles. The coating material was applied over the surface of the rebars with a brush and was allowed to cure. The initial weight of the rebars was taken and then the rebars were tied together to form the skeleton reinforcement cage. Twenty four numbers of beam specimens were cast using M35 grade of concrete. (Fig. 1). After curing for a period of 28 days, the specimens were transferred to Fibre Reinforced Plastic (FRP) tanks and were subjected to accelerated corrosion process.

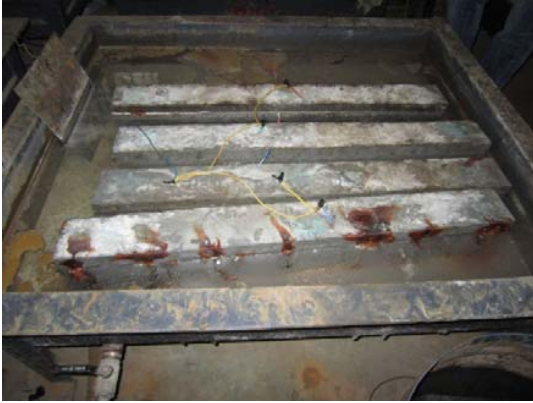
Fig. 3 Accelerated Corrosion Process for Unstressed Condition

Galvanostatic method was used to accelerate the corrosion process. Having the embedded steel as anode and an external stainless steel plate as cathode the beam specimens were impressed a selected current intensity under low voltage conditions for a period of 15 days. The specimens and steel plates were immersed in an electrolyte solution of 3% sodium chloride concentration [2] to simulate the conditions of sea water artificially. The current was applied using a regulated D.C. Rectifier. (Figs. 2 & 3)

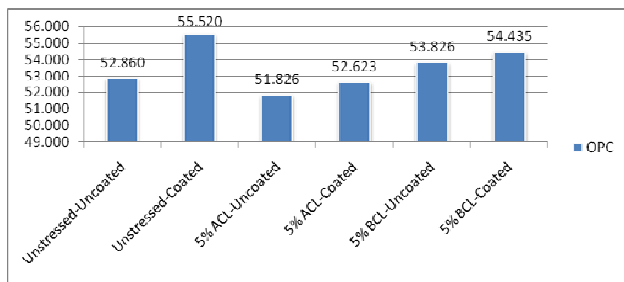
Fig. 4 Load Carrying Capacity for Specimens of OPC (in kN)

The load carrying capacity of the specimens with coated rebars is 5.03 % more than that of the specimens with uncoated rebars.

The load carrying capacity of the specimens with coated rebars is 1.53 % more than that of the specimens with uncoated rebars.

The load carrying capacity of the specimens with coated rebars is 1.13 % more than that of the specimens with uncoated rebars.

In general, the load carrying capacity of unstressed specimens is higher than the stressed specimens subjected to corrosion. Also, the load carrying capacity of the specimens with coated rebars (stressed 5% above crack load & 5% below crack load) is less than the specimens with uncoated rebars.

The load carrying capacities of various specimens are given in Figs. 4 to 7.
