# Energy Systems and Crushing Behavior of Fiber Reinforced Composite Materials

**Abstract**—Effect of geometry on crushing behavior, energy absorption and failure mode of woven roving jute fiber/epoxy laminated composite tubes were experimentally studied. Investigations were carried out on three different geometrical types of composite tubes (circular, square and radial corrugated) subjected to axial compressive loading. It was observed in axial crushing study that the load bearing capability is significantly influenced by corrugation geometry. The influence of geometries of specimens was supported by the plotted load – displacement curves of the tests.

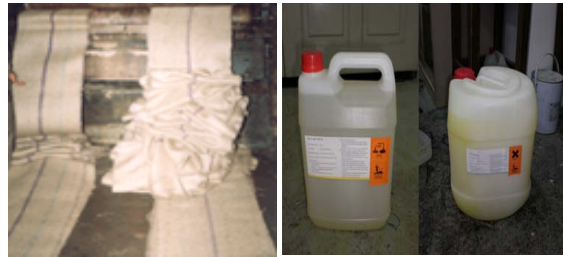
Fig. 4 Jute Fiber, Epoxy with hardener

Three types of specimen have been investigated, SJFT, CJFT and RCJFT. The entire structures are made of woven roving jute fiber/epoxy as shown in Figure 4. Three specimens were fabricated under the same conditions with a fixed fiber orientation angle of  $0^\circ/90^\circ$  and epoxy resin (ZE-LAM 7892 A) with hardener (ZE-LAM 7892 B). All the specimens have inside diameter (d) 10 cm, height (h) 10 cm and wall thinness (t) 5mm. Three types of wooden mandrels have been manufactured in the workshop. The mandrels have the same length of 30 cm as shown in Fig 5.

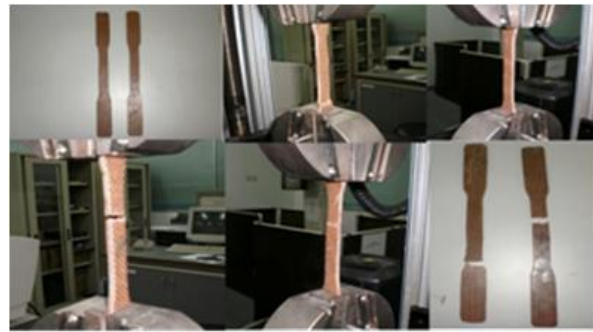
Fig. 6 Set Up of Tensile Test

The mechanical properties of jute fabric/epoxy composite materials have been investigated by using the INSTRON tensile testing machine, where the specimen is subjected to tension as shown in Figure 6. Mechanical properties of jute fiber/epoxy composite material are listed in Table 3.

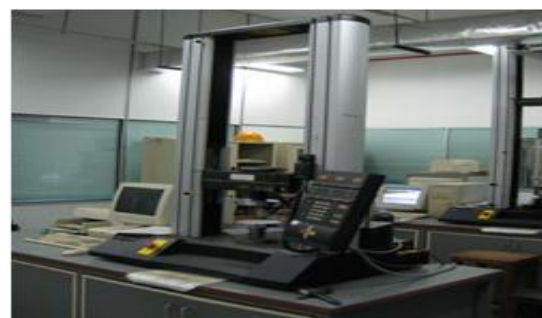
Fig. 7 Photograph of the INSTRON machine

The specimens were tested in quasi-static axial compression between two flat steel plates one is static and the other one moving with constant crushing speed. INSTRON 4469 digital testing machine (Figure. 7) with full scale load range of 50kN was used. Three specimens of each type of composite tubes were tested. Load platens were set parallel to each other before testing. All composite tubes were compressed at a loading rate of 15 mm/min until limited crush, which implies complete compaction of the tubes being tested. Load and displacement were recorded by an automatic data acquisition system. Progress and history of triangular crushing test of SJFT, CJFT and RCJFT are shown in Figures 8-10.

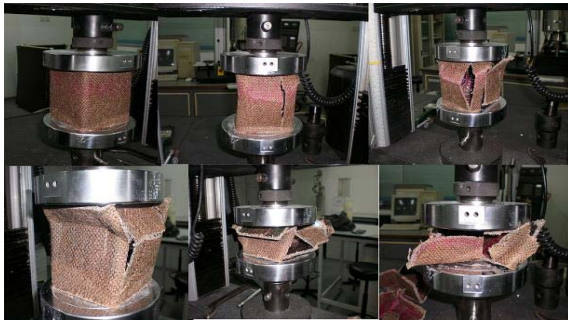
Fig. 8 Progress of Crashing Test of SQJFT

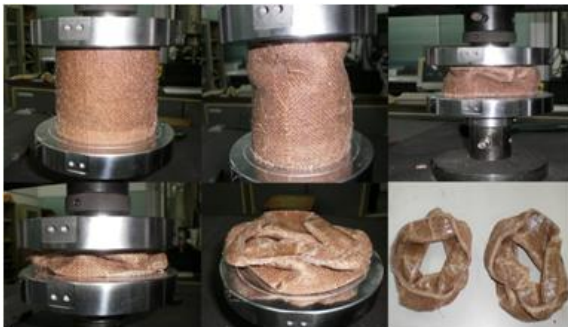
Fig. 9 Progress of Crashing Test of CJFT

Figure 12 (a) shows a typical crushing deformation of the CJFT subjected to quasi-static compressive load. Non-linearity is evident during the pre-crush-stage as shown in Figure 9b, where non-axisymmetric buckling is seen, which is characterized by unstable local tube wall buckling initiated the failure at the top end of the specimen as shown in Figure 12b. In this stage the tube resistance reaches its first and highest peak (45.35kN) at a deformation of 4.44 mm. On the other hand, the tube load-carrying capacity decreases gradually with the progress of crushing process. It is seen that the progressive folding in buckling is characterized by hinge formation and folding of the tube walls as in the case of ductile fiber-reinforced materials with the development of wrinkles. These wrinkles and buckles initiate and develop sequentially from one end of a tube under buckling process. The accumulation of the materials of the specimen caused the growth in the load/displacement curve at the end as shown in Figure 12c.

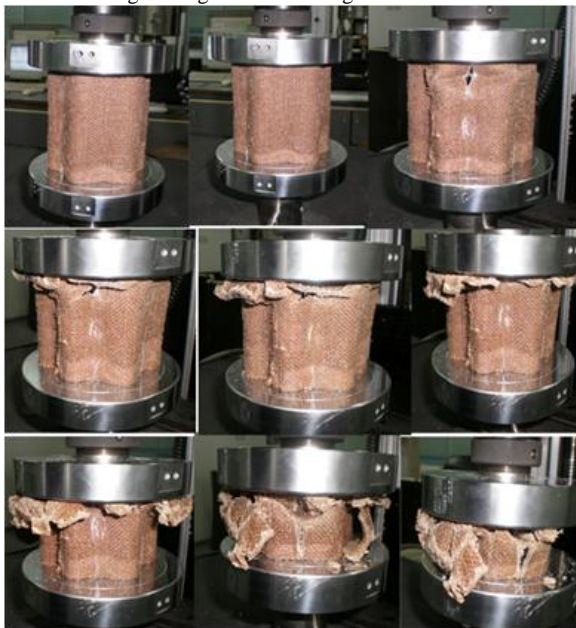
Fig.10 Progress of Crashing Test of RCJFT

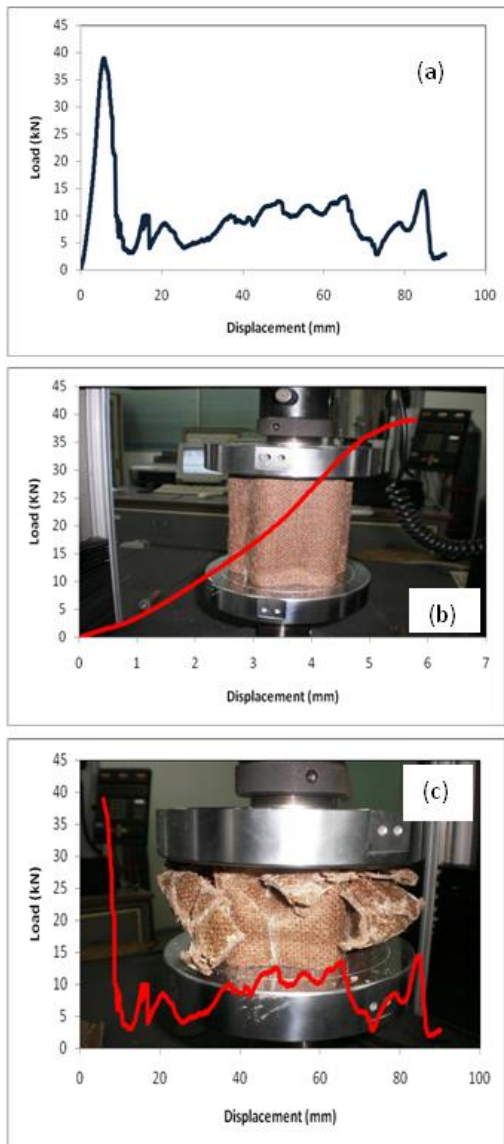
Fig. 13 Load-Displacement Curve of RCJFT

Figure 13 shows a crushing deformation of the RCJFT, subjected to quasi-static compressive load, which is characterized by longitudinal fracture, crack propagation and splitting of the tube walls transversely to the tube longitudinal axis. This is typically initiated at the top end of the compressed tube associated with low crash energy absorption compared to the stable progressive end-crushing mode. In this mode, the audible matrix cracking and fiber breakage occurred when the tube wall resistance reaches its peak magnitude of 38.84 kN at 5.77 mm as shown in Figure 130-a and 13-b. It is observed that the tube resistance sharply reduces with the progress of crushing and the tube walls were splitting transversely with rapid propagation of brittle fracture in the corrugated walls of the tube leading to a catastrophic failure as shown in Figure 13c.
