Evaluation of Corrosion in Steel Reinforced Concrete with Brick Waste

Julieta D. Chelaru, Maria Gorea

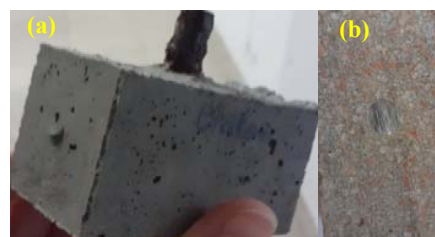
Fig. 1 The mortar samples: (a) generally view; (b) cross section

The raw mortar samples were poured into metallic molds with 40 mm × 40 mm × 160 mm in size. The steel rebar with 6 mm diameter was embedded in middle of mortar samples (Fig. 1). The samples molds with mortar were maintained in RH 95% during 24 hours. For the corrosion tests, the samples were removed from the mold and cured in humidity atmosphere.

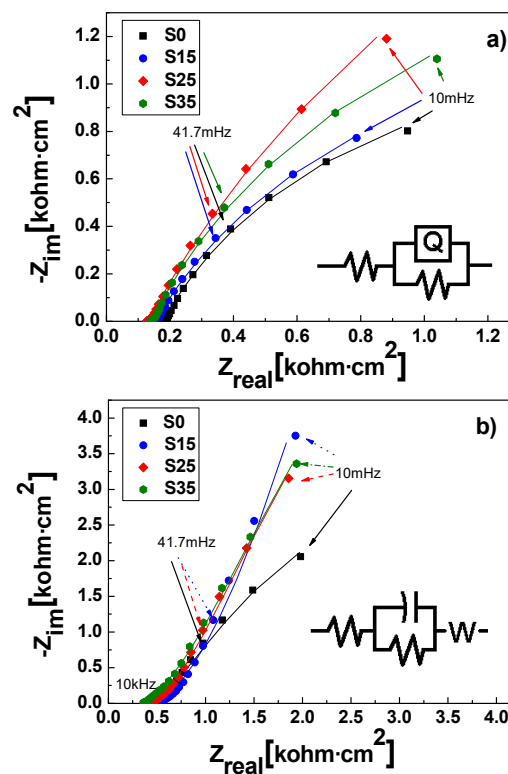
Fig. 2 Nyquist impedance diagrams for the rebar electrodes at: (a) 1 month, (b) 26 months, immersed in 3 wt.% NaCl; the lines represent fitted data

The EIS plots were recorded immediately after OCP in order to investigate the behavior corrosion of steel rebar in different compositions of mortar. The results are presented in Fig. 2. The Nyquist plots for samples that were maintained for 1 month in humid conditions indicated that the impedance spectra exhibit one depressed capacitive loop (Fig. 2 (a)). The impedance spectra were analyzed for all samples by fitting the experimental data with an equivalent electrical circuit that

contain only one R-C couple (Fig. 2 (a)); R_{ct} representing the charge transfer resistance and, C_{dl} the double layer capacity, at the rebar steel | electrolyte interface. The values of C_{dl} were calculated using (1):

Analyzing the Nyquist plots in the case of samples maintained for 26 months in humid conditions, it can be noticed a completely different behavior compared with samples maintained for 1 month. The impedance spectra were analyzed for all samples by fitting the experimental data with a R(CR)W equivalent electrical circuit. The presence of Warburg impedance indicates that the electrochemical reactions are controlled by diffusion phenomenon (Fig. 2 (b)). The R_{Ω} represents the electrolyte resistance between the reference electrode and the work electrodes surface, in the case of both equivalent electrical circuits used. To understand the electrochemical process occurring at the WEs surface, the parameters for all samples were obtained by using the proposed equivalent electrical circuits. The quality of fitting procedure was evaluated by the chi squared (χ^2) values, which were of the order 10^{-4} . The results are shown in Table III.

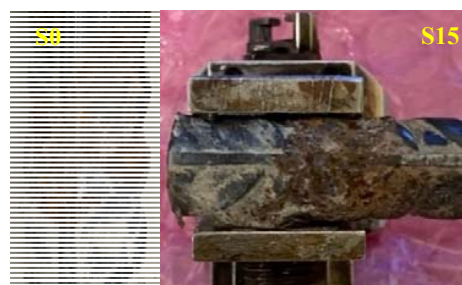
Fig. 4 Rebar samples for SEM-EDX analysis

SEM-EDX analysis was used for illustrating the intermediary layer between steel rebar and mortar matrix (S0 and S15). The steel rebar samples are presented in Fig. 4. Visual examination on the surface of the rebar embedded in mortar does not show corroded areas. However, the area directly exposed to the external conditions presents a severe corrosion. The results of the SEM-EDX analysis are presented in Figs. 5 and 6.
