# Experimental Study on the Floor Vibration Evaluation of Concrete Slab for Existing Buildings

**Abstract**— Damages from noise and vibration are increasing every year, most of which are noises between floors in deteriorated building caused by floor impact sound. In this study, the concrete slab measured vibration impact sound for evaluation floor vibration of deteriorated buildings that fails to satisfy with the minimum thickness. In this experimental study, the vibration scale by impact sound was calibrated and compared with ISO and AIJ standard for vibration. The results show that vibration in slab with thickness used in existing building reach human perception levels.

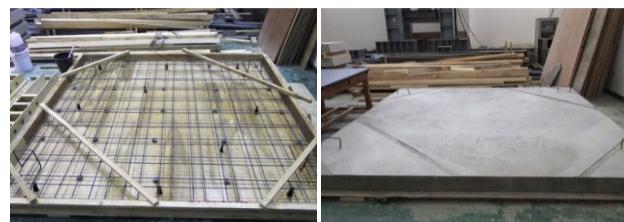
Fig. 1 Specimen of vibration measurement

Design strength of the specimen for floor vibration assessment of concrete slab is 24MPa, and the specimen was manufactured pursuant to KS F 2865 and JIS A 1440-2 with size of 3200X3200X140mm [7],[8]. D13 rebar was arranged for 28 days of atmosphere curing. For the experiment, a 70kg adult male was allowed to jump from the center every second to

(a) Mold of floor vibration      (b) Specimen of floor vibration

inflict impact on the floor, and measurement was done at each point. Measurement as done using accelerometer, and Fast Fourier Transform was performed for comparative analysis with the vibration assessment criteria. Figs. 1 (a) and (b) are mold of floor vibration and specimen of floor vibration.

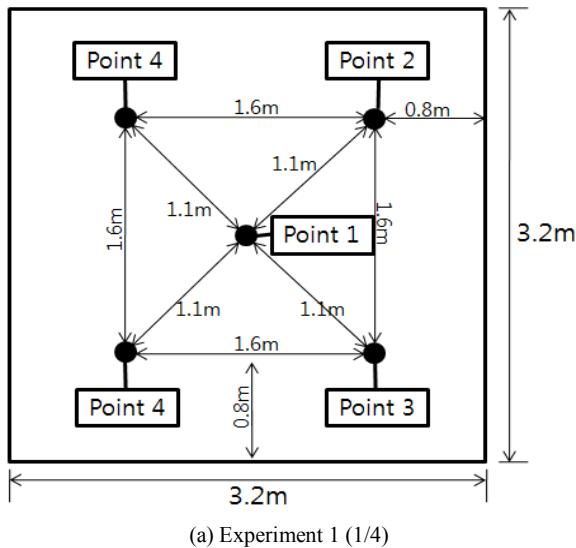
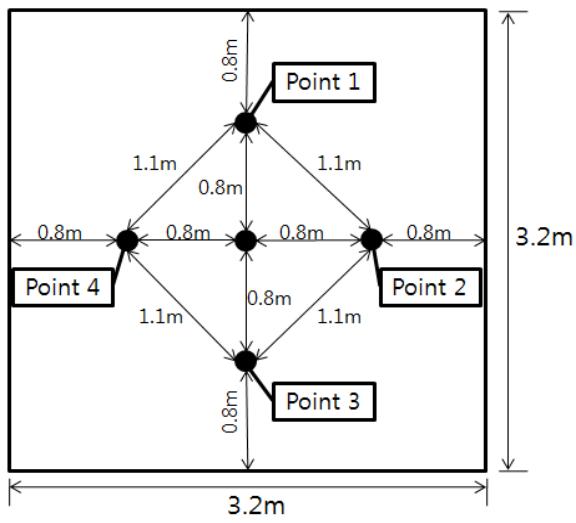
Fig. 2 Point of vibration measurement

(a) Experiment 1 (1/4)

(b) Experiment 2 (1/2)

As shown in Figs. 2 (a) and (b), the experiment for vibration measurement using accelerometer was divided into 1/4 point of experiment 1 and 1/2 point of experiment 2. Figs. 3 (a) and (b) show data measurement using accelerometer and Table II is the AIJ residential performance assessment criteria [5].

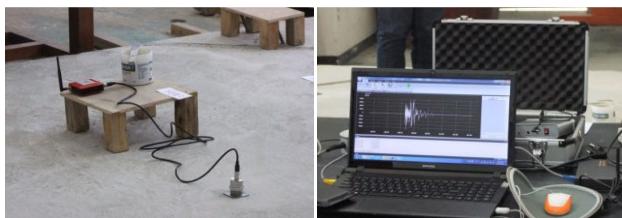
Fig. 3 Data measurement by accelerometer

(a) Accelerometer

### (b) Data measurement

In vibration measurement, selection of an appropriate sensor is the most important aspect. For selection of sensor, dynamic range which includes expected frequency domain of the measurement subject, resonance frequency, signal sensitivity under measurement conditions, and noise level of the sensor must be taken into account. The sensor was installed according to the basic guidelines to maintain horizontality, and it was fixed to an accurate position so that the response axis agreed with the direction of measurement. In addition, since the sensor can be affected by temperature, magnet and electricity, a place that does not receive external influence like nearby high-tension power line was selected for installation. Table I shows the specifications of accelerometer.

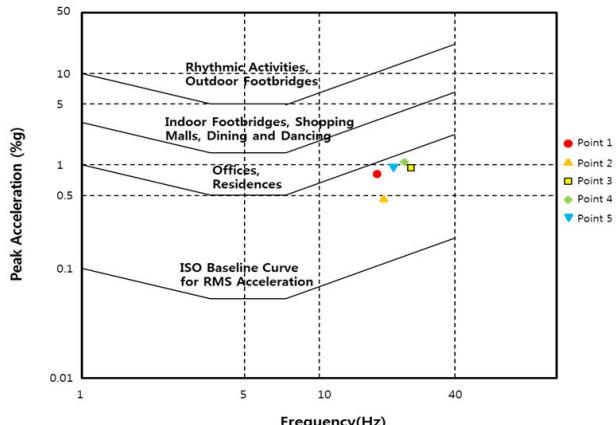
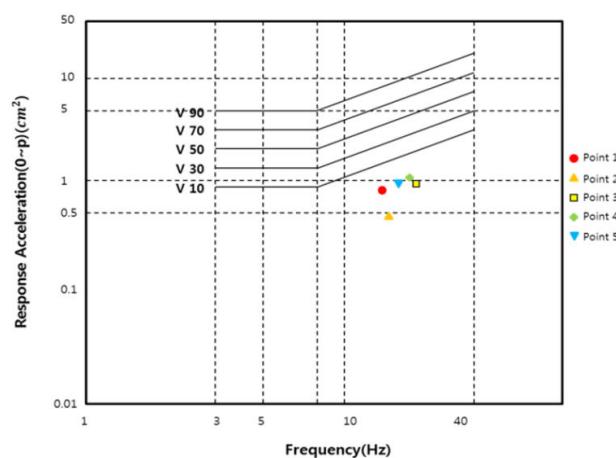
Fig. 4 Compare standard of experiment 1

(a) ISO

(b) AIJ

Serviceability value at which people feel discomfort was based on the recommended value of ISO 2603-2. As in Table III, serviceability limit of office and residential spaces at predominant frequencies of 18.5, 19.6, 22.6, 20.0 and 22.3Hz for Points 1~5 is 0.7, 0.5, 0.9, 1.1 and 0.9% of gravitational acceleration. Accordingly, 0.7, 0.5, 0.9, 1.1 and 0.9%g were set as reference values. The highest acceleration amplitudes measured were 0.73, 0.47, 0.87, 1.07 and 0.87%. These values are not close to the recommended values for office and residential spaces. Since the range of vibration was 18.5%~22.57%g, there is no problem in terms of serviceability. Figs. 4 (a) and (b) comparatively analyze the measurements results of experiment 1 with the criteria of ISO and AIJ. Figs. 5 (a) and (b) show the frequency value of Point 5 among experimental values of experiment 1.
