# Laser Welded Ni-Cr Dental Alloys Inspection

**Abstract**—Minor problems arising from optimizations by welding of fixed prostheses frameworks can be identified by macroscopic and microscopic visual inspection. The purpose of this study was to highlight the visible discontinuities present in the laser welds of dental Ni-Cr alloys. Ni-Cr base metal alloys designated for fixed prostheses manufacture were selected for the experiments. Using cast plates, preliminary tests were conducted by laser welding. Macroscopic visual inspection was done carefully to assess the defects of the welding rib. Electron microscopy images allowed visualization of small discontinuities, which escapes visual inspection. Making comparison to Ni-Cr alloys taken in the experiment and laser welded, after visual analysis, the best welds appear for Heraenium NA alloy.

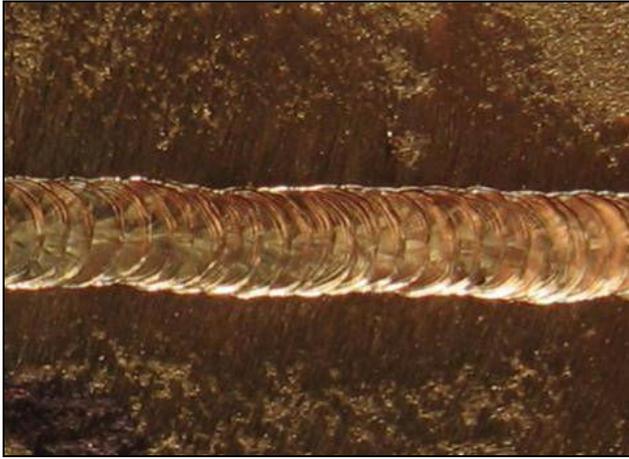
Fig. 1 Aspect of a welded Ni-Cr alloy sample (welding without filler): uniform overlapping of the spots, no visible defects

Macroscopic visual inspection was done carefully to assess the defects of the welding rib. Welding rib width, craters on the surface, continuity of the weld, visible cracks, penetration degree of the spot, and any surface inclusions were examined (Fig. 1-4). Some samples showed visible defects, but other seemed without any discontinuity and were completed with microscopy examinations.

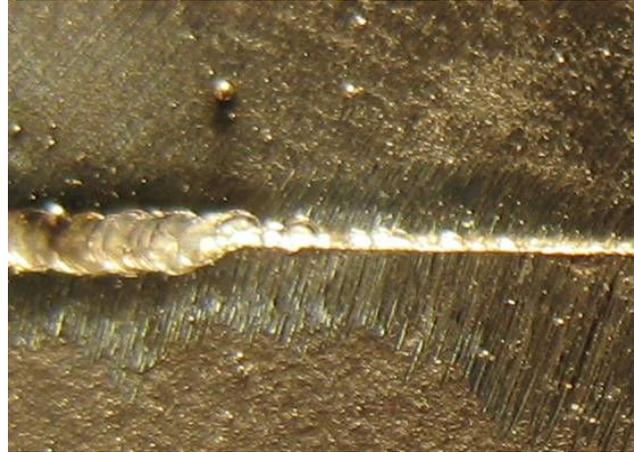
Fig. 4 Aspect of Ni-Cr alloy sample (welding with filler material): poor penetration on the opposite side

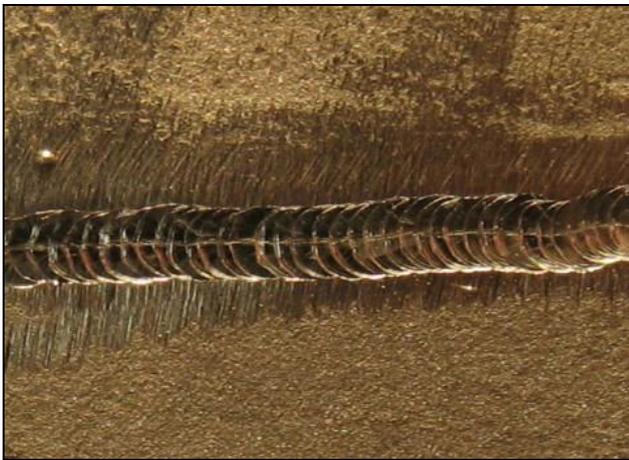
Fig. 2 Aspect of Ni-Cr alloy sample (welding without filler material): uniform width of the weld, continues crack along the joining line

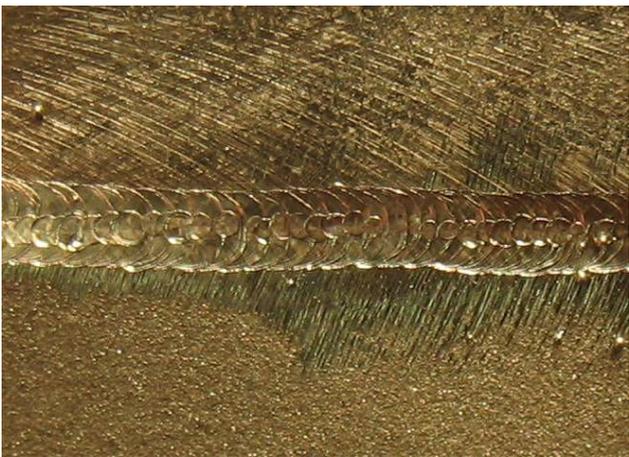
Fig. 3 Aspect of Ni-Cr alloy sample (welding without filler material): good penetration on the opposite side

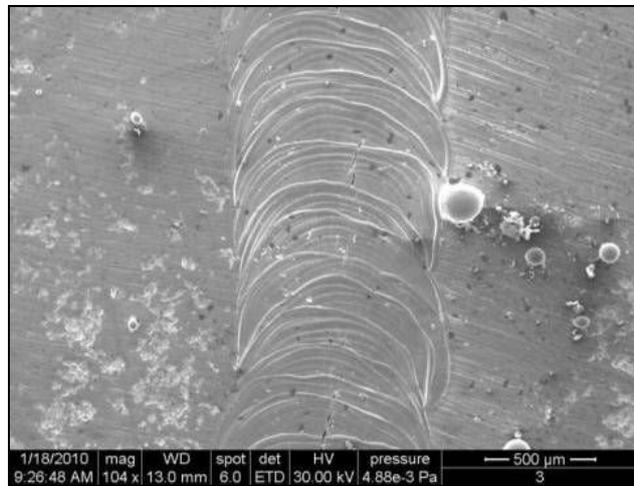
Fig. 5 Electron microscopic image of a Ni-Cr alloy welded joints without filler material: short longitudinal cracks on the welding rib (mag 104x)

The examined samples revealed some small cracks in the welding rib, both longitudinal and transverse or oblique. Some start from the main longitudinal cracks, some from the middle spot, others are completely isolated.

Also details of the the weld surface, spots aspect, their overlapping and distribution of filler material could be detected by microscopic analysis (Fig. 5-8).

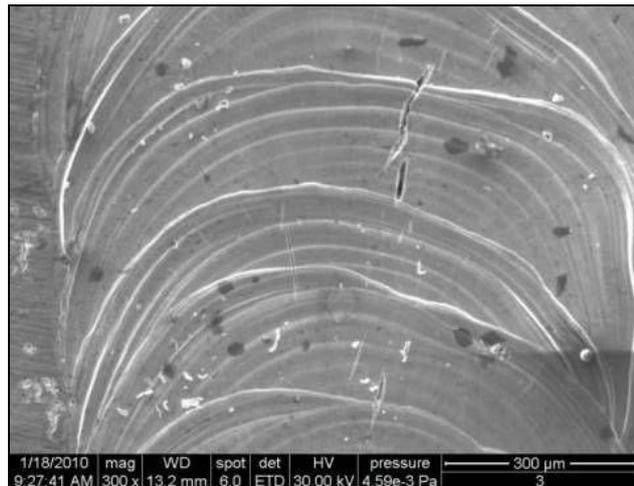
Fig. 6 Electron microscopic image of a Ni-Cr alloy welded joints without filler material: short longitudinal cracks on the welding rib (mag 300x)

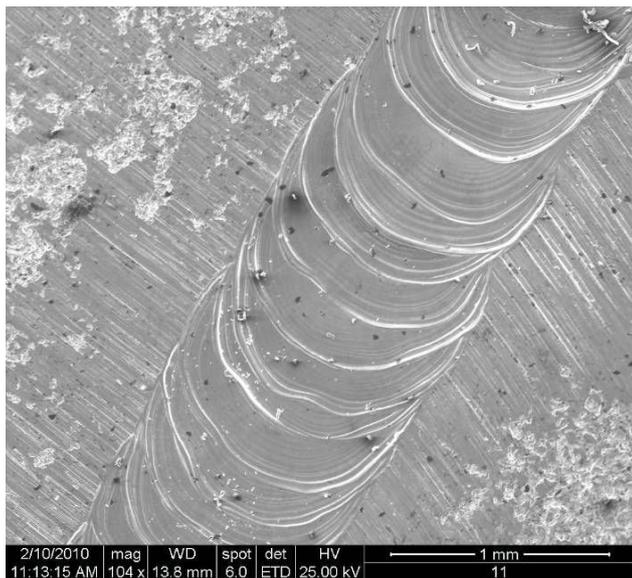
Fig. 7 Electronmicroscopic image of a Ni-Cr alloy welded joints without filler material: no visible defects on the welding rib (mag 104x)

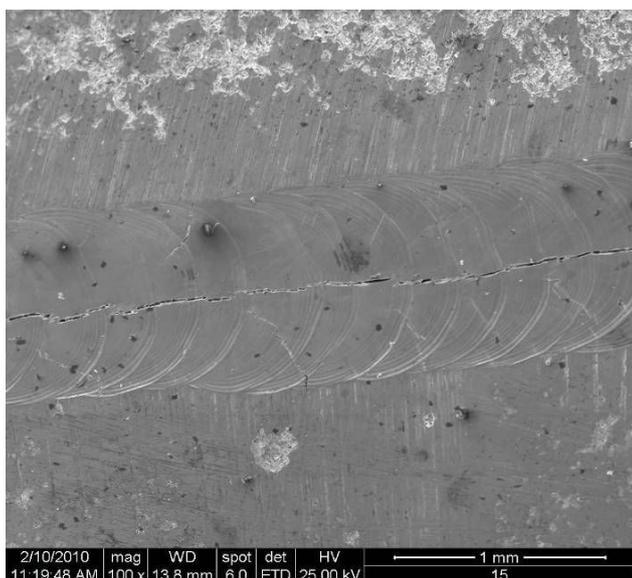
Fig. 8 Electronmicroscopic image of a Ni-Cr alloy welded joints without filler material: continuous longitudinal crack on the welding rib (mag 100x)
