# Non-Chronological Approach in Crane Girder and Composite Steel Beam Installation: Case Study

Govindaraj Ramanathan

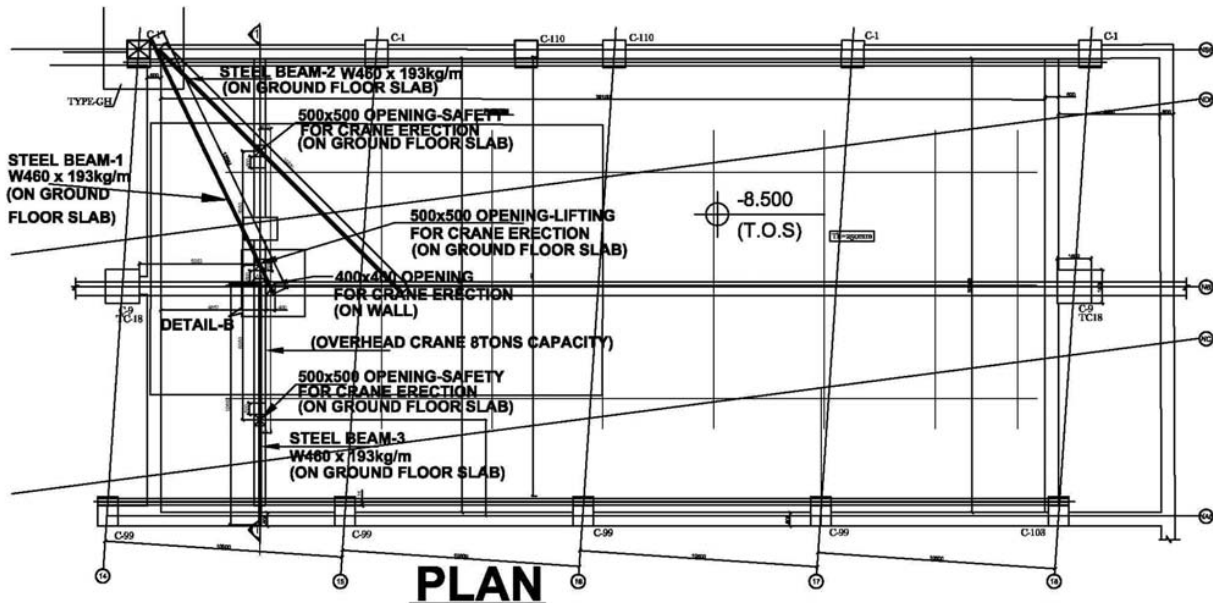
Fig. 1 Plan view of crane-girder below the ground floor slab

In a project with two-story massive building, we have to install a 19-meter long overhead crane girder just below the ground level. There was a composite beam (steel and concrete) of 42-meter length at the ground floor and it crosses 90 degrees at the center of overhead crane girder. There were five numbers of composite columns located above the ground floor composite beam and similar structure continued up to second floor. Moreover, the composite beam supports floor slabs and beams of 10 m wide on both sides at each floor. The usual chronological procedure is described as below:

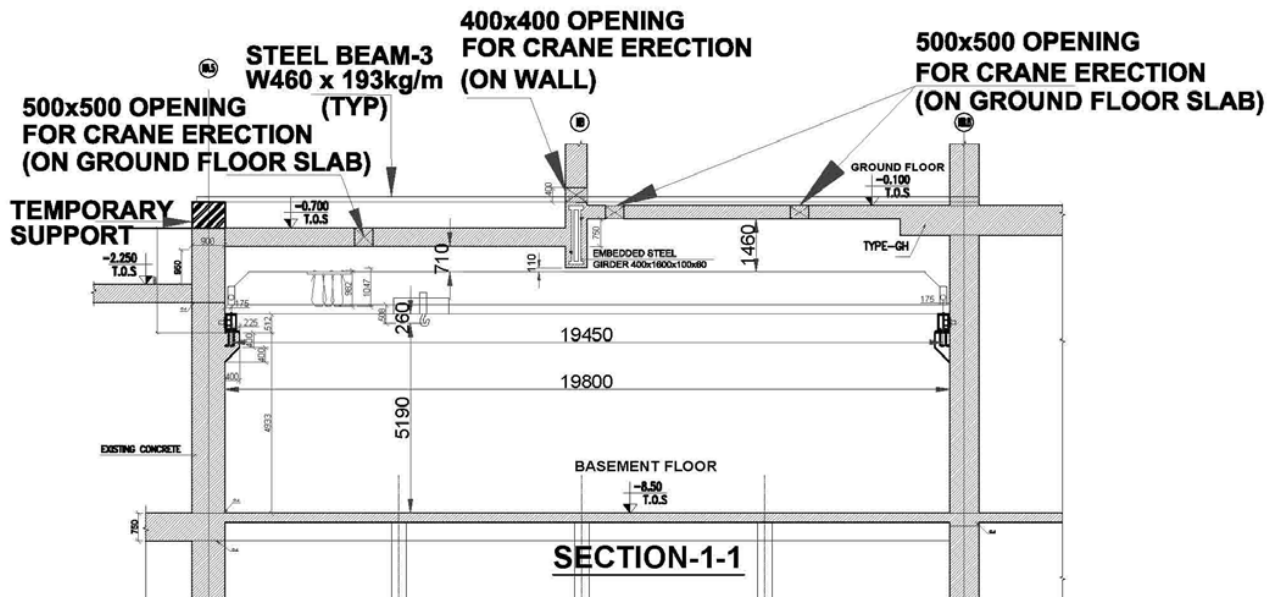
Fig. 2 Section view of crane-girder below the ground floor slab

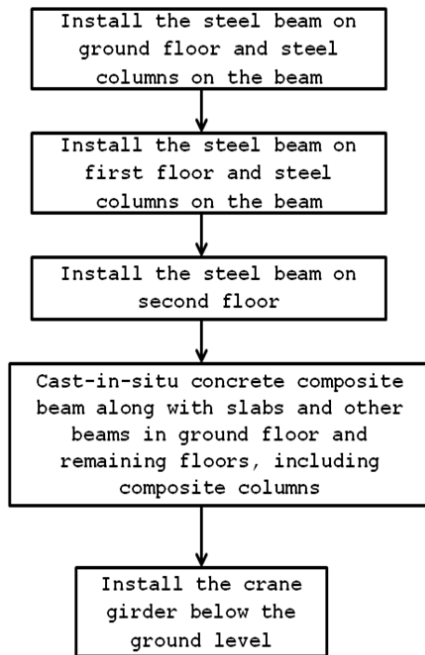
Fig. 3 Proposed non-chronological procedure

After careful study of the actual situation, the following sequences of work activity (as illustrated in Fig. 3) decisions were taken with pre-measure activities.

We started with the installation of steel beams and steel columns starting from ground floor based on our proposed approach, as illustrated in Fig. 3. The steel beams are of 400 X 1400 mm, 400 X 1700 mm, and 400 X 2000 mm. The columns are of 400 X 1600 mm, 400 X 1400 mm, and 400 X 1000 mm. The overhead crane girder is of 19 m long.

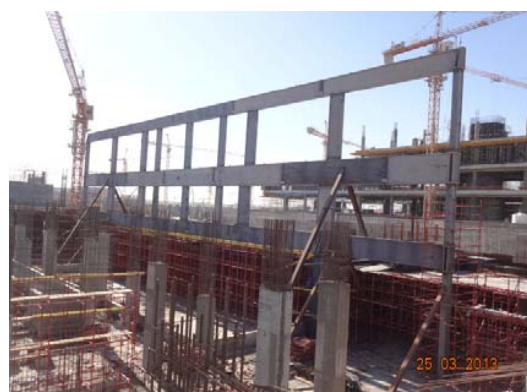
Fig. 4 (a) Installation of steel beams and columns (basement view)

The installation of steel beams and steel columns from ground floor view is illustrated in Figs. 4 (a) and (b). The complete structure after the installation of overhead crane girder is illustrated in Fig. 5. The spacing between the top of the overhead crane girder and the bottom of the beam is 250 mm.

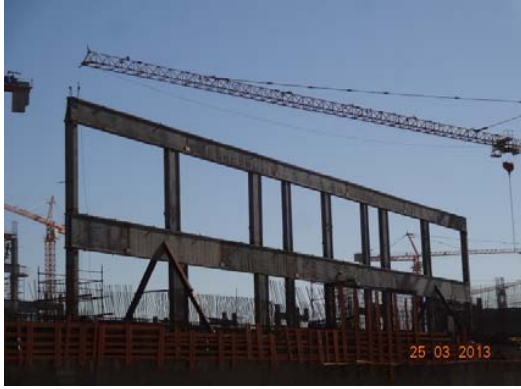
Fig. 4 (b) Installation of steel beams and columns (ground floor view)

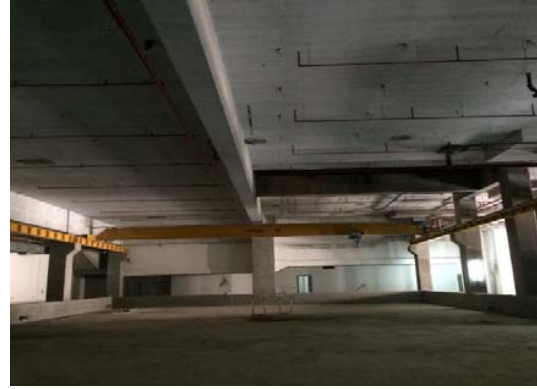
Fig. 5 Installation of overhead crane girder
