# Performance Analysis of Ferrocement Retrofitted Masonry Wall Units under Cyclic Loading

**Abstract**—A huge portion of old masonry buildings in Bangladesh are vulnerable to earthquake. In most of the cases these buildings contain unreinforced masonry wall which are most likely to be subjected to earthquake damages. Due to deterioration of mortar joint and aging, shear resistance of these unreinforced masonry walls dwindle. So, retrofitting of these old buildings has become an important issue. Among many researched and experimented techniques, ferrocement retrofitting can be a low cost technique in context of the economic condition of Bangladesh. This study aims at investigating the behavior of ferrocement retrofitted unconfined URM walls under different types of cyclic loading. Four 725 mm × 725 mm masonry wall units were prepared with bricks jointed by stretcher bond with 12.5 mm mortar between two adjacent layers of bricks. To compare the effectiveness of ferrocement retrofitting a particular type wire mesh was used in this experiment which is 20 gauge woven wire mesh with 12.5 mm × 12.5 mm square opening. After retrofitting with ferrocement these wall units were tested by app

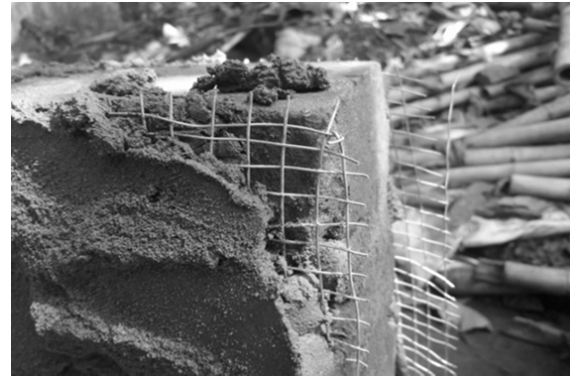
Fig. 4 Brick Wall After Applying of Ferrocement Coating

plastered with 12.5 mm mortar on both faces. Now 20 gauge woven wire meshes were wrapped on two walls (FRS-20 and FRSC- 20) on both faces. 12.5 mm mortar was again applied on these wrapped wire meshes to complete the ferrocement work. Fig. 4 represents the state of a wall after the completion of applying ferrocement coating.

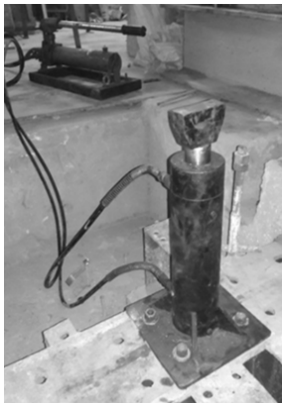
Fig. 5 Hydraulic Jack

After completion of preparation, the walls were ready to be tested by testing machine. A hydraulic jack was used to apply cyclic load to the specimens as showed in Fig. 5. The hydraulic jack was pressure operated and its maximum capacity was 150 Mpa. Two M-shaped steel frames were also used in this experiment. One steel frame was attached with the hydraulic jack.
