Performance Evaluation of an Aboveground LNG Storage Tank Cover using Nondestructive and Destructive Tests

Sungnam Hong, Sun-Kyu Park, Jieun Jeong, and Jinwoong Choi

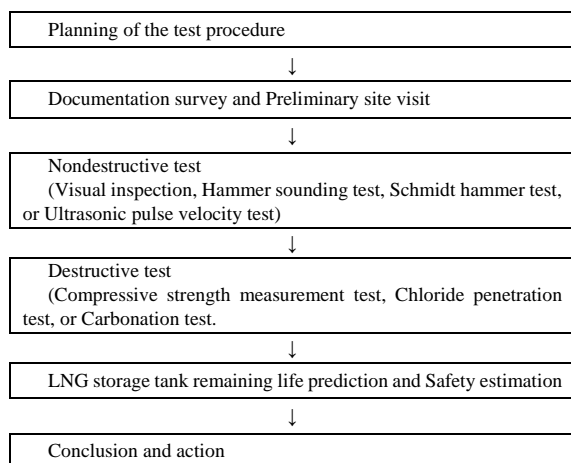
Fig. 2 LNG storage tank performance evaluation procedure

The deterioration and performance of the concrete cover of an LNG storage tank were evaluated to manage the tank cover's service life, in accordance with the procedure suggested in Fig. 2 The following conclusions were drawn.

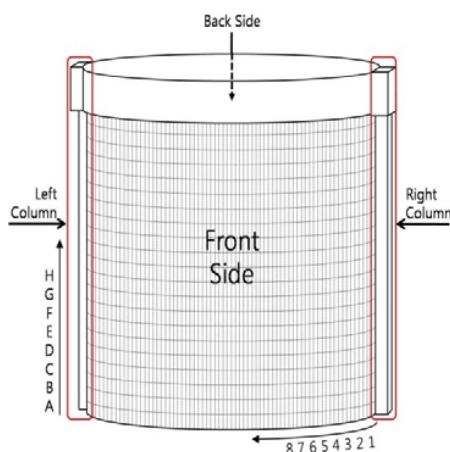
The object of the tests was the 1,000m³ pilot LNG storage tank located in the Incheon LNG receiving terminal, as shown in Fig. 1. As mentioned, few precedent studies on tests of the concrete cover of LNG storage tanks have been reported. In this study, a concrete cover test procedure is suggested using nondestructive tests and destructive tests [8]-[14], as described in Fig. 2. The suggested procedure can be used for regular performance evaluation of the concrete cover of LNG storage tanks. Before the nondestructive tests were conducted, the LNG storage tank was sectionalized into a front side, a back side, a right column, and a left column. The front and back sides were gridded with a horizontal distance of 27 cm and a vertical distance of 54 cm, as shown in Fig. 3. Numbers were given clockwise at each horizontal intersection, and letters were given in alphabetical order at each vertical intersection from the bottom to the top.

Fig. 3 Grid system for the front and back sides of the LNG storage tank cover

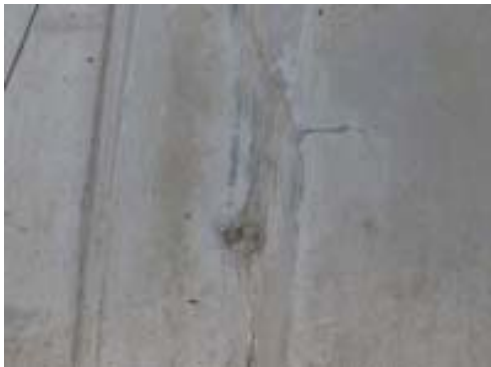
(b) Sector A117-C117

During the visual inspection of the LNG storage tank cover, cracks similar to those shown in Fig. 4 (a) were observed, but they were not considered problems based on their widths and patterns. The cracks observed in sectors A117-C117 and B65 were also thought to have not affected the structure; but considering their lengths, an ultrasonic test was conducted. Other than the cracks and areas with peeling, exfoliation, or steel exposure, no serious anomaly that can result in structural problems was observed during the visual inspection of the LNG storage tank cover.

Fig. 4 Cracks on the concrete wall

The ultrasonic test was conducted in the suspected areas based on visual inspection and the Schmidt hammer test. The test was conducted at the A117-C117 and B65 grids that had long cracks and at J46-M46, K56-N56, K68-N68, J97-M97, and Q110-T110, which were suspected based on the Schmidt

(1) Based on the width and patterns of the cracks that were observed during the visual inspection of the LNG storage tank, the cracks were considered non-structural cracks. The concrete strength of the suspected areas that were found through the Schmidt hammer test was estimated using the strength estimation equation. The results showed that all the sections had a higher design strength value of 30MPa, which means they had no anomaly.
