Plasterwork Ornamentation Finds of Hoşap Castle Archeological Excavation (2007-2015)

M. Top, H. Telli

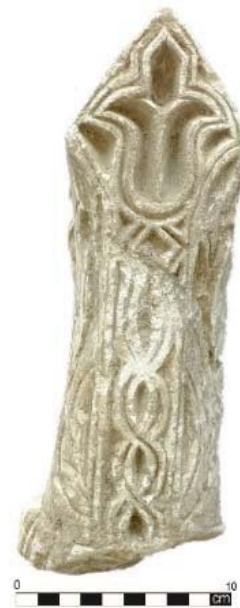
Fig. 33 Peak of a hood

The piece of plasterwork ornament that we think of as the peak of a range hood, is unique among the finds, and is an important find. It is understood that the hole in the back is opened to fasten it up (Fig. 33). During the Early and Classical Ottoman period, a hillier chain, which usually composed of side by side palmette motifs, is seen on both gypser and tile plated walls. In the late Ottoman period, however, we see this as a single hillier in the peaks of the range hoods. The best examples to this are Tokat and Divrigi houses [15]. It is known that such a tradition is made of stucco material in the late period. However, this hillier is unique among the finds and in which room of the harem it is located is not documented. A similar ornamentation is also found on the hobnail located in the drop-shaped stone relief which is on the main entrance gate partaking on the entrance bastion of the Hosap Castle.

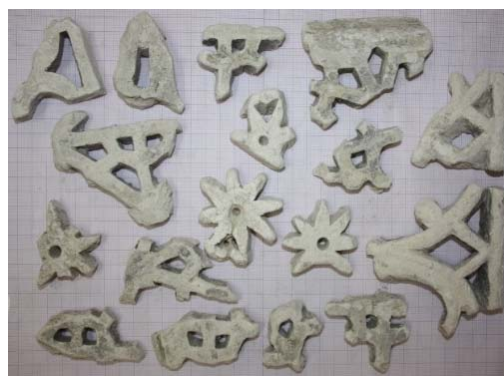
Fig. 40 Fragment of window

It is also known that window guards are made of stucco in the Ottoman and Middle East geographies, although they are non-durable materials, and they are created by various compositions. However, there are not enough finds to produce a complete composition or to be integrated (Fig. 40). When the Cachet's windows was considered, more fragment finding could be expected. If all the pieces collected more carefully, these pieces could be integrated by a work done by the restorators.
