# Preservation of Isparta Yılan Kırkan (Yılan Kıran) Fountain within the Scope of Sustainability

Meryem Elif Çelebi Yakartepe, Ayşe Betül Gökarslan

The restoration decisions of Yılan Kırkan Fountain in Isparta province of Turkey is a good example of the works of sustainable architecture and the preservation of architectural inheritance. It is aimed that Yılan Kırkan Fountain, which is desolate nowadays with no function, to be restored by the local authorities and university, included in the daily life and continue its function.

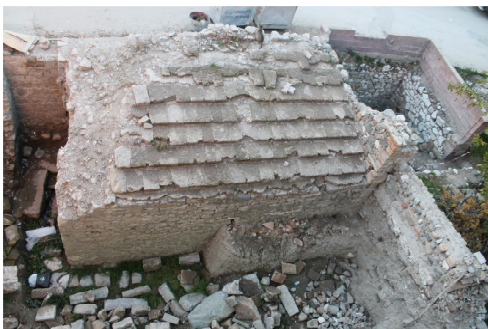
Fig. 4 Yılan Kırkan Fountain, from worksite which located besides fountain

The debris on the immovable was cleaned in 1999 and the fountain was revealed. During the debris cleaning, an inscription of the fountain with the proportions of 0.26 x 1.01 m was found. A cleaning excavation was carried out with the by the decision no. 3087 by Antalya Cultural Heritage Preservation Board dated 30.04.2009 [3] (Fig. 4).

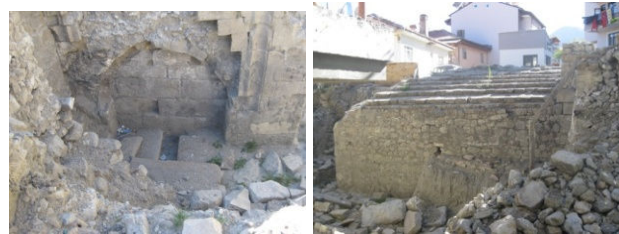
Fig. 6 Fountain's south and east facades

The north and south sides of the fountain consist of niches with semi-circle arch within a rectangular molding. It is known that there were inscriptions in these sides; however, this inscription did not survive to these days. In the north side of the fountain, there is a semi-circle arch window gap opening to the water reservoir (Figs. 6 and 7).

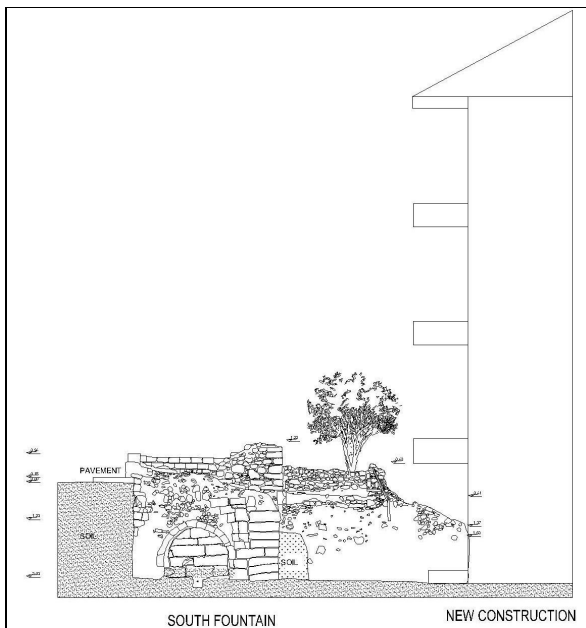
Fig. 8 Yılan Kırkan Fountain's south facade (relief)

Today, the attempts of contractor-style structuring crushes, even destroys many historical constructions. The construction, structuring of which started in the same parcel with Yılan Kırkan Fountain, got too close to the fountain and due to elevation difference, the fountain which went below remained neglected and desolate (Fig. 8 and 9).

The debris removed during the structuring works too close to the fountain was thrown on the historical fountain and while starting the structuring on the fountain yard, the cover coat of the historical fountain was damaged during the cleaning of the debris. Most of the cover stones on the sides of the fountain

It is suggested that the fountain should be moved to an area appropriate for its nature in the town center and repaired, since;

After the historical fountain is moved, the restoration should be completed with reintegration, consolidation and liberating techniques.

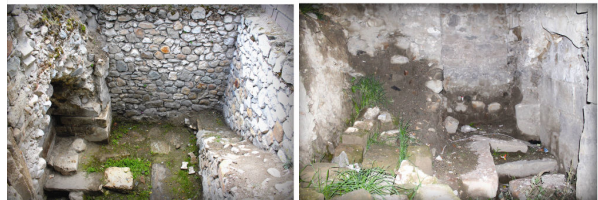
A large portion of the fountain is destroyed; material losses occurred in the north and south sides. There are vegetation problems on the sides and dampness and mossiness problem on the ground. The west side remained under the rising road elevation and the main mass of the structure remained in the construction yard of an apartment that is being built. The distance between the apartment and the fountain is less than 1 meter (Fig. 10).

Fig. 10 Fountain deteriorations (material losses, vegetation on the sides, dampness, mossiness problems from the ground etc.)
