Relining of Domestic Piping System with Rubber Filled Epoxy and Reinforced Polyester Composites

Parastou Kharazmi, Folke Björk

II. INVESTIGATION OF RELINING COMPOSITES AFTER EXPOSURE TO ELEVATED TEMPERATURE AND WATER

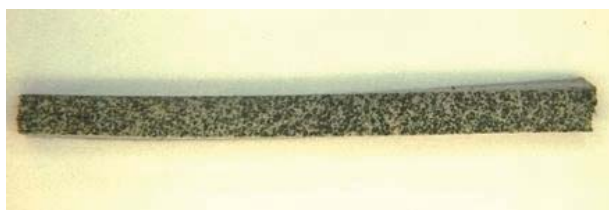
Fig. 3 A strip of the epoxy modified with rubber sample after 2 months exposure to deionized water at 80°C and complete drying

As it can be seen from Figs. 3 and 4, epoxy material exposed to water at 80°C did not show the same degradation as the polyester based relining.

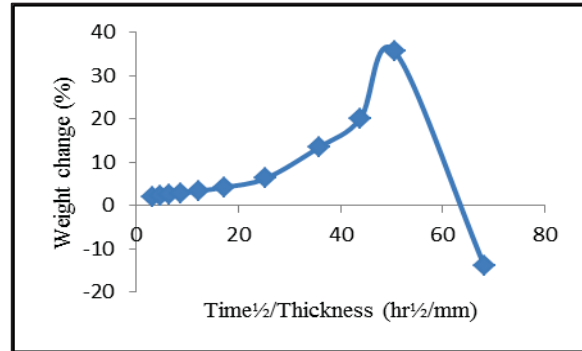
Fig. 8 Absorption curve for rubber filled epoxy immersed in water at 60°C in oven during 14 months

In comparison of the two material types, it is noticeable that the epoxy material is absorbing water over a longer period of time and the water absorption is faster compared to the polyester based relining material.

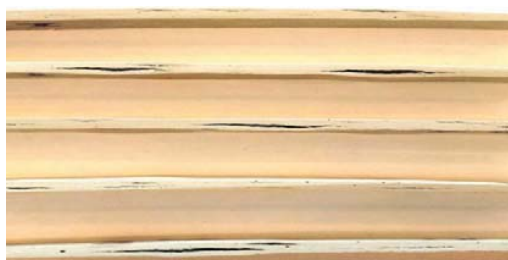
Fig. 12 Specimens prepared from polyester material immersed in water at 80°C for two months and after drying shows how delamination has happened along the edges

Microscopy on relining material after exposure and drying shows that material is not sensitive while exposing to low temperature and only air but it is more sensitive while exposed to water in high temperature and shows delamination and degradation.
