Self-Help Adaptation to Flooding in Low-Income Settlements in Chiang Mai, Thailand

Nachawit Tikul

Keywords—Flooding, low-income settlement, housing, adaptation.

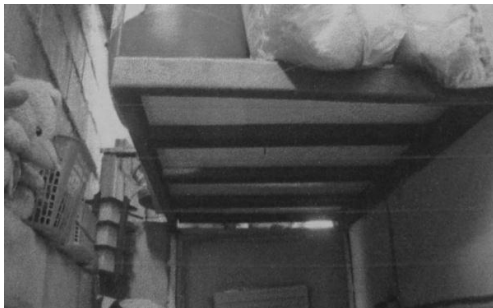
Fig. 2 Shelf preparation for protection of personal belongings

evacuate from the low-income settlements. Shortage of drinking water and food rarely occurred during floods with the three low-income settlements, because there were short flood duration and the residents could access retail stores around their houses or public assistance. This is an advantage of low-income settlements in urban areas. In the case of problems with the toilets, they solved the problem by using the neighbor's toilet or defecating into plastic bags. Even when they cannot use electricity, residence can normally still live in their houses since they have fewer home appliances. The strong furniture, such as beds, tables, cabinets, and shelves, were adapted to become the floor for living when 1-storey houses flooded less than 1.00 m. In addition, they prepared to protect things by lifting them above the water or put them on the shelves, which were built on the wall (Fig. 2). However, the shelves cannot be built in every house due to a lack of structural strength, and therefore in some cases, property and furniture remained in the flood waters.

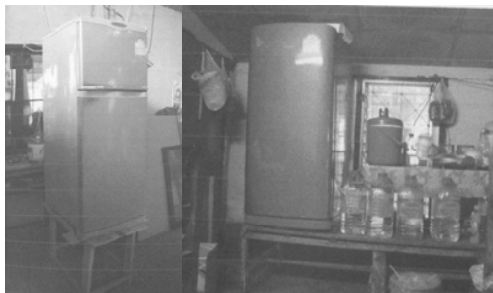
Fig. 3 Lifting the refrigerator above regular flood levels
