Site Inspection and Evaluation Behavior of Qing Shang Concrete Bridge

Keywords—Field investigation, prestressed concrete box girder, maintenance, Qing Shan Bridge

BRIDGE DESCRIPTION

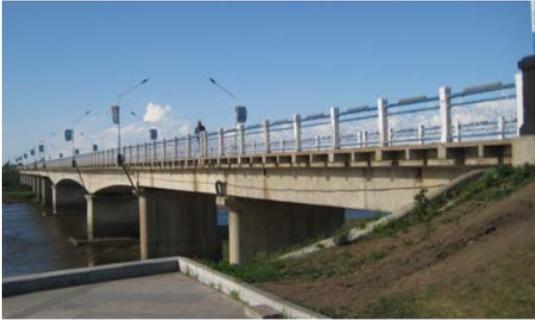
Qing Shan Bridge shown Fig. (1.1) is located in He Gang – Nenjiang 303 provincial highway lane, Heilongjiang Province, China; an important bridge in the urban areas of Wu Dalian Chi. The bridge has been operating for more than 29 years since August 1982. Bridge length is 314.0 meters, including 13 Span; the bridge consists of the left approach, right approach and the main bridge span. among them, the left approach abutment no. 1- Pier no. 2 (A1 ~ P2) has two span, 20 meter of reinforced concrete simply supported T beam; the main bridge pier no. 2 – pier no. 5 (P2 - P5) has three-span in total, overall prestressed concrete box girder, spans arrangement are (30m +50 m +30 m); the right (P5 ~ A2) Approach has eight spans, 20 meter of reinforced concrete simply supported T beam, the horizontal section consists of five simply supported T beam, jointed together.

Fig.1 is located in He Gang – Nenjiang 303 provincial highway lane, Heilongjiang Province, China

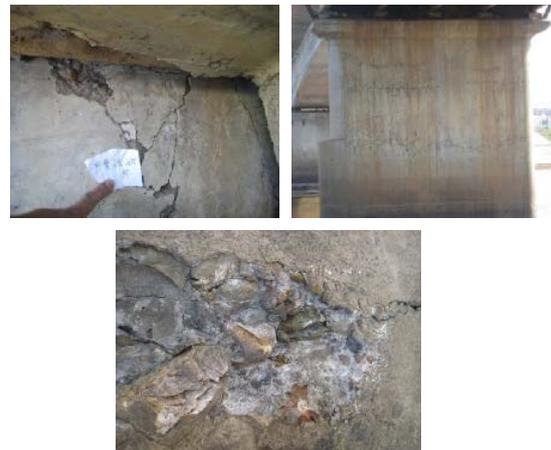
Fig. 4 Damage of concrete bridge abutment #14 and pier No. 5

After checking the abutment joints, the joints were filled with sand and small stones and other debris; the result will be the abutment expansion joints lose functionality. The beams were close to the abutment wall, and the reasons for these

defects include the following :(1) elongation due to heated up beam contract the concrete of back wall. (2). soil pressure behind the abutment makes the abutment move or tilt forward. In other word, the pressure between the beam and the back wall directly causes the damage and defect of concrete as shown in Fig. (4).

The cracked part of the back wall, affecting the durability of the bridge, also if the abutment is damaged to certain degree, the stability of the bridge will be worse.

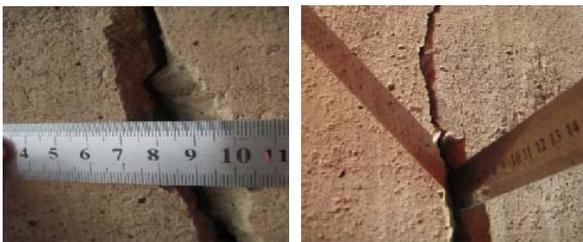
There are 12 bridge piers; all have different defects in certain degree, detailed as followings: first : Pier overall had a good condition, there is no damage of concrete bridge surface, no apparently cracks, only in the center of the piers, at upper part that has a micro-crack, width about 0.2mm, length about 2m. Reason for cracking was degradation of temperature or mass concrete dried, rather than structural joints. Second : the piers # 5 have the most seriously damaged, it's the transition pier between main bridge and approach bridge span , which have a large cracks, described as follows:(1) large crack with maximum width of about (1mm - 2mm) as shown in Fig. (5). There is a crack located in the middle area of the pier had not extended to the top of pier. The inside crack width about 5mm, the depth was more than 60mm.The vertical crack about 3mm, all were beyond the bridge regulatory require, were overtake the bridge specifications. The main reasons caused the cracks was temperature or big concentrate during construction. There was no doubt about that, during the recent years, the cracks lost their function, leading to the rain or the melt ice flew onto the pier surface, and the course of melt and freeze had accelerated the speed of the crack expanding. (2) The horizontal crack in the pier root was caused by temperature (heat) produced, in the winter as it is also subject to the freeze-thaw cycle. (3) There are many different reasons for cracks of the pier #5, mainly includes the melted ice lead penetrated through concrete to the aggregate lead to improper reaction and negative affection, as a result, the water flew directly pier surface. Winter freeze-thaw cycles are aggravated by the net crack growth.

Fig. 5 5 Pier # 5 crack depth

- (7) The extent of serious damages in piers #5 and # 11 the maintenance and reinforcement must be carrying out for piers. The extent of other minor damage should also apply maintenance process.

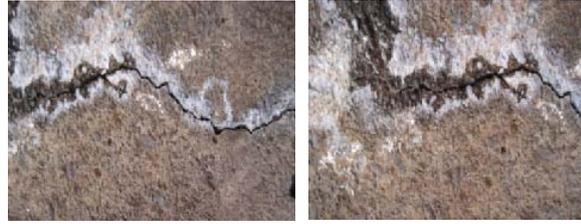
Pier #5 conditions is worse, badly influence on carrying capacity and the durability of the bridge. Some cracks there have white lime precipitation, crack width about 0.6mm, as shown in Fig. (6).

Fig. 6 South side of the pier # 5 surface cracks whitening

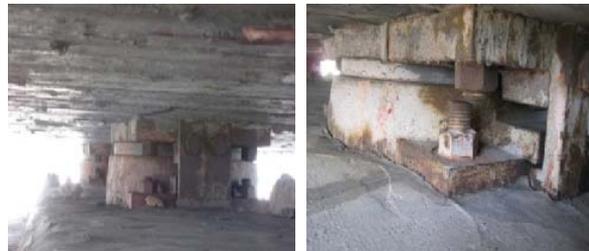
Simply supported reinforced concrete T beam was used steel bearing, bearing dose not showing damage reduction activities, Capping beam have no any obvious damage.

Fig. 8 Bearing steel plate

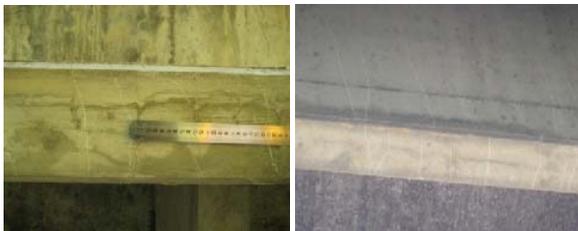
The T beam of all 10 spans were investigated, the occurrence of most T beams have cracking phenomenon occurred. T Beam crack region appears at the bottom under bent beam, crack extended upward along the ribbed T beam, the individual extends to the T beam flange crack, crack width distributed over 0.1mm to 0.4mm, the maximum was about 0.4mm, and crack spacing was about 10 to 15cm. The bridge needs to be improved the flexural bending strength. T beam support region have shear cracks, diagonal cracks were found there, but does not covered large area, crack width about 0.2mm. Cracks generated by the structural force and that

reflect the possible consequences of inadequate carrying capacity of the bridge, which effect on bridge safety and durability. Fig. (9) show the cracks types.

Fig. 9 (c) T beam cross-cracks in the region

- (1) The active implementation of the Qing Shan Bridge, detailed investigation, the static load test, designed must be carried out to provide the necessary technical basis for the maintenance.
- (2) Approach spans of reinforced concrete T-beam should provide design of the implementation reinforcement to increase the carrying capacity of the bridge.
- (3) Replacement of expansion joints. However, in order to improve driving conditions and improve the bridge level of service, while reducing the workload

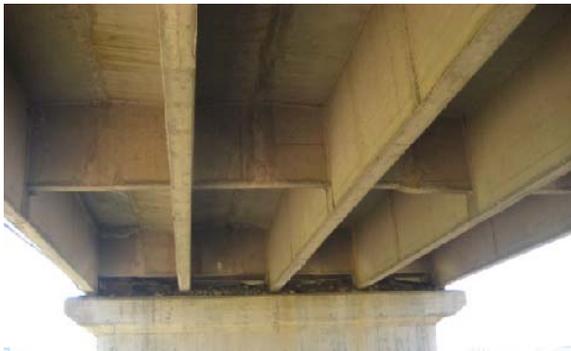
All lateral connections on the bridge observed in detail, simply supported T beam horizontal connections in good condition and the occurrence of cracking was apparent, diaphragm locally have crack, but crack width was small, about 0.1mm.

Fig. 9 (d) T Beam connections is good, no obvious damage (diaphragm)

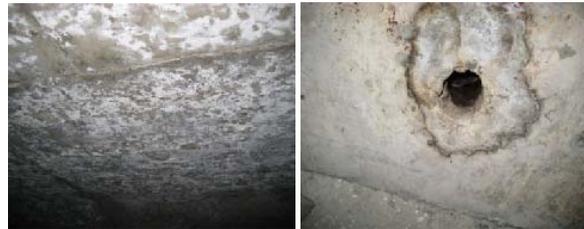
The continuous beam span for the whole box girder and the concrete surface was in a good condition, no obvious damage and cracks. Climb from the box at pier 2 internal inspection of the box found within the surface of structural cracks, top of the local area (especially the original hanging holes of hanging span) the concrete take off, tendons exposed and leaking.

Bridge deck waterproofing was in bad condition, box

leakage, closed hole wasn't dense construction which effect on the durability of the bridge

Fig. 9 (a) the internal box water drainage damage

- (4) Provide appropriate repairs for steel corrosion, concrete cracking and falling concrete parts.
- (5) Completely replace the waterproof layer, re-set the road vent pipe (vent pipe should be guaranteed about 20cm below the main beam);
- (6) Re-laying of pavement, to resolve technical issues such as Bump;

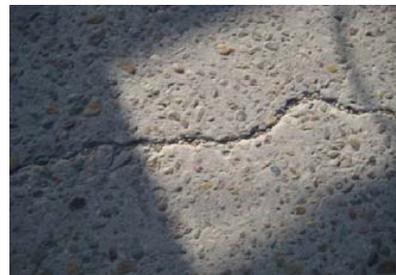
Cement concrete pavement deck with less smoothness, spots potholes, and cracks. Cracking phenomenon effect on carrying capacity of the bridge, functionality, durability,etc, as shown in Fig. (10)

Fig. 10 Deck Damage

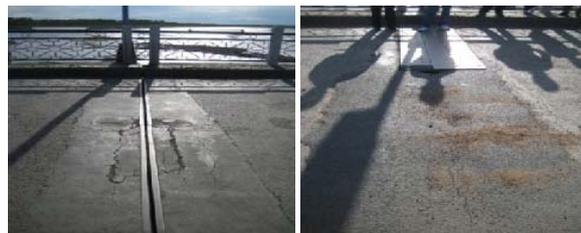
There are severely damaged expansion joints shown in Fig. (11), basically loss of functionality, overloading rolling, improper maintenance witch effect on durability.

Fig. 11 Serious damaged bridge deck expansion joint

of the daily maintenance and management, proposed a continuous deck structure, to minimize the number of joints.

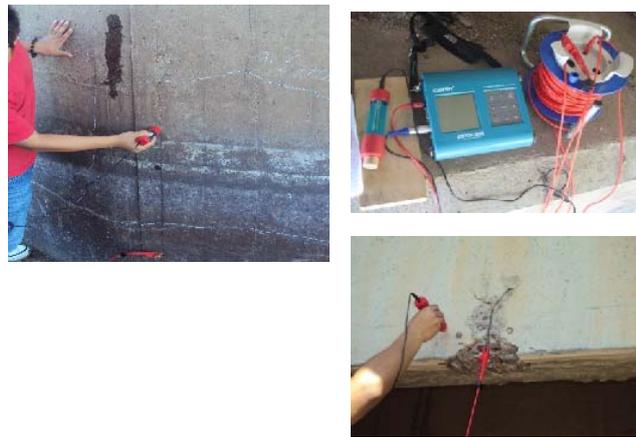
Test results showed that: According to the relationship between steel potential values and the steel corrosion, that the main reinforced concrete cover layer has serious damage, the other side layers had no visual cracks. The damage of concrete layer shows the seriously steel corrosion as shown in Fig. (12).

Fig. (12) Steel corrosion detectors
