# Solid Particle Erosion of Heat Treated TNB-V4 at Ambient and Elevated Temperatures

Muhammad Naveed, Richard Stechow, Sebastian Bolz, Katharina Hobusch, Sabine Weiß

**Keywords**—Solid particle erosion, gamma TiAl, TNB-V4, high temperature erosion.

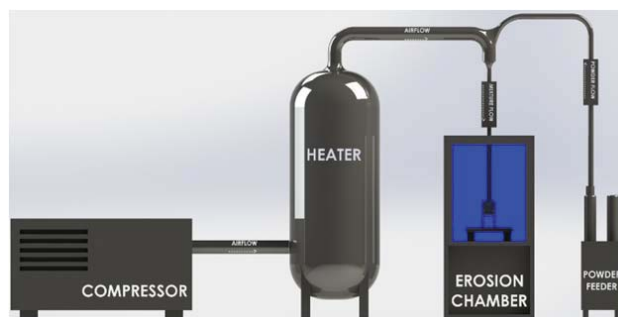
Fig. 2 Schematic representation of the high temperature erosion testing rig

An in-house built high temperature erosion testing rig has been employed for the testing of the specimens (Fig. 2). A compressor is used for providing compressed gas to the series connected heat exchanger. Induction heaters are incorporated within the heat exchanger for the heating of the compressed gas. The compressed hot air is then sent to a mixing tube where sand particles from the powder feeder are mixed in. The flow rate of the sand can be controlled by controlling the speed of the rotating plate of the powder feeder (AMT AG, Switzerland). This mixed stream of air and sand particles is then directed towards the specimen holder through a 3 m long tube. This long tube allows a high velocity of the particles at the specimen surface. The specimen temperature of the high temperature jet is measured using an Infratherm IPE 140 pyrometer (IMPAC Infrared GmbH, Germany).
