The Application of Distributed Optical Strain Sensing to Measure Rock Bolt Deformation Subject to Bedding Shear

Thomas P. Roper, Brad Forbes, Jurij Karlovšek

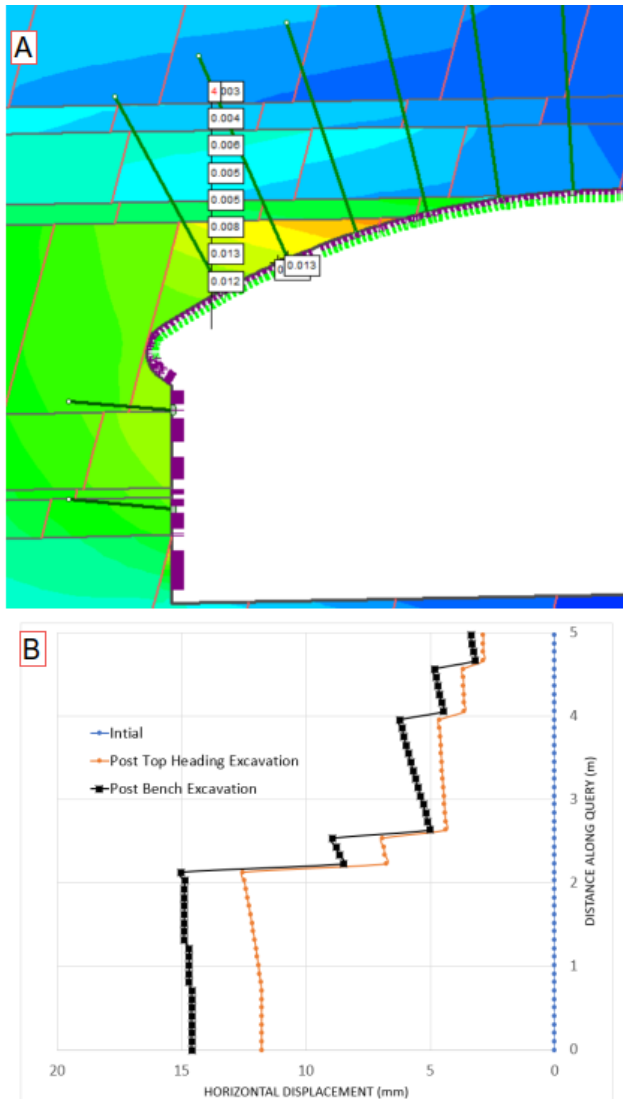
Fig. 1 (A) RS2 model of typical Hawkesbury Sandstone tunnel at 60 m depth after heading excavation and bench excavation (B)

Horizontal displacement query above the tunnel shoulder showing displacement along the bedding planes (bedding shear) after heading and bench excavation

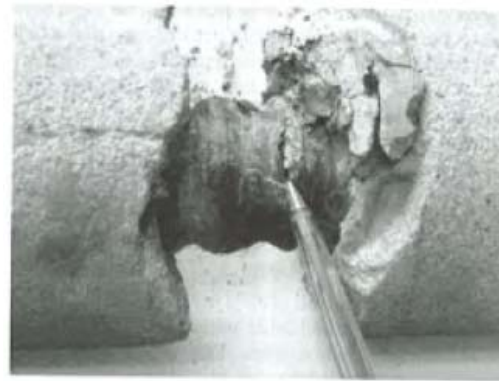
Fig. 2 Rupture of the DCP bolt plastic sheath after [1]

the DCP bolt ranks as the most corrosion resistant [14]. However, shear displacement along rock defects following rock bolt installation can reduce the longevity, and at higher strains, the integrity of installed DCP bolts. This was demonstrated in [1] where rupture of the protective sheath surrounding the bolt was observed at 15 mm and 18 mm shear displacement across a 5-mm lab model clay discontinuity, between two mass sandstone blocks. This damage compromises the DCP bolt's ability to meet its 100+ year design life required by tunnel owners. This problem is, by practical measures, unavoidable when installing primary bolts as permanent support at depths below 40-50 m without the adoption of one of four possible solutions. They include:

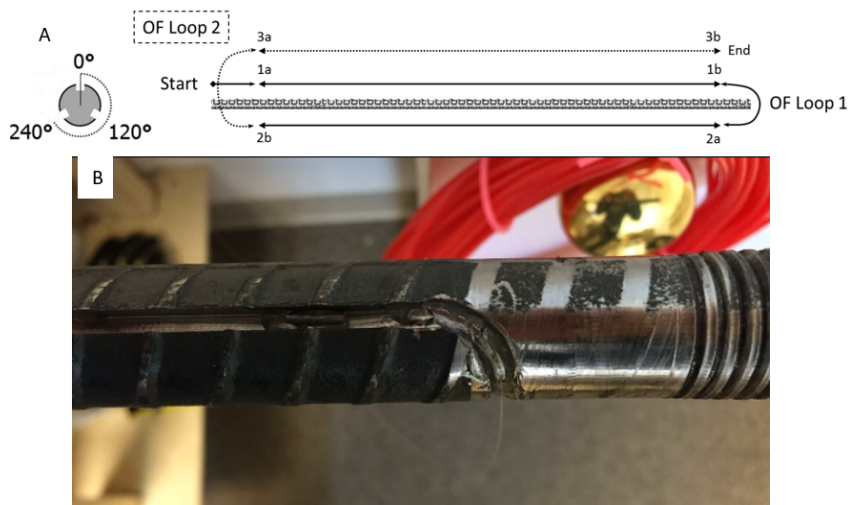
Fig. 3 A) Schematic representation of the optical sensor embedded in to the bolt in to the bolt at 120° spacing. Xa to Xb represents one sensing length of the bolt. These lengths are used allocate strain to the appropriate section of cable for accurate calculation B) photograph of the 2 mm x 2 mm milled groove in the bolt

DCP rock bolts with milled grooves at 120° spacing (Fig. 3) were made for the project. An optical fiber is looped around the bolt in these grooves and encapsulated with a resin. Knowing the length of each groove, elastic bending theory can be used to separate the coaxial strain and lateral strain using the method in [4]. A 3D strain profile is the result. Using DOS, strain can be measured every 0.65 mm along the bolt, which is equivalent to thousands of strain gauges. The maximum strain can be determined regardless of the installation orientation. This monitoring solution provides the accuracy and resolution required for monitoring of discrete deformation along the rock bolts.

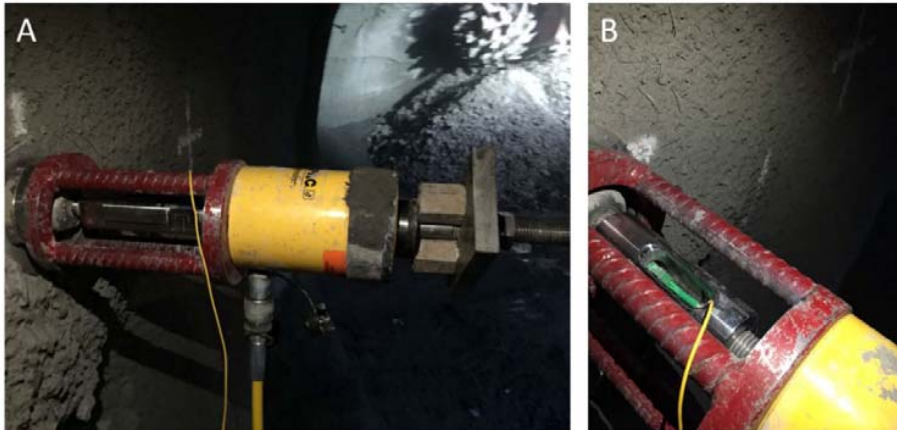
Fig. 4 Pull test apparatus set-up with modified coupler to allow the sensor connection with the analyser

One bolt was pull tested using a modified coupler (Fig. 4). The bolt was tensioned in 50 kN increments up to 250 kN. The intention of this pull test was to load up to failure of the bolt shank, however the custom coupler threads failed during the next increment. The results are shown in Fig. 5. This test proved that the bolt and equipment functioned well at loads well beyond the yield strength of the bolt. This test also provided some insight to the critical embedment length of a DCB bolt installed in a 45mm diameter hole within class SH-I/II Ashfield Shale [12]. The critical embedment depth is the length of bond required to mobilise the full tensile strength of the bolt [7]. At each increment of load, there was a strain response up to, but not beyond, the first 1.05 m of the bolt as shown in Fig. 5 (i.e. the bolt and bond length beyond this point did not resist any of the end load). A comparable trend, however with a more exponential decay in strain, was observed in [15]. This is a display of how the DOS instrumented bolts can be used to aid a tunnel designer in understanding the load, strain and system stiffness distribution in rock bolts and when the failure mode changed from bond strength to rebar strength.

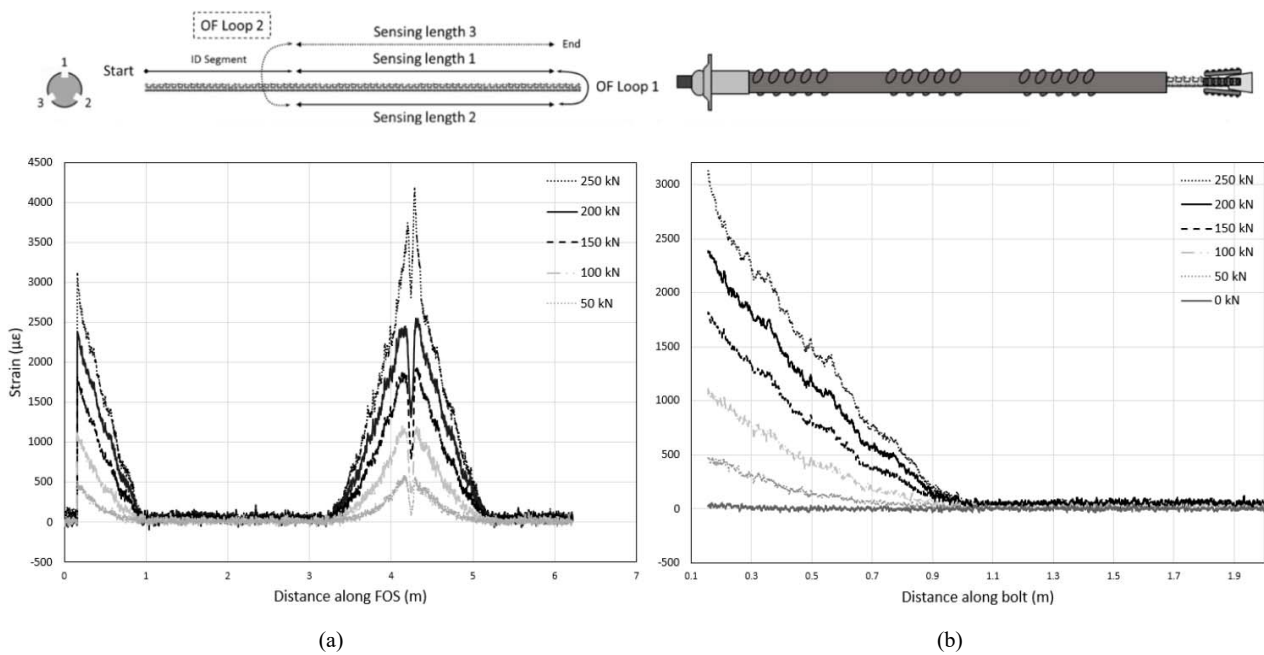
Fig. 5 Result of a pull test on 2m FOS instrumented monitoring bolt; (a) the fiber length strain. (b) is the equivalent strain along the bolt profile. Schematic of the of the looped fiber and DCP bolt above the graphs as a visual aid

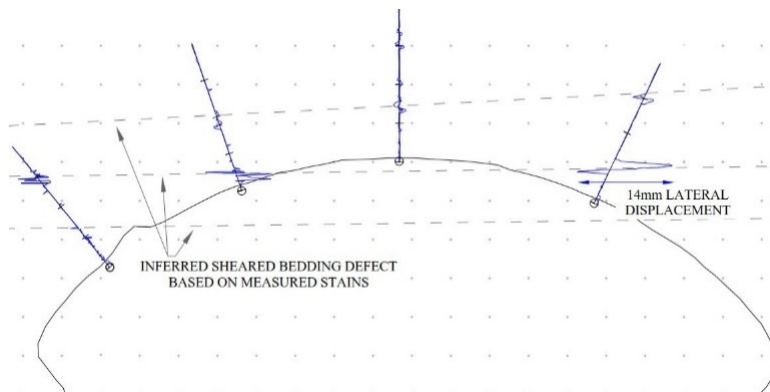
Fig. 6 Lateral strain of the FOS bolts superimposed on the excavation of the trial area; Sheared bedding planes could be identified across the tunnel profile and crown following the displacement event. Strain exaggerated by 170

Four 4.0 m long x 22 mm diameter DCP instrumented bolts were installed across the tunnel profile, as shown in Fig. 6. A borescope hole was also drilled approximately 1.0m offset from each bolt (Normal to the profile in Fig. 6). Logging of the borescope holes allowed for a determination of the geological profile within very close vicinity of the bolt and importantly identification of where the bedding defects were. In the event of ground movement/bedding shear, the visual shearing could be compared to the bolt strain measurements.

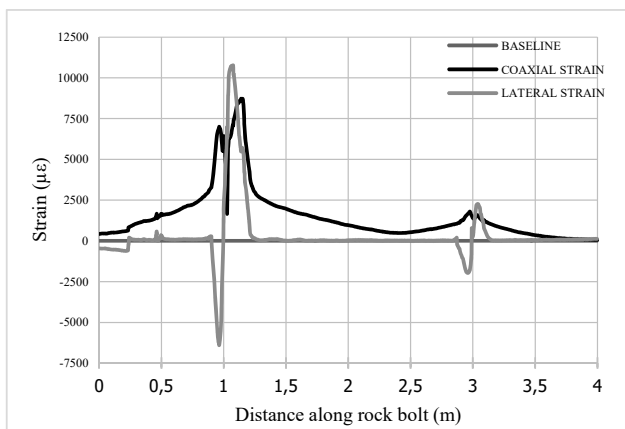
Fig. 7 Strain along the bolt length after a bedding shear event; The double peak of the axial response shows S-shaped bending over the sheared defect. Equivalent lateral displacement of 14 mm

During the excavation of an adjacent cross-passage a ground displacement ‘event’ occurred. Using the local industry-standard method of monitoring (and inferring) shear damage on bolts, through the borescope holes, bedding shear displacement of ~14mm was recorded (Fig. 8) along a very ‘clean’ and simple bedding shear plane. Several geologists and engineers independently scaled the same borescope hole and all estimated this value with +/- 2 mm. The adjacent DOS monitoring bolt measured similar lateral displacement as shown in Fig. 7 of 14 mm. The bolt’s ‘S’ shaped reaction occurred over a 290 mm section of the bolt, giving insight to the elongation geometry occurring around a bedding shear. Coaxial strain of 8720 $\mu\epsilon$ was measured corresponding to a load of 200-225 kN through the rebar at this bedding shear location. This triggered the reinstallation of rock bolts. The two bolts on the left-hand side of Fig. 6 were damaged by equipment after the displacement event following shotcrete repairs and re-installation of bolts so unfortunately the post deformation event measurement could not be taken on these bolts. A visualisation of the behaviour measured in Figs. 6 and 7 can be seen in Fig. 9. In similar ground conditions, a temporary DCP rock bolt can be seen in cross section above the tunnel, after secondary excavation above a tunnel in creating a cavern and exposing the previously installed ground support. A DCP bolt is seen to intersect a bedding plane (between a sandstone bed and a siltstone bed) and dilated concentric fracturing. The bolt is resisting both the dilation of the concentric fracturing and (likely) shear along the bedding plane keeping the blocks secure. A ‘real world example’ of the behaviour models, such as that in Fig. 1, is represented. Having the opportunity to visually capture this behaviour is rare; however, the use of FOS monitoring bolts allows the capture and measurement of it.

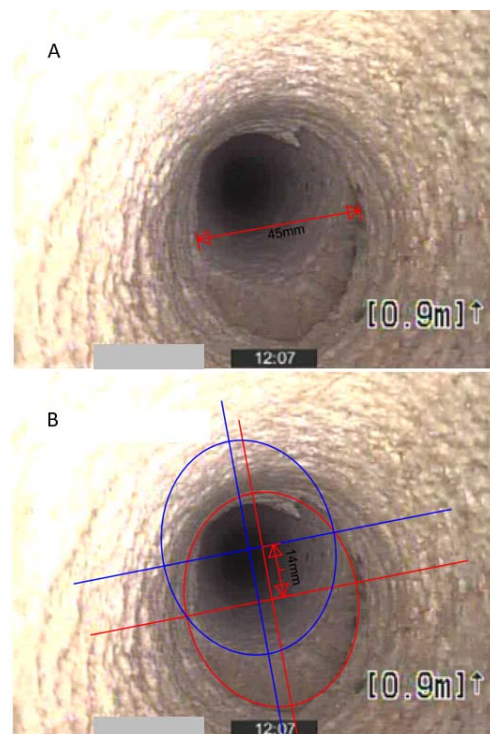
Fig. 8 Image captured in a borescope hole adjacent to the FOS bolt in Fig. 7; the 45-mm hole is off-set by ~14 mm following bedding shear

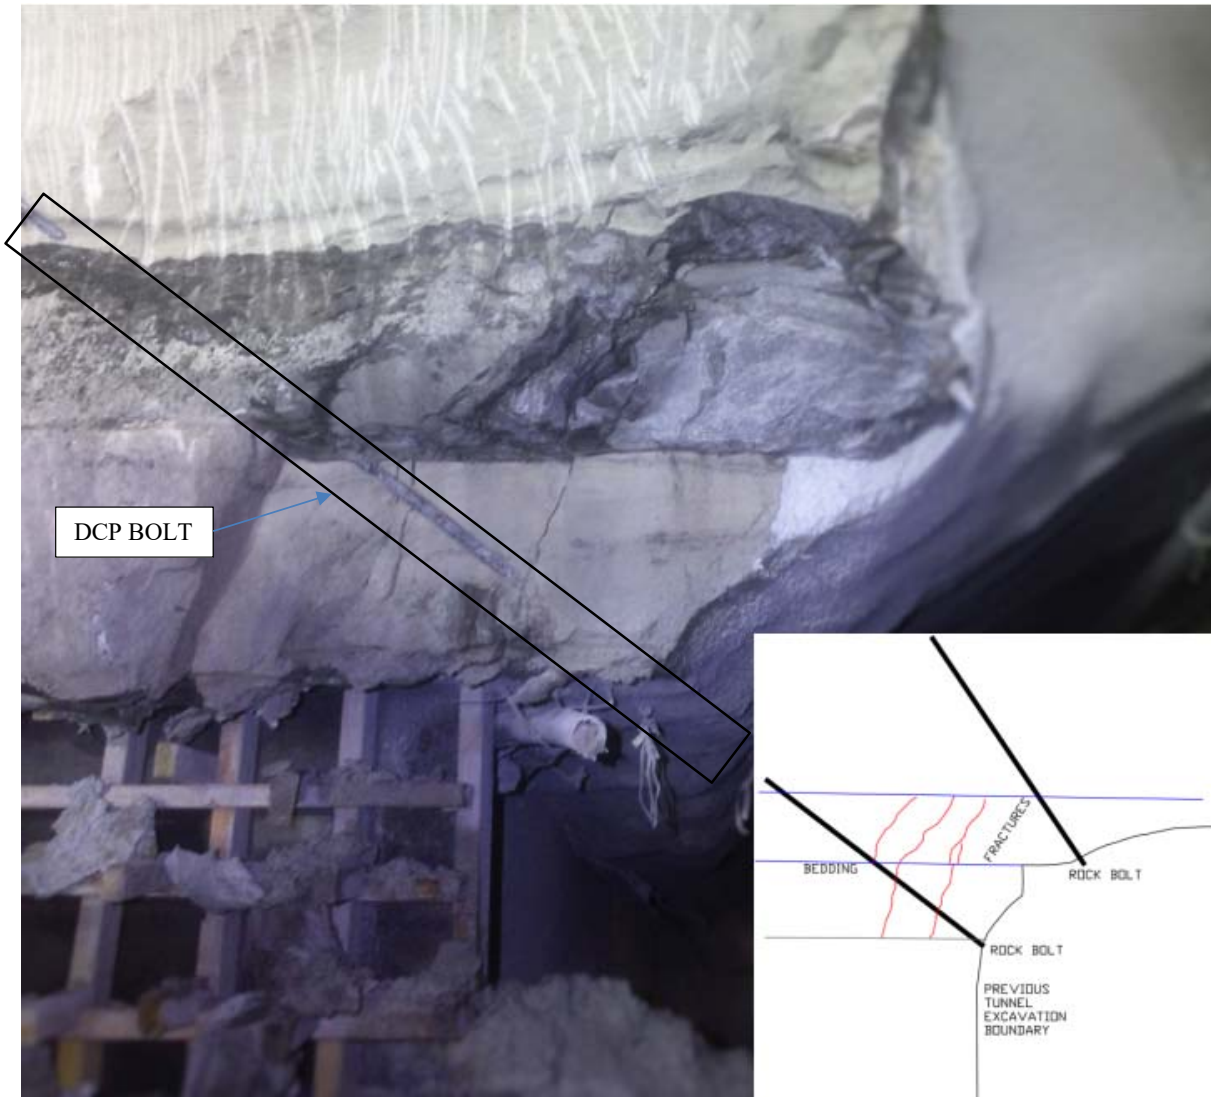
Fig. 9 A photo and explanatory sketch of an exposed DCP bolt above a tunnel shoulder following secondary excavation above the crown

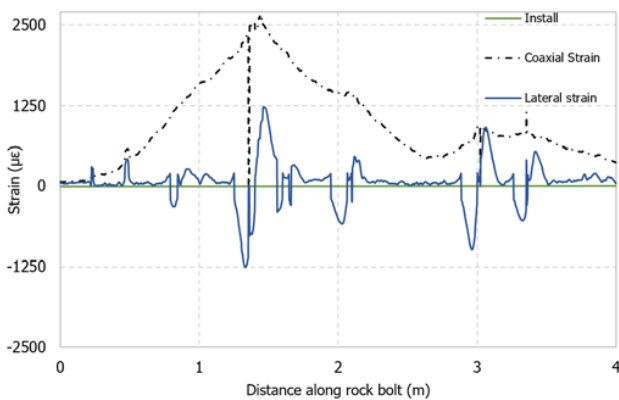
Fig. 10 Monitoring Bolt installed near the middle of the tunnel crown; largest strain component is axial, 2550 $\mu\epsilon$, compared to lateral at 1250 $\mu\epsilon$ at a bedding parting

The monitoring bolt installed in the centre of the tunnel performed as expected, with the axial component of the strain being far higher than the lateral strain. Fig. 10 shows the

coaxial and lateral strain profile along the bolt. This behaviour is consistent with bolted beam analogies used to describe the behaviour of bedded rock where, bed dilation is expected at the centre of an excavation with increased shear occur towards the walls. Noting that because of an adjacent cross passage excavation and a multistage heading excavation, some asymmetry in the crown displacement was also expected.
