# The Application of Distributed Optical Strain Sensing to Measure Rock Bolt Deformation Subject to Bedding Shear

**Abstract**—Shear displacement along bedding defects is a well-recognised behaviour when tunnelling and mining in stratified rock. This deformation can affect the durability and integrity of installed rock bolts. In-situ monitoring of rock bolt deformation under bedding shear cannot be accurately derived from traditional strain gauge bolts as sensors are too large and spaced too far apart to accurately assess concentrated displacement along discrete defects. A possible solution to this is the use of fiber optic technologies developed for precision monitoring. Distributed Optic Sensor (DOS) embedded rock bolts were installed in a tunnel project with the aim of measuring the bolt deformation profile under significant shear displacements. This technology successfully measured the 3D strain distribution along the bolts when subjected to bedding shear and resolved the axial and lateral strain constituents in order to determine the deformational geometry of the bolts. The results are compared well with the current visual method for monitoring shear displacement using boresc

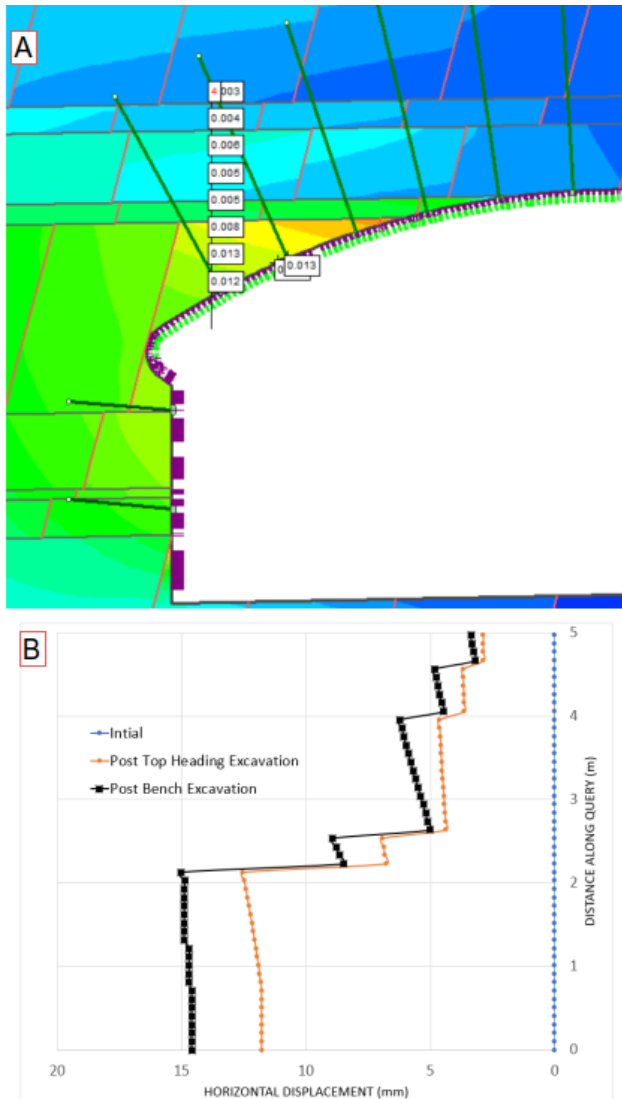
Fig. 1 (A) RS2 model of typical Hawkesbury Sandstone tunnel at 60 m depth after heading excavation and bench excavation (B) Horizontal displacement query above the tunnel shoulder showing displacement along the bedding planes (bedding shear) after heading and bench excavation

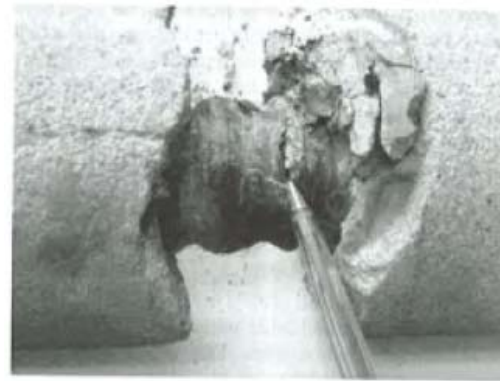
Fig. 2 Rupture of the DCP bolt plastic sheath after [1]

the DCP bolt ranks as the most corrosion resistant [14]. However, shear displacement along rock defects following rock bolt installation can reduce the longevity, and at higher strains, the integrity of installed DCP bolts. This was demonstrated in [1] where rupture of the protective sheath surrounding the bolt was observed at 15 mm and 18 mm shear displacement across a 5-mm lab model clay discontinuity, between two mass sandstone blocks. This damage compromises the DCP bolt's ability to meet its 100+ year design life required by tunnel owners. This problem is, by practical measures, unavoidable when installing primary bolts as permanent support at depths below 40-50 m without the adoption of one of four possible solutions. They include:

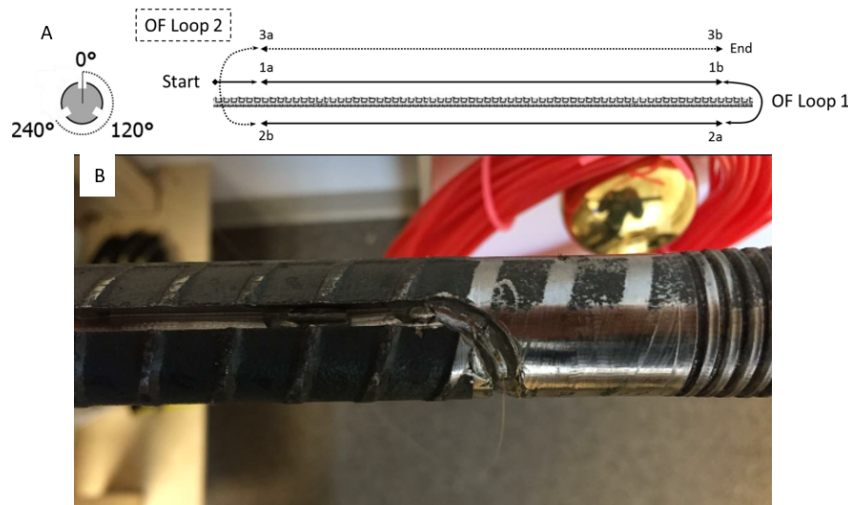
Fig. 3 A) Schematic representation of the optical sensor embedded in to the bolt in to the bolt at 120° spacing. Xa to Xb represents one sensing length of the bolt. These lengths are used allocate strain to the appropriate section of cable for accurate calculation B) photograph of the 2 mm x 2 mm milled groove in the bolt

DCP rock bolts with milled grooves at 120° spacing (Fig. 3) were made for the project. An optical fiber is looped around the bolt in these grooves and encapsulated with a resin. Knowing the length of each groove, elastic bending theory can be used to separate the coaxial strain and lateral strain using the method in [4]. A 3D strain profile is the result. Using DOS, strain can be measured every 0.65 mm along the bolt, which is equivalent to thousands of strain gauges. The maximum strain can be determined regardless of the installation orientation. This monitoring solution provides the accuracy and resolution required for monitoring of discrete deformation along the rock bolts.

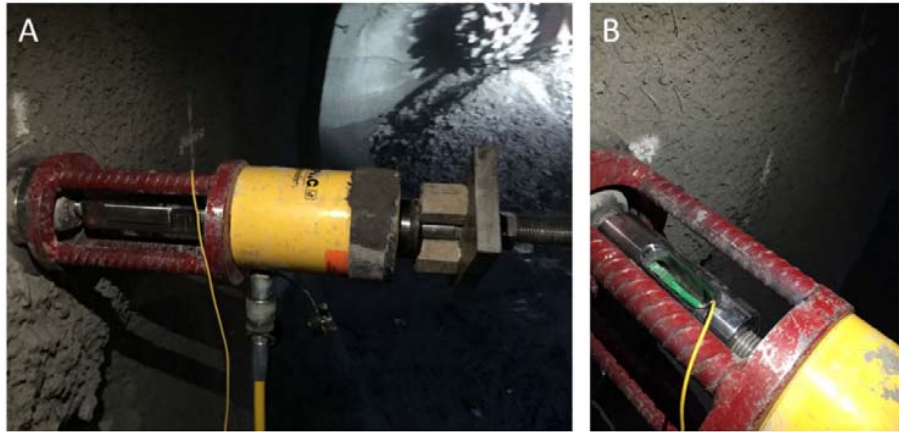
Fig. 4 Pull test apparatus set-up with modified coupler to allow the sensor connection with the analyser

One bolt was pull tested using a modified coupler (Fig. 4). The bolt was tensioned in 50 kN increments up to 250 kN. The intention of this pull test was to load up to failure of the bolt shank, however the custom coupler threads failed during the next increment. The results are shown in Fig. 5. This test proved that the bolt and equipment functioned well at loads well beyond the yield strength of the bolt. This test also provided some insight to the critical embedment length of a DCB bolt installed in a 45mm diameter hole within class SH-I/II Ashfield Shale [12]. The critical embedment depth is the length of bond required to mobilise the full tensile strength of the bolt [7]. At each increment of load, there was a strain response up to, but not beyond, the first 1.05 m of the bolt as shown in Fig. 5 (i.e. the bolt and bond length beyond this point did not resist any of the end load). A comparable trend, however with a more exponential decay in strain, was observed in [15]. This is a display of how the DOS instrumented bolts can be used to aid a tunnel designer in understanding the load, strain and system stiffness distribution in rock bolts and when the failure mode changed from bond strength to rebar strength.

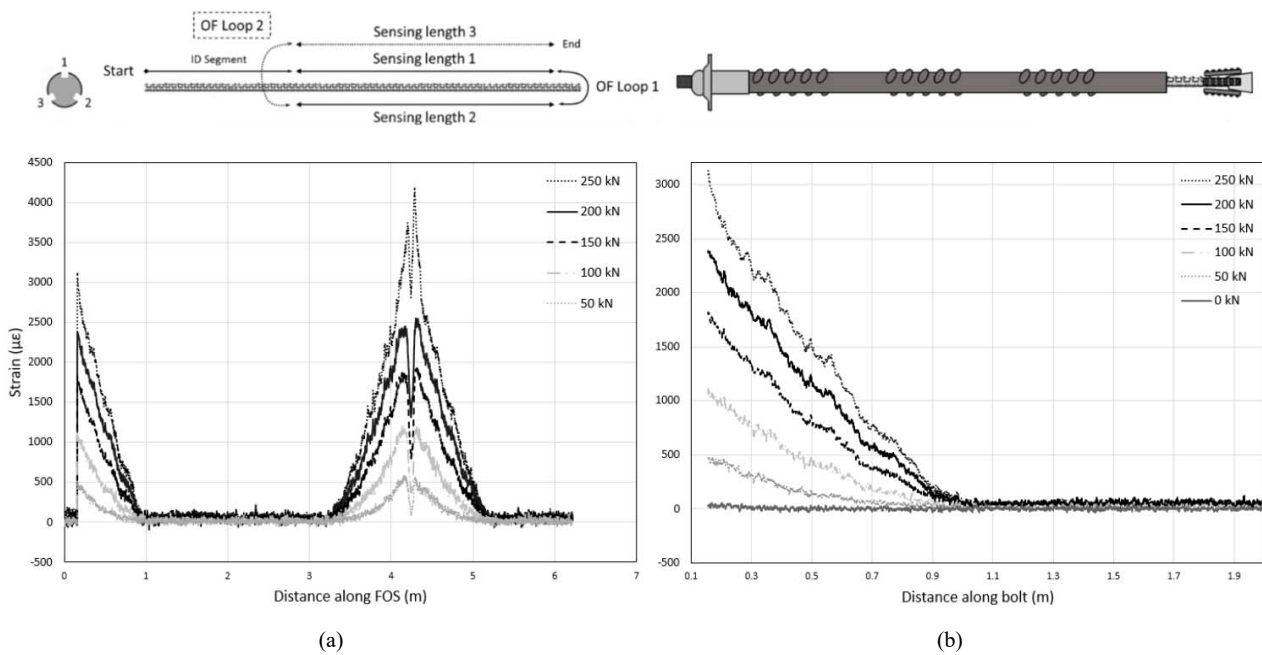
Fig. 5 Result of a pull test on 2m FOS instrumented monitoring bolt; (a) the fiber length strain. (b) is the equivalent strain along the bolt profile. Schematic of the of the looped fiber and DCP bolt above the graphs as a visual aid

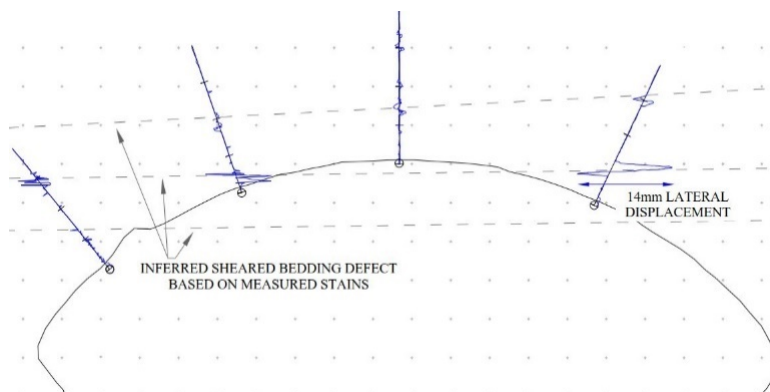
Fig. 6 Lateral strain of the FOS bolts superimposed on the excavation of the trial area; Sheared bedding planes could be identified across the tunnel profile and crown following the displacement event. Strain exaggerated by 170

Four 4.0 m long x 22 mm diameter DCP instrumented bolts were installed across the tunnel profile, as shown in Fig. 6. A borescope hole was also drilled approximately 1.0m offset from each bolt (Normal to the profile in Fig. 6). Logging of the borescope holes allowed for a determination of the geological profile within very close vicinity of the bolt and importantly identification of where the bedding defects were. In the event of ground movement/bedding shear, the visual shearing could be compared to the bolt strain measurements.

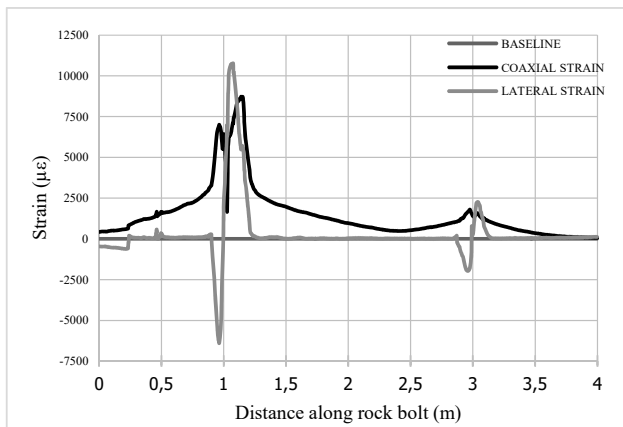
Fig. 7 Strain along the bolt length after a bedding shear event; The double peak of the axial response shows S-shaped bending over the sheared defect. Equivalent lateral displacement of 14 mm

During the excavation of an adjacent cross-passage a ground displacement ‘event’ occurred. Using the local industry-standard method of monitoring (and inferring) shear damage on bolts, through the borescope holes, bedding shear displacement of ~14mm was recorded (Fig. 8) along a very ‘clean’ and simple bedding shear plane. Several geologists and engineers independently scaled the same borescope hole and all estimated this value with  $\pm 2$  mm. The adjacent DOS monitoring bolt measured similar lateral displacement as shown in Fig. 7 of 14 mm. The bolt’s ‘S’ shaped reaction occurred over a 290 mm section of the bolt, giving insight to the elongation geometry occurring around a bedding shear. Coaxial strain of  $8720 \mu\epsilon$  was measured corresponding to a load of 200-225 kN through the rebar at this bedding shear location. This triggered the reinstallation of rock bolts. The two bolts on the left-hand side of Fig. 6 were damaged by equipment after the displacement event following shotcrete repairs and re-installation of bolts so unfortunately the post deformation event measurement could not be taken on these bolts. A visualisation of the behaviour measured in Figs. 6 and 7 can be seen in Fig. 9. In similar ground conditions, a temporary DCP rock bolt can be seen in cross section above the tunnel, after secondary excavation above a tunnel in creating a cavern and exposing the previously installed ground support. A DCP bolt is seen to intersect a bedding plane (between a sandstone bed and a siltstone bed) and dilated concentric fracturing. The bolt is resisting both the dilation of the concentric fracturing and (likely) shear along the bedding plane keeping the blocks secure. A ‘real world example’ of the behaviour models, such as that in Fig. 1, is represented. Having the opportunity to visually capture this behaviour is rare; however, the use of FOS monitoring bolts allows the capture and measurement of it.

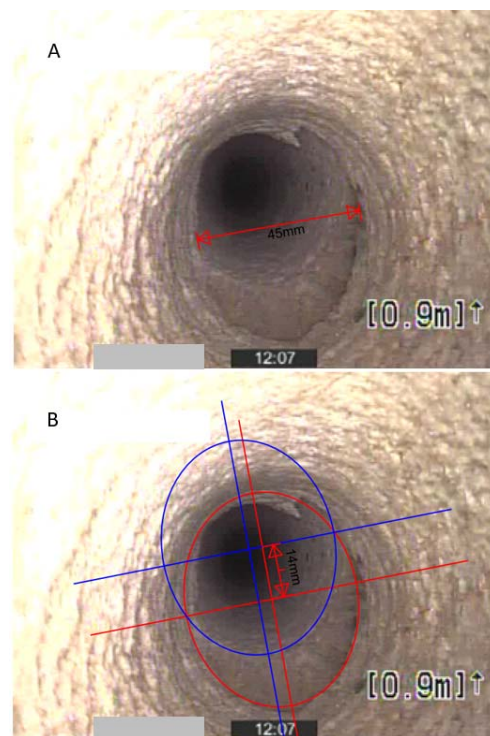
Fig. 8 Image captured in a borescope hole adjacent to the FOS bolt in Fig. 7; the 45-mm hole is off-set by ~14 mm following bedding shear

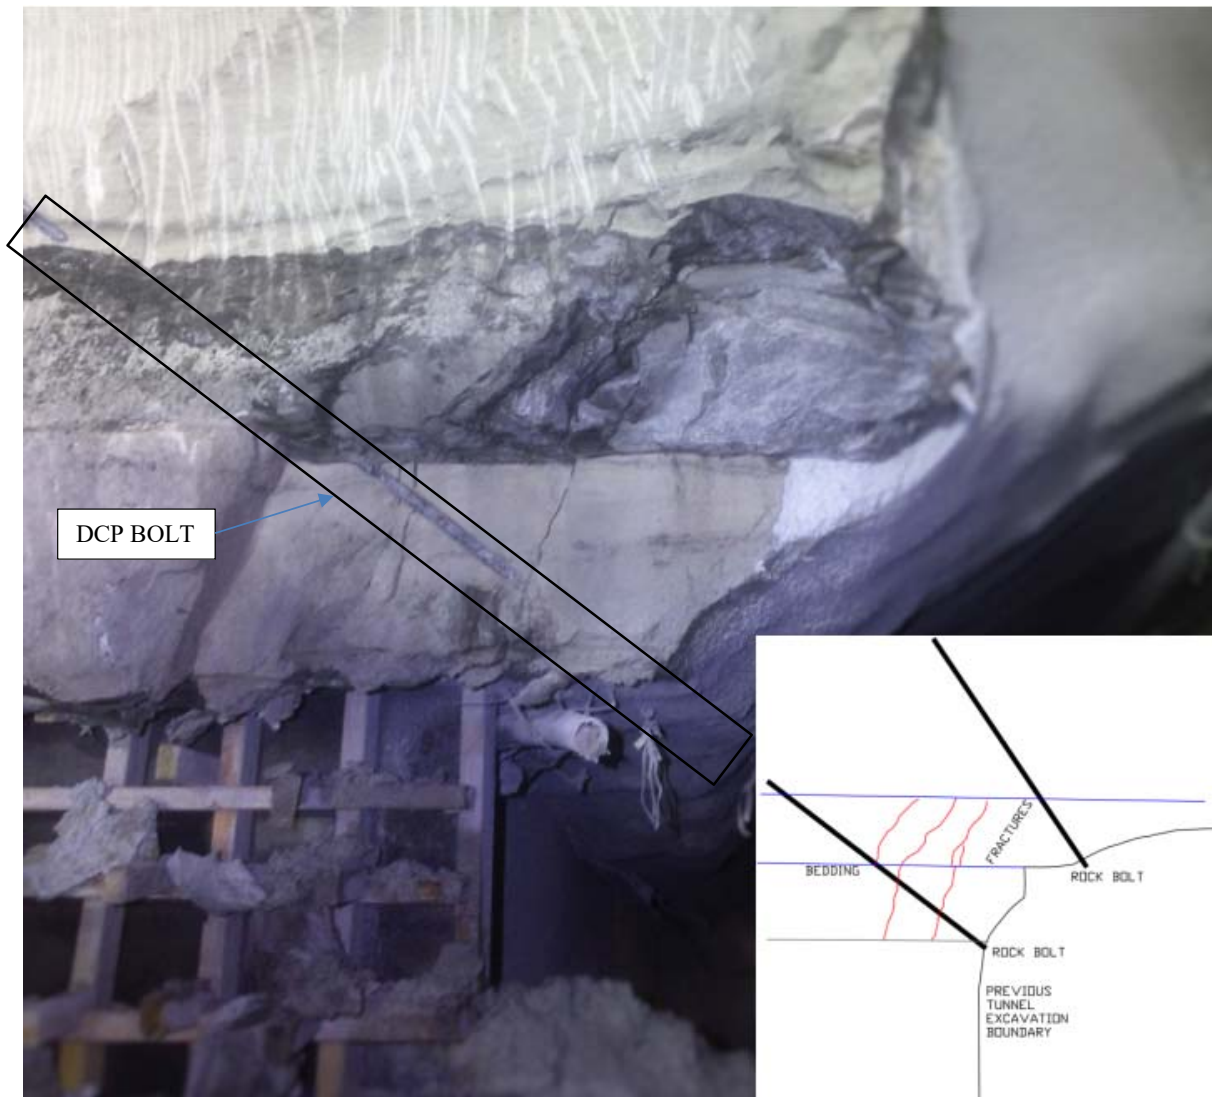
Fig. 9 A photo and explanatory sketch of an exposed DCP bolt above a tunnel shoulder following secondary excavation above the crown

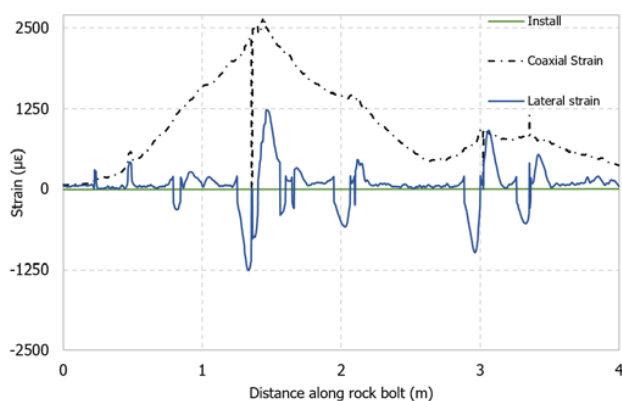
Fig. 10 Monitoring Bolt installed near the middle of the tunnel crown; largest strain component is axial, 2550  $\mu\epsilon$ , compared to lateral at 1250  $\mu\epsilon$  at a bedding parting

The monitoring bolt installed in the centre of the tunnel performed as expected, with the axial component of the strain being far higher than the lateral strain. Fig. 10 shows the

coaxial and lateral strain profile along the bolt. This behaviour is consistent with bolted beam analogies used to describe the behaviour of bedded rock where, bed dilation is expected at the centre of an excavation with increased shear occur towards the walls. Noting that because of an adjacent cross passage excavation and a multistage heading excavation, some asymmetry in the crown displacement was also expected.
