# The Performance and the Induced Rebar Corrosion of Acrylic Resins for Injection Systems in Concrete Structures

C. S. Paglia, E. Pesenti, A. Krattiger

**Abstract**—Commercially available methacrylate and acrylamide-based acrylic resins for injection in concrete systems have been tested with respect to the sealing performance and the rebar corrosion. Among the different resins, a methacrylate-based type of acrylic resin significantly inhibited the rebar corrosion. This was mainly caused by the relatively high pH of the resin and the resin aqueous solution. This resin also exhibited a relatively high sealing performance, in particular after exposing the resin to durability tests. The corrosion inhibition behaviour and the sealing properties after the exposition to durability tests were maintained up to one year. The other resins either promoted the corrosion of the rebar and/or exhibited relatively low sealing properties.

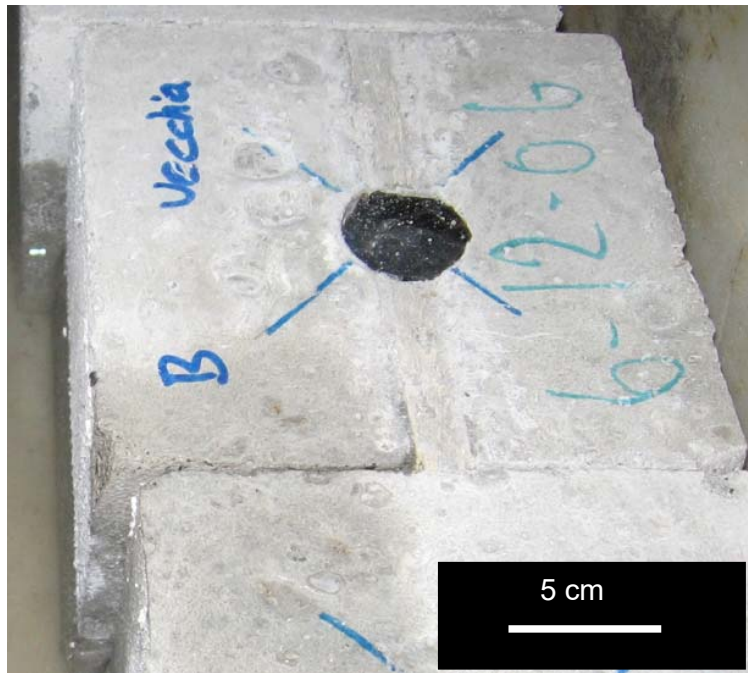
Fig. 1 Concrete cube of 150 mm length with the central cylindrical cavity filled with the resin

The sealing performance tests were carried out by preparing C 40 concrete cubes with length 150 mm. In the middle of the cube a 30 mm diameter hole was drilled. The depth of the hole was 100 mm. The resins (A, B, D, F/A+BI) were mixed according to the mix proportion of the supplier's data sheet and poured directly into the holes. The same resins were subjected to cyclic exposure at different temperature in air and in water according to the norm EN 13687-3 [9] with the following exposure conditions: 2 hours in water at  $21\text{ }^{\circ}\text{C} \pm 2\text{ }^{\circ}\text{C}$ , 4 hours in air at  $-15\text{ }^{\circ}\text{C} \pm 2\text{ }^{\circ}\text{C}$ , 2 hours in water at  $21\text{ }^{\circ}\text{C} \pm 2\text{ }^{\circ}\text{C}$  and 16 hours in air at  $60\text{ }^{\circ}\text{C} \pm 2\text{ }^{\circ}\text{C}$  (EN 13687-3). After the cyclic exposure, the resins were inserted into the holes (Fig. 1) and the cubes were tested on the water impermeability according to the norm EN 12390-8 [10]. The water was forced to penetrate through the surface of the cube at a pressure of  $500 \pm 50\text{ kPa}$  for  $72 \pm 2$  hours. The cubes were then broken in two halves to evaluate the water penetration profiles.

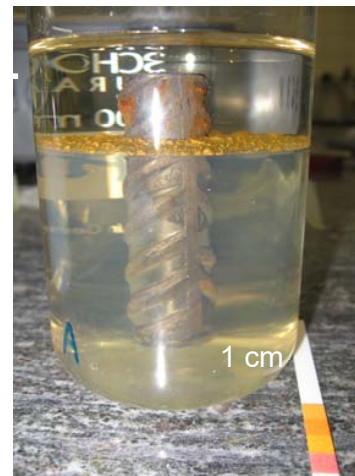
Fig. 2 Steel rebar partially immersed into the resin and into the aqueous solution

Steel rebars S235 with a diameter of 12 mm were inserted into the resins during the mixing and pouring of the resins into a glass container. The rebars were immersed into the resins and partially exposed for ca. 1 cm in the upper part to the aqueous solution (Fig. 2). The glass containers were then sealed with paraffin foils. The rebars were also immersed in a  $\text{Ca}(\text{OH})_2$  saturated solution to simulate the concrete pore solution and in tap water as a reference. After 1 year of exposition, the rebar corrosion was investigated with a

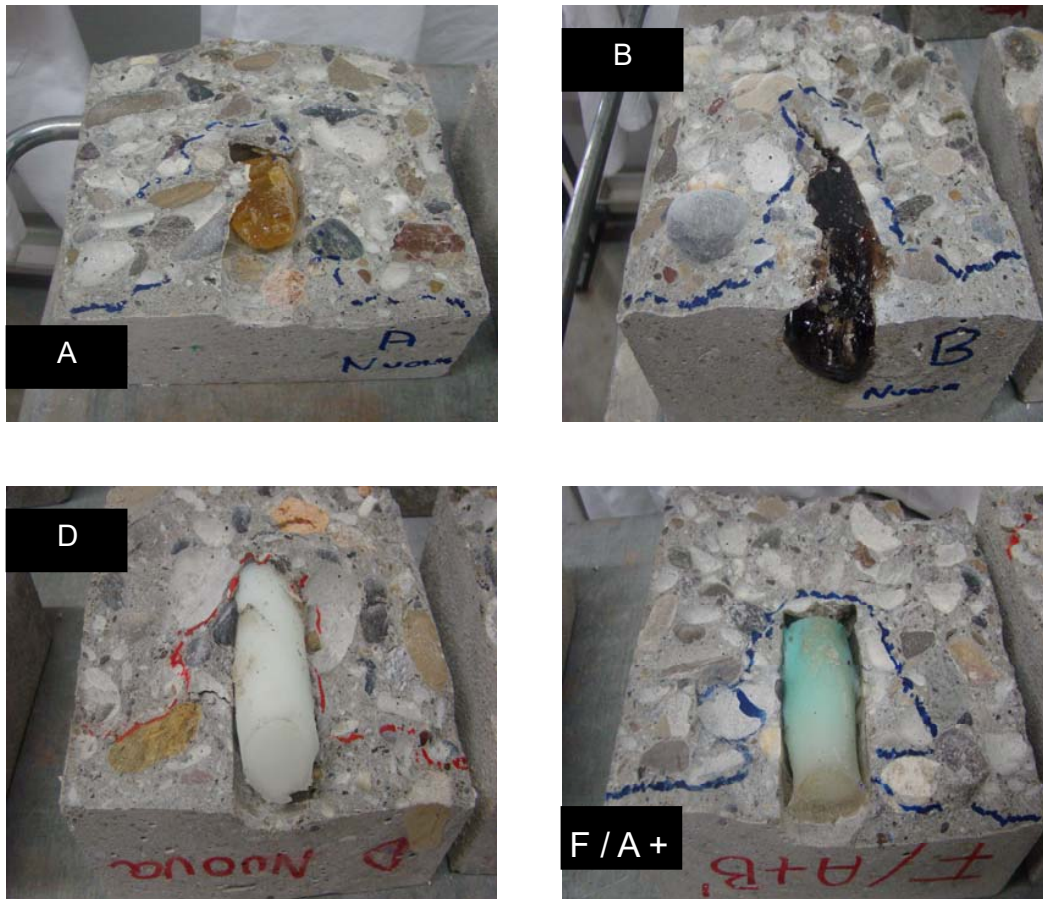
Fig. 3 Water penetration fronts measured according to the norm EN 12390-8 of the halves of concrete cube holes filled with the resins

The water penetration profiles for the cubes filled with the freshly mixed resins and broken in two halves exhibit a wide and deep penetration front along the hole filled with resin A. A relative reduction of the water penetration depth and width is observed for resins B, D and F/A+BI (Fig. 3).

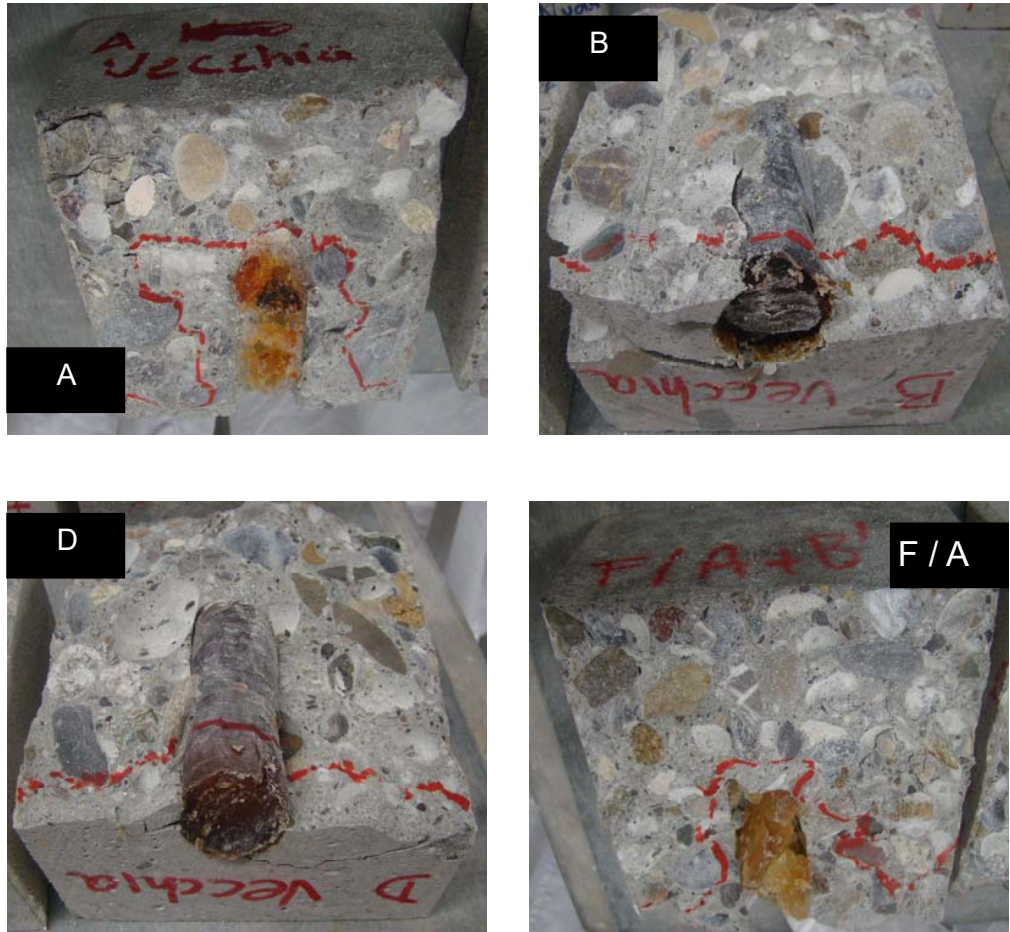
Fig. 4 Water penetration fronts measured according to the norm EN 12390-8 of the halves of concrete cube holes filled with the resins previously exposed to the durability cycles according to the norm EN 13687-3

interface resin-concrete. The weaker is the sealing along this latter interface, the wider is the penetration front line, as for instance for resin A. Interestingly, the depth and width of the water penetration front of the resin A and F/A+ BI, previously exposed to the durability cycles, increases or remain almost the same as compared to the holes filled with the same resins, but not subjected to the durability cycles (Figs. 3, 4 B, F/A+BI). On the contrary, resin B (acrylamide-based) and resin D (methacrylate-based) exhibit, after the exposure to the durability cycles and placing in the concrete holes, a significant reduction in the water penetration front lines. In fact, for these latter resins, a maximum water penetration depth of 32 mm and 24 mm, respectively, is observed (Table

III). In these latter cases, the interface resins-concrete appears to be almost completely sealed by the resins.

The penetration fronts are almost horizontal and are generally controlled by the concrete permeability itself and not by a lack of sealing along the interface resin-concrete. Thus, for these latter resins, ageing processes taking place over time do not significantly modify the relatively good water sealing performance.

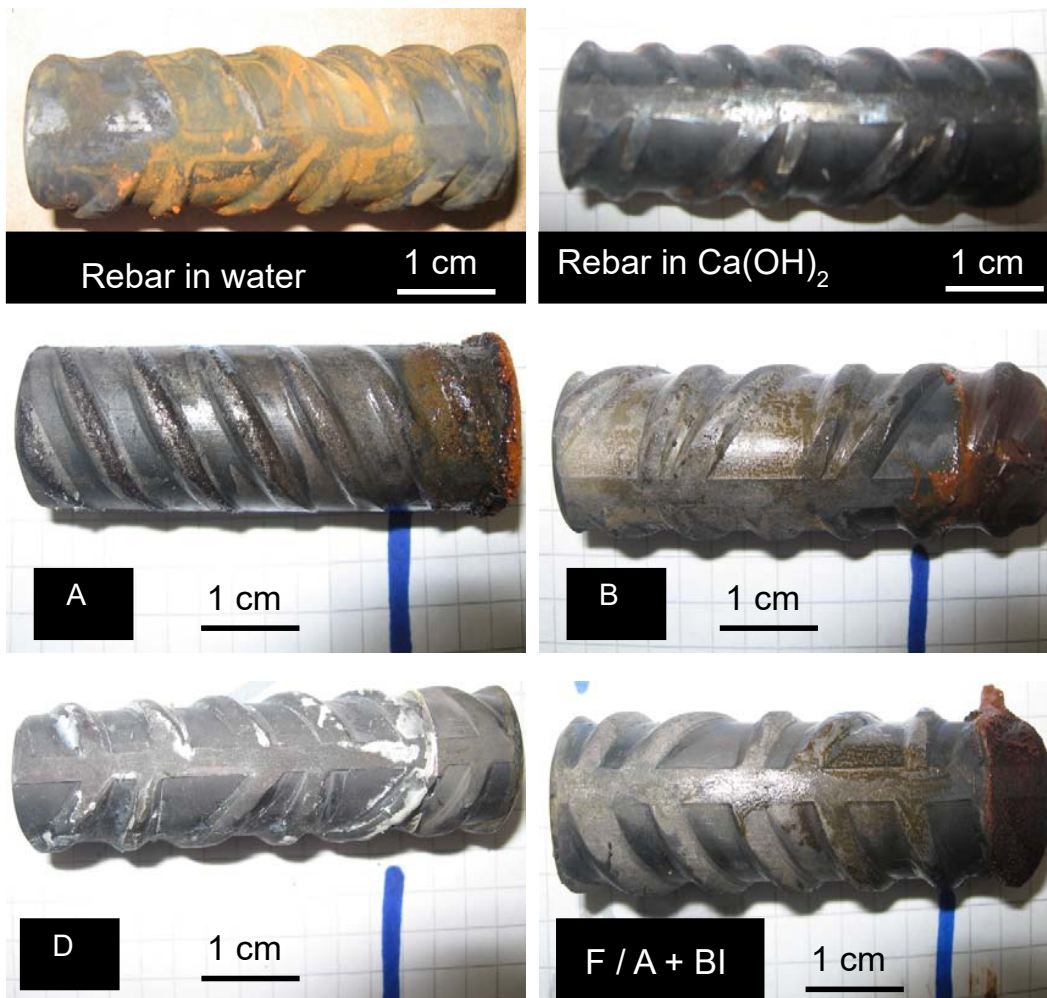
Fig. 5 General overview of the rebars corrosion partially immersed in the aqueous solution and partially in the resins (line = boundary aqueous solution - resin)

A general overview of the rebars partially immersed in the resins and in the aqueous solutions indicates the presence of corrosion products on the rebar surface for resins A, B and F/A+BI. The parts of the rebar immersed in the aqueous solutions generally exhibit an increased formation of corrosion products as compared to the parts immersed in the acrylic resins (Fig. 5). On the contrary, the rebar immersed in the aqueous solution and in resin D does not exhibit corrosion products. As comparison, the rebar immersed in tap water exhibits a uniform corrosion along the entire rebar surface, while the rebar immersed in the saturated  $\text{Ca}(\text{OH})_2$  is generally protected from corrosion (Fig. 5).

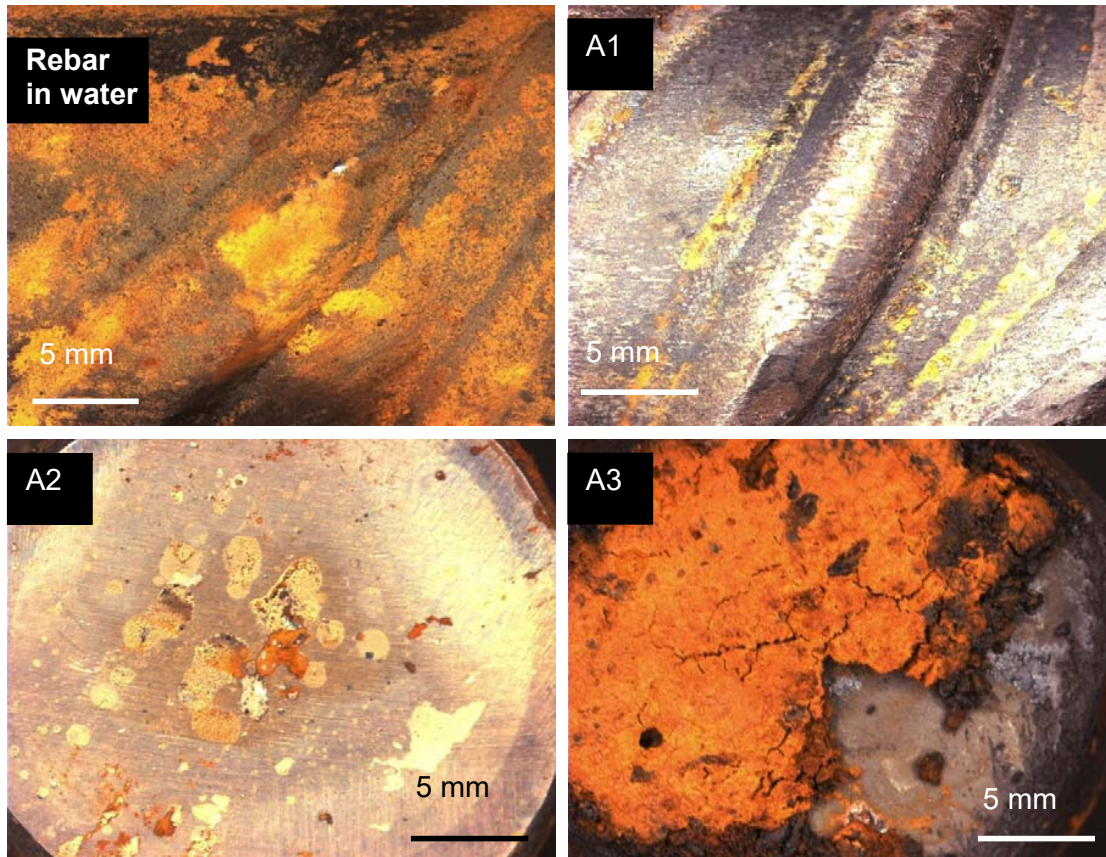
Fig. 6 Detailed view of the rebar in contact with tap water and with the resin A. A1: Slight formation of corrosion products for the rebar immersed in the resin. A2: Slight formation of corrosion products and resin debris on the lower surface of the rebar immersed in the resin. A3: Layer of corrosion products on the upper rebar surface in contact with the aqueous solution A

A detailed view of the corrosion of the rebar immersed in the resin A indicates a slight formation of corrosion products on the rebar surface immersed directly into the resin, while the rebar immersed into the aqueous solution exhibits an increased formation of corrosion products (Fig. 6). A general increased presence of corrosion products for the part of the rebar immersed in the aqueous solution as compared to the rebar immersed in the resin is also observed for resin B (Fig. 7).

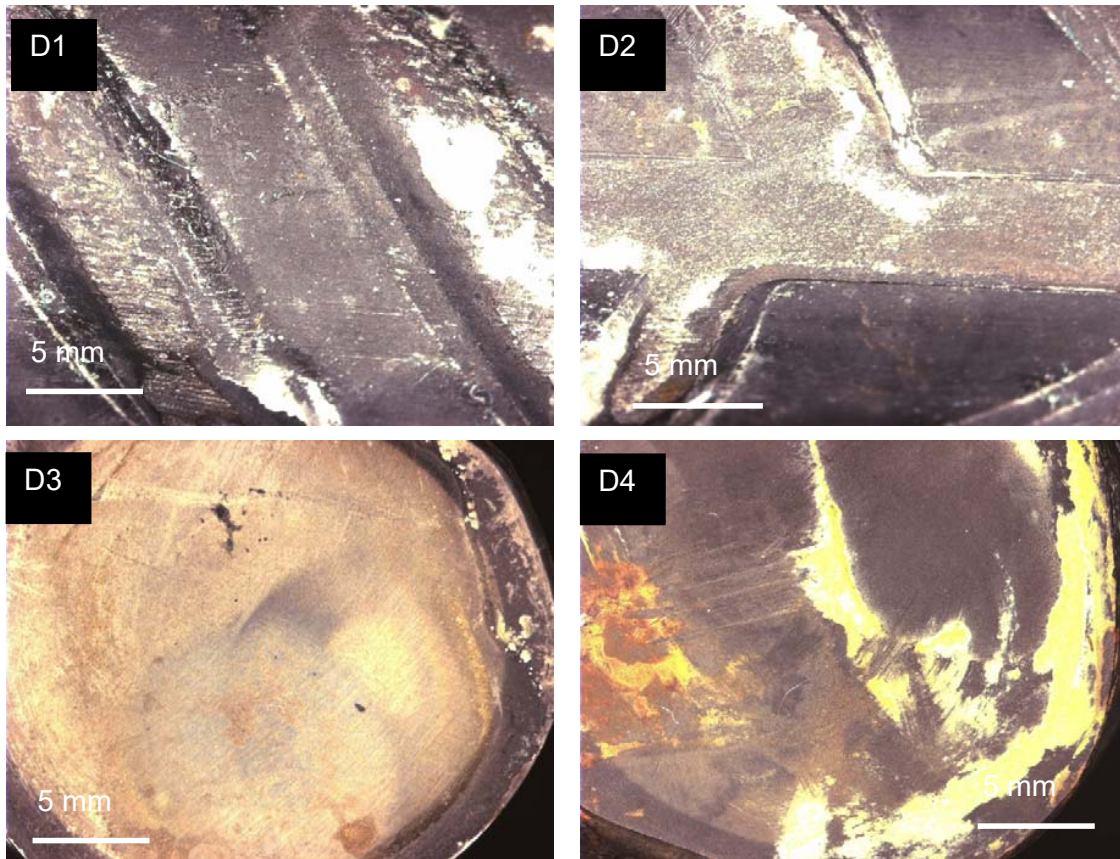
Fig. 8 Detailed view of the rebar in contact with resin D. The corrosion of the rebar immersed in the resin (D1, D3) or in the aqueous solution D (D2, D4) is basically absent

For resin D (methacrylate-based), the corrosion is generally absent for the rebar region immersed in the resin as well as for the rebar region immersed in the aqueous solution D (Fig. 8).

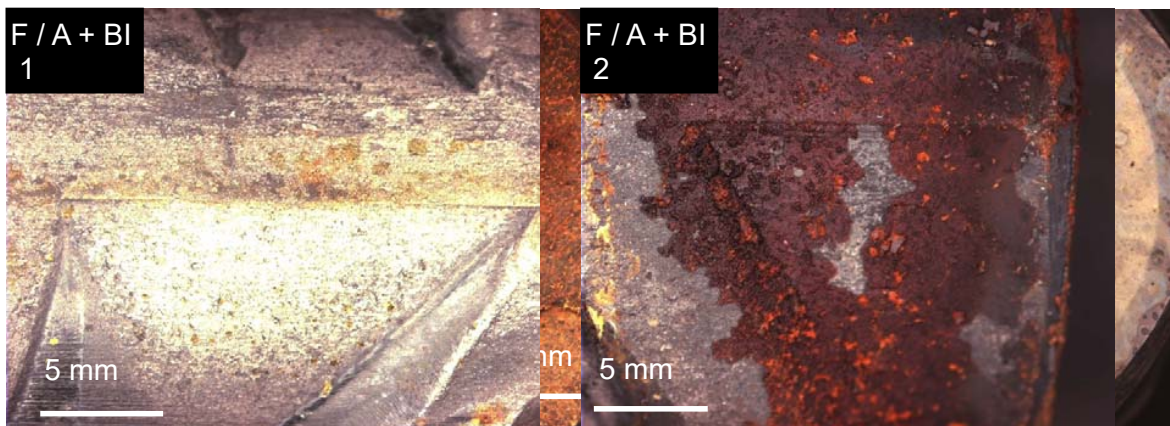
Fig. 9 Detailed view of the rebar in contact with resin F/A+ BI. F/A+ BI 1: slight presence of corrosion products for the rebar immersed in the resin. F/A+ BI 2: corrosion of the rebar immersed in the aqueous solution F /A+BI. F/A+ BI 3 Slight formation of corrosion products on the lower surface of the rebar immersed in resin F/A+ BI. F/A+ BI 4 Layers of corrosion products on the upper rebar surface in contact with the aqueous solution F/A+ BI

On the other hand, the methacrylate-based resin F/A+ BI exhibits similar corrosion features as resin A and resin B (Fig. 9).

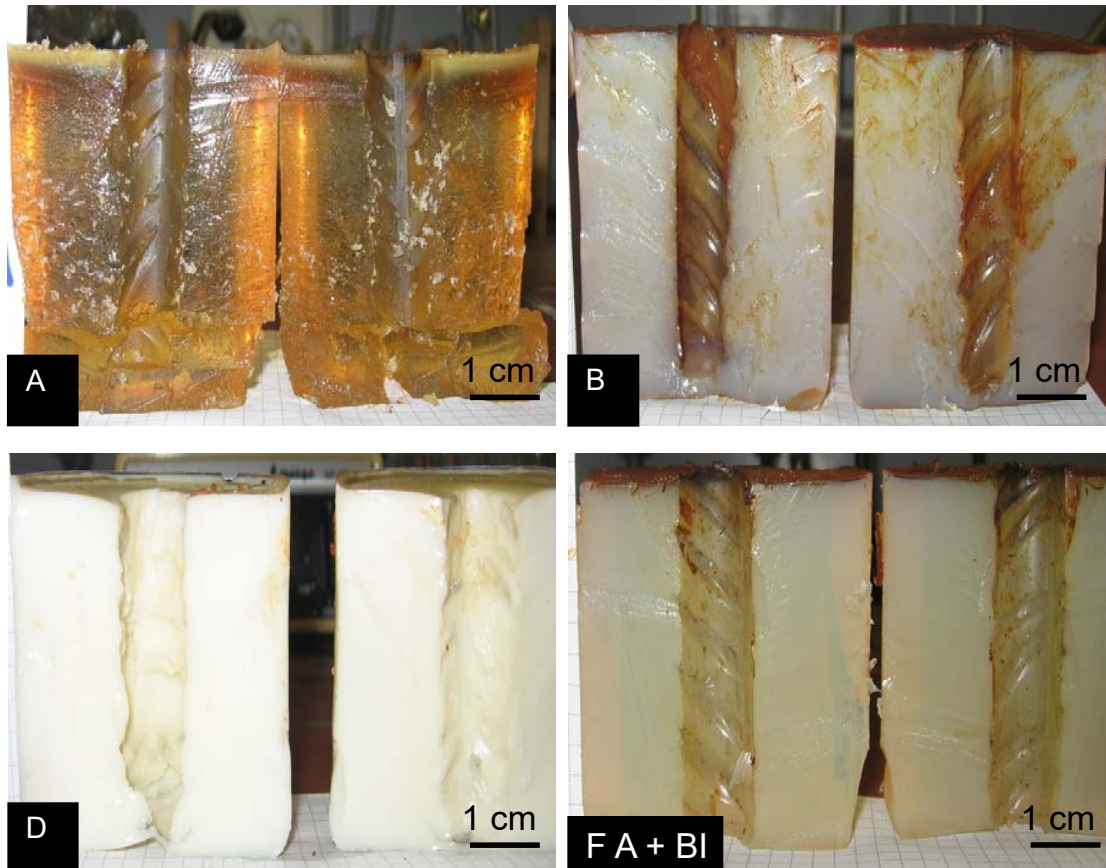
Fig. 10 Resin A: slight presence of corrosion products, in particular in the upper part of the resin (red-black colour) close to the aqueous solution. Resin B: uniform presence of corrosion products along the rebar region. Resin D: almost total absence of colouring effects due to the formation of corrosion products. Resin F/A+BI: uniform presence of corrosion products along the rebar region, in particular in the upper region close to the aqueous solution

In order to further clarify the presence of corrosion products, the resins were cut in two halves and examined with respect to the colour change along the regions where the rebars were placed. In this concern, it is clear that the resin D did not generally exhibit corrosion products along the rebar region, while the other resins indicate a presence of corrosion products, which contributed to the colouring of the resin along the rebar regions (Fig. 10).
