Use of Short Piles for Stabilizing the Side Slope of the Road Embankment along the Canal

Abstract—This research presents the behavior of slope of the road along the canal stabilized by short piles. In this investigation, the centrifuge machine was used, modelling the condition of the water levels in the canal. The centrifuge tests were performed at 35 g. To observe the movement of the soil, visual analysis was performed to evaluate the failure behavior. Conclusively, the use of short piles to stabilize the canal slope proved to be an effective solution. However, the certain amount of settlement was found behind the short pile rows.

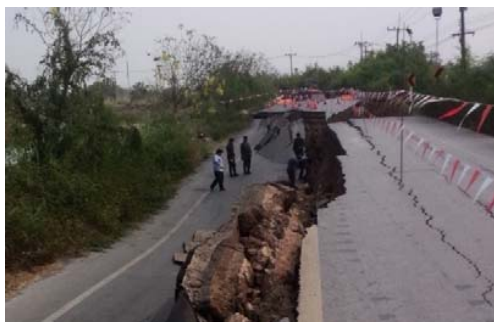
Fig. 1 Road along the canal no.13 collapsed

On the 2nd of March 2016, the road embankment along Canal no.13 (Klong 13) collapsed (Fig. 1) for approximately 100 m long. The canal at the failure area was found to be nearly dry, and a large water pond was found to be located near the failure section (Fig. 2).

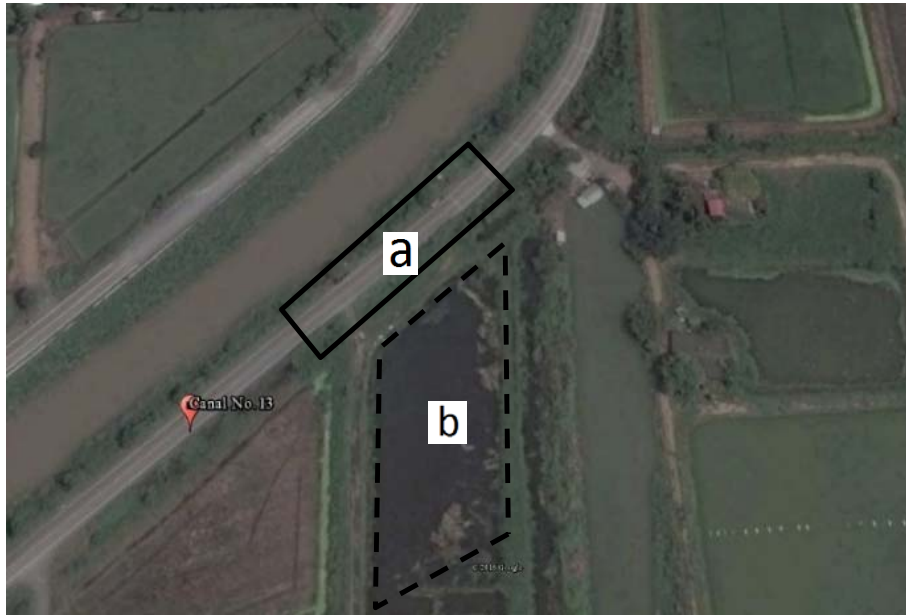
Fig. 2 a. The collapsed areas b. Shrimp ponds

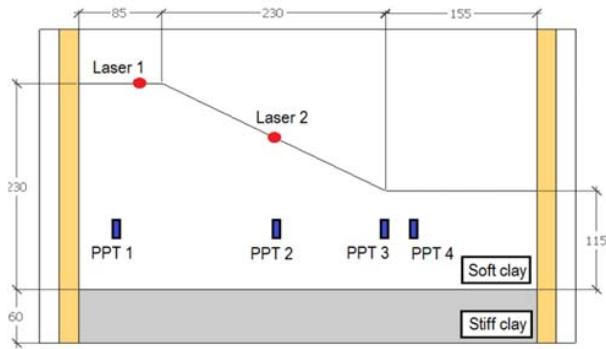
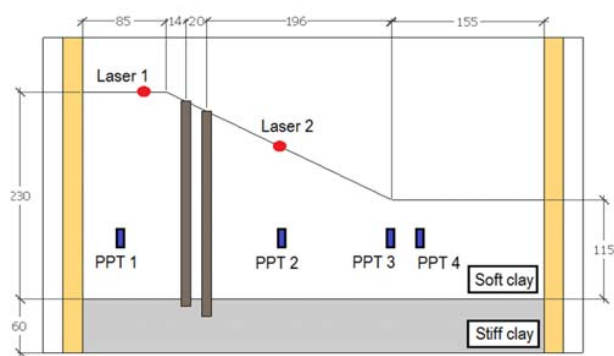
Fig. 3 The setup of instrumentations in both boxes (a) The box without reinforced piles (b) The box with reinforced piles

- PIV Camera: Located in front of the box to record the direction of soil movement.
- Laser: Record the settlement data.
- Pore Pressure water (PPT): Record the changes of water pressure.
- Water Tanks with flow control valve: Control the head of water while testing and the flow rate.

Fig. 3 illustrates the setup of instrumentations of both boxes.

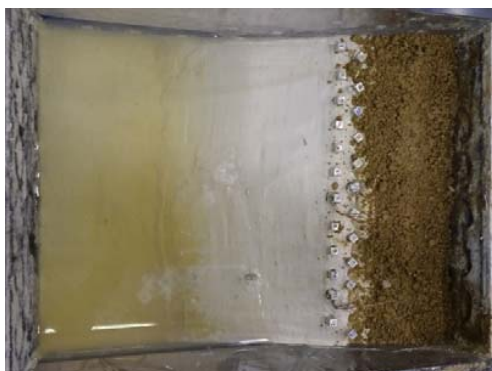
Fig. 5 Top view of piles group box

When the piles were placed alternately, the soil between these piles were virtually not moving because of soil arching, expectedly that the two pile rows will acted as a retaining wall (Figs. 4 and 5).

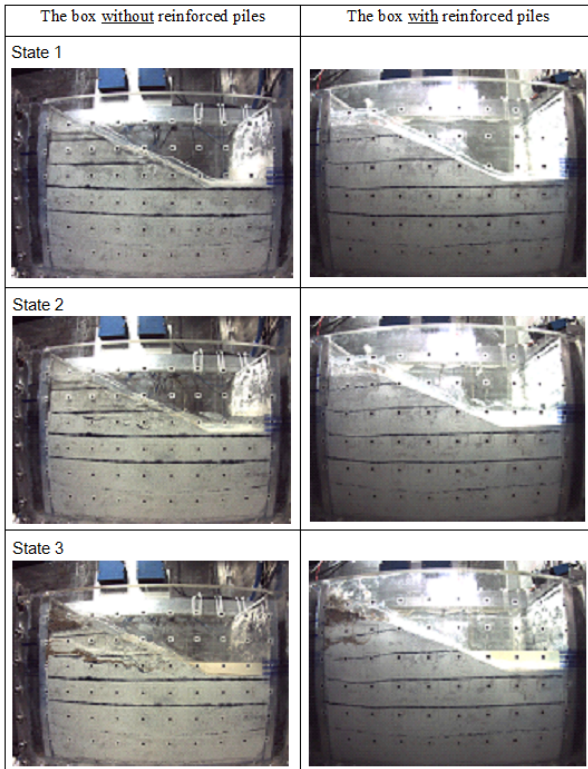
Fig. 6 The results of testing

The results of the centrifuge test can be classified into three states as (Fig. 6):

- State 1: Initial state, after soil preparation but before being spinned up to 35 g.
- State 2: Water level changes according to test plan but before CDG was added:
 1. In the box without reinforced piles, the soil moved down the slope, and the failure plane was found.
 2. In the box with reinforced piles, the soil behind short pile rows moved vertically, but no failure plane was observed.
- State 3: The final step, CDG was added to represent the embankment road:
 1. In the box without reinforced pile, the slope failure was clearly shown (Fig. 7).
 2. In the box with reinforced pile, the soil behind short pile rows moved vertically. Although, more settlement was found and the piles moved slightly, failure plane was not found (Fig. 8).

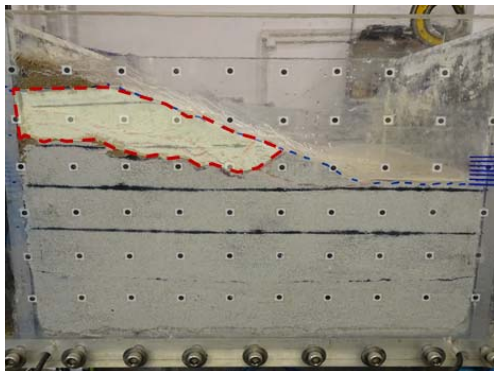
Fig. 7 Failure plane in the box without reinforced piles

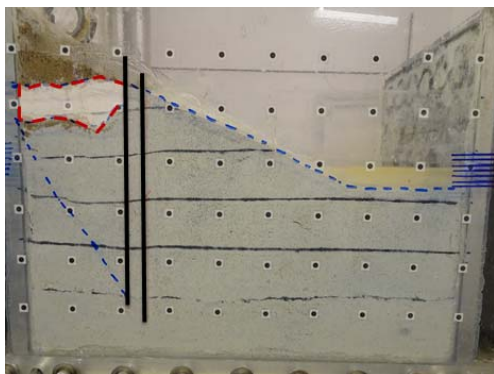
Fig. 8 The vertical settlement area in the box with reinforced piles
