Wear Behavior of Commercial Aluminium Engine Block and Piston under Dry Sliding Condition

M. S. Kaiser, Swagata Dutta

Keywords—Wear, friction, gravimetric analysis, aluminium-silicon alloys, SEM, EDX.

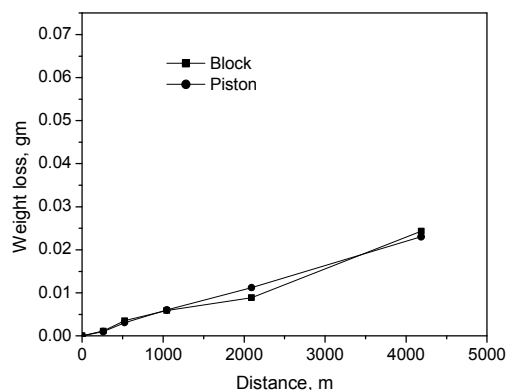
Fig. 1 Variation of weight loss (gm) with the variation of sliding distance (m) at applied pressure of 0.30MPa (Load 5N) and sliding velocity 0.29 ms^{-1}

Figs. 1 and 2 elucidate the variation of weight loss with the variation of sliding speed for both engine block and piston alloy at applied pressure of 0.30MPa (Normal Load 5N) and 1.4MPa (Normal Load 20N) respectively. Moreover, Figs. 3 and 4 depict the variation of wear rate with the variation of sliding speed for both engine block and piston alloy at applied pressure of 0.30MPa (Normal Load 5N) and 1.4MPa (Normal Load 20N) respectively. Other parameters, such as sliding velocity (0.29 ms^{-1}), surface roughness ($2 \mu\text{m}$), and humidity (80%) are identical for these four figures. It can be seen from Fig. 1 that, at lower applied pressure (0.30MPa) the weight loss at all sliding distances vary insignificantly for both block and piston. As the sliding distance increase the weight loss increases for both the alloys. At relatively higher applied pressure (1.4MPa) both the alloys show higher weight loss as compared to weight loss at low load and at all sliding distances (Fig. 2). However, for higher applied pressure, differences in weight loss values for block and piston are evident. The block showed higher weight loss at relatively low and high ends of sliding distance.

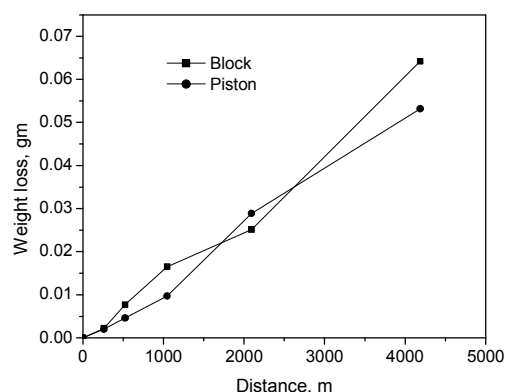
Fig. 2 Variation of weight loss (gm) with the variation of sliding distance (m) at applied pressure of 1.4 MPa (Load 20N) and sliding velocity 0.29 ms^{-1}

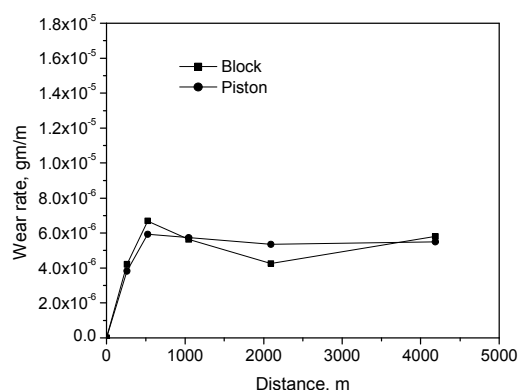
Fig. 3 Variation of wear rate (gm/m) with the variation of sliding distance (m) at applied pressure of 0.30 MPa (Load 5N) and sliding velocity 0.29 ms^{-1}

Figs. 3 and 4 present the wear rate vs. sliding distance plot for both block and piston. At lower applied pressure, it can be observed that wear rate increased at a steep rate initially for both block and piston and after a certain point onwards attained a constant value (Fig. 3). In the case of higher applied pressure, the nature of the curves are quite similar to that of the lower applied load, only difference is in the value of wear rate increased quite significantly for both the alloys (Fig. 4) with block showing higher values than piston at lower and higher realm of the investigated sliding distance range. The competition of frictional heat softening and strain hardening determined the down -and-up trending. Figs. 3 and 4 clearly indicate that the wear rates of both the alloy increased with increasing the load from 5N to 20N. The wear rate for engine block increased from $6 \times 10^{-10} \text{ gm/m}$ (5N) to 1.6×10^{-5} (20N) at sliding distance of 1000 m. For all sliding distances, the wear rate for both the alloys increased one order of magnitude with increasing load from 5N to 20N. For both applied pressures the piston alloy showed lower wear rate as compared to that of block alloy. The result is due to the presence of higher percent of Ni and Mg in piston alloy as seen from the chemical analysis (Table I). Ni forms an intermetallic Al_3Ni which

increases as Ni content increases. This intermetallic increases the strength of the piston alloy leading to lower wear rate. More over Mg addition is beneficial to enhance the abrasion resistance of the alloy due to uniformly distribution of hard particles and reduction of friction coefficient [10]. The sliding movement occurs in very small areas at the peaks and over time. The ruptures or breaks at the peaks increase the contact area and results in rise in temperature. The increase in the load causes rise in friction.

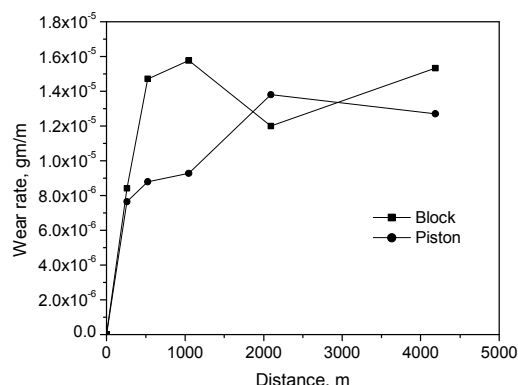
Fig. 4 Variation of wear rate (gm/m) with the variation of sliding distance (m) at applied pressure of 1.4 MPa (Load 20N) and sliding velocity 0.29 ms^{-1}

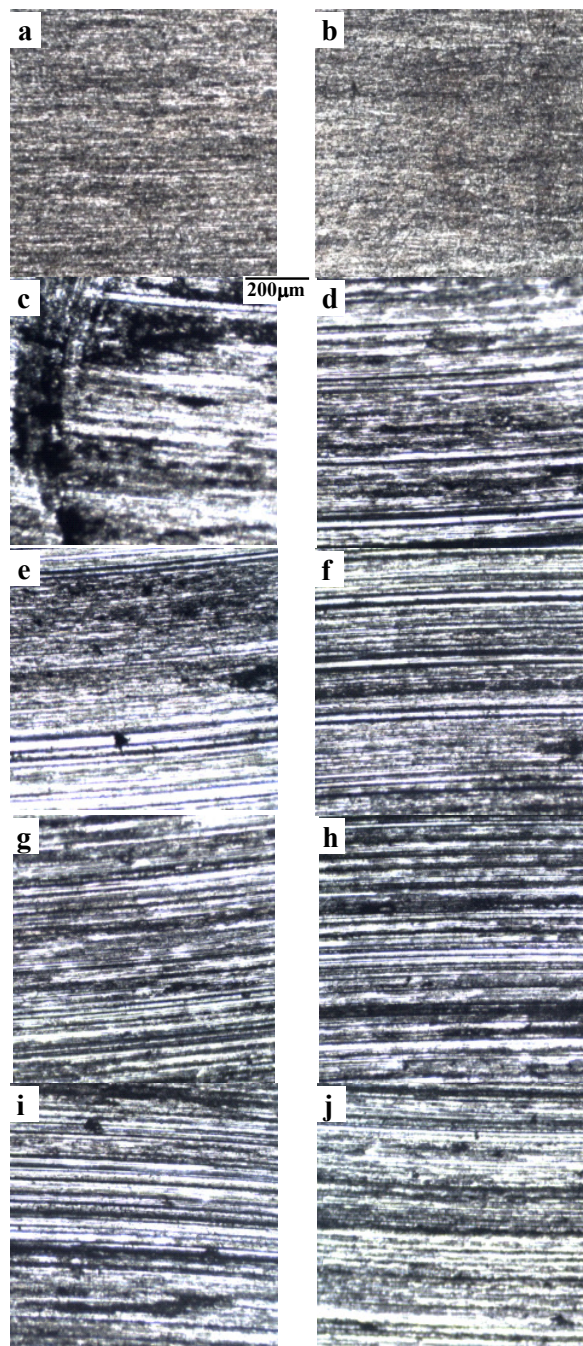
Fig. 5 Optical micrograph of worn surfaces before wear (a) block, (b) piston, after wear at applied pressure of 0.30MPa for 15 min (c) block, (d) piston, for 4 hours (e) block, (f) piston, at applied pressure of 1.40MPa for 15 min (g) block, (h) piston and for 4 hours (i) block (j) piston

In this study of dry sliding wear of two Al-Si alloys against a cast iron counter-body, the wear was described as a mixed mode of elastic-plastic contact where Archard's law was obeyed. The applied pressure range investigated was 0.30 MPa and 1.4 MPa. This range of applied pressure was previously found to exhibit mild wear (MW) in these alloys [11]. In Fig. 5 are presented the worn surfaces for both block and piston alloys at different loads and sliding distances. Firstly, it can be observed that for a given alloy and for a given load, as the sliding distance increase the wear marks becomes more visible and deep. In some portions of the investigated worn surface there are evidence of crater formation. It can also be seen that for a given alloy and at a given sliding distance, as the load is increased the wear marks also becomes more deep and prominent. Increasing the load from 5N to 20N also increases the fraction of flaky wear debris. At low loads and at all sliding distances, the wear marks in the worn surfaces of block and piston alloy are similar in nature whereas at higher applied loads the wear marks in the worn surfaces of block are more deep and intense than that of the piston alloy leading to their higher material loss and corresponding high wear rate. The wear mechanisms in the dry sliding of Al-Si alloys can be classified as oxidative wear. Oxidative wear occurred at low applied loads. In this wear process an aluminium oxide layer (10-80 nm) formed on both the wearing Al-Si surface and the counter-face [11]. Wear occurred firstly by oxidation of the asperities and then secondly by fracture and compaction of the oxidized wear debris into this film. The wear rate was low, due to the amount of metal removed being confined to the thickness of this oxide formation. Some localized deformation of the substrate and fracture of the Si particles was observed. Oxidative wear was considered to be generally independent of the Si content or Si particle size. Under conditions of mild wear a tribolayer was formed on the surface of Al-Si alloys. This layer was found to consist of an ultrafine mixture of aluminium, silicon and α -iron. The formation of this surface resulted from the transfer of material from both the Al-Si alloy pin material and the steel counter-face. It was also found that the observed iron-rich layer, formed on the Al-Si surface due to mutual material transfer between the sliding surfaces, was composed of an ultrafine mixture of Al, Si and α -Fe ($<1 \mu\text{m}$). Furthermore, it was argued that as wear continued, the deposition reached a stage where these transferred layers could not adhere and became detached [11].

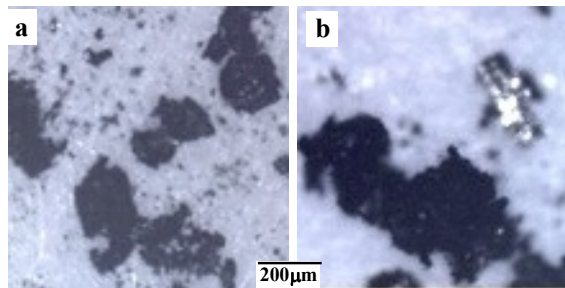
Fig. 6 Wear debris collected from wear test at 1.4 MPa (20N) applied pressure and sliding distance of 4200m for (a) Block, (b) Piston

Fig. 6 shows the typical wear debris collected from the wear test. At low loads the wear debris was equiaxed, laminar and consisted of a small iron content. An increase in the applied normal load formed wear debris of various shapes and sizes. The debris size ranged from a few microns, to a few millimeters. Visually, the debris produced at 20 N appeared in

the form of a dark, brown powder. The micrograph (Fig. 6) shows the debris produced at a load of 20 N was mainly composed of very fine, equiaxed particles but also contained plate-like and ribbon-shaped iron particles in smaller amounts. The fine and large debris particles were a mixture of Al, Si, Fe, and oxygen. The ribbon-shaped particles had an appearance similar to machined chips, and were mainly composed of Fe indicating that they were cut from the steel counter-face.

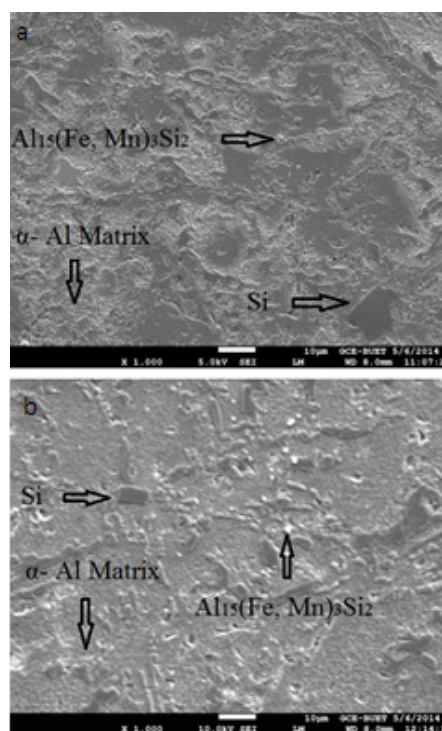
Fig. 7 SEM micrographs of as-received Al-Si (a) block and (b) piston

The SEM micrographs of as-received Al-Si block and piston are shown in Figs. 7 (a) and (b) respectively.

The microstructure consisted of mainly primary Al dendrite, eutectic Si, $\text{Al}_{15}(\text{Fe, Mn})_3\text{Si}_2$, Mg_2Si and a few number of Fe-rich intermetallic phases on α -Al matrix in the inter-dendritic region. It can be seen that the eutectic Si phase is flake-like

and acicular morphologies. Two type of NiAl_3 phase are the plate-like and needlelike morphologies [7].

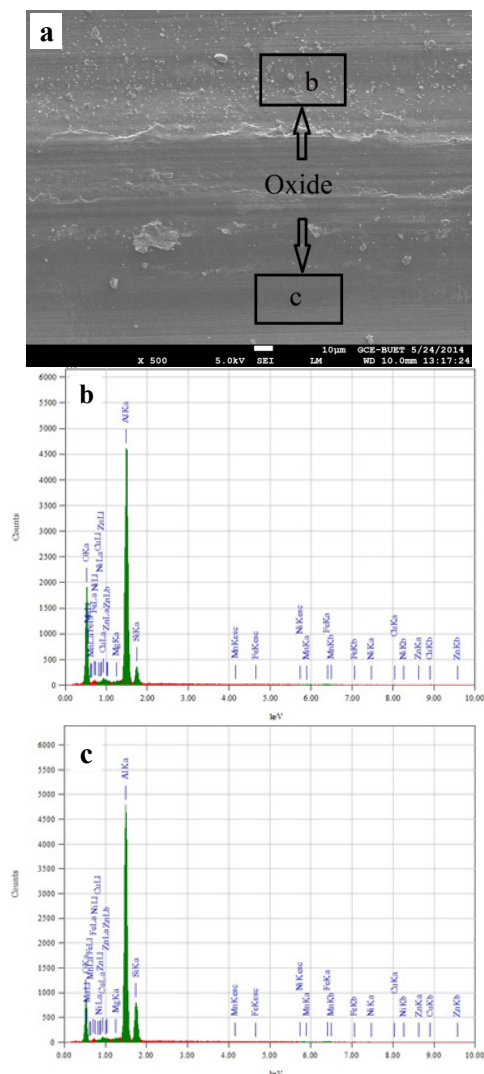
Fig. 8 SEM images of worn surfaces of aluminium engine block after wear at 1.4 MPa applied pressure and sliding distance of 4200m

The SEM micrographs of the worn surfaces of Al-Si block and piston are shown in Figs. 8 and 9. The corresponding EDX profile analysis of the block alloy for the selected area of the SEM is shown in Figs. 8 (b) and (c). The weight percentage of elements found by EDX analysis in these areas were 37.67% O, 51.03% Al, 5.60% Si, 0.75% Mn, 3.74% Fe and 0.76% Cu, 0.44% Zn and, 22.23% O, .04% Mg, 58.01% Al, 15.49% Si, 2.27% Fe, 0.72% Ni, 0.80% Cu, 0.42% Zn respectively.

Generally, a transferred layer either in continuous or discontinuous form was observed for the samples. The widths of the surface grooves were between 4 μm and 20 μm . In this wear process an aluminium oxide layer (10-80 μm) formed on both the wearing Al-Si surface and the counter face. Wear occurred firstly by oxidation of the asperities and then secondly by fracture and compaction of the oxidized wear debris into this film. The wear rate was low, due to the amount of metal removed being confined to the thickness of this oxide

formation. Some localized deformation of the substrate and fracture of the Si particles was observed. Sliding marks are observed on all the worn surfaces which are of typical ploughing action in comparatively soft metal. It is also seen that the depth and width of the sliding marks increases with increase of applied load and sliding distance. The worn surface is relatively rough and exhibits rather coarse and deep sliding marks. In contrast, the coarseness and deepness of the sliding marks increases with increasing load on the tested alloys. At relatively low speeds and loads, the heat generated by the asperity contact leads to oxide formation on the aluminum surface. The layer is thin and can deform elastically contributing to very low wear rates which can be considered as mild wear. Increasing the load causes adhesion to occur between the two materials in contact and removal of the surface oxide in the form of laminar particles. At low loads the wear debris was characterized by dark-brown coloured powder mixed with Fe, Al, and Si and O, very fine equiaxed particles, small amounts of ribbon shaped particles (Fe chips), and Plate-like particles (Fe-Al-Si-O). At relatively high loads Plate-like particles composed of Fe, Al, and Si and O and metallic Al flakes (Al-Si) was observed [11]. The worn surface was characterized by surface with shallow grooves at loads while the groove width and depth increased as the loads increases.

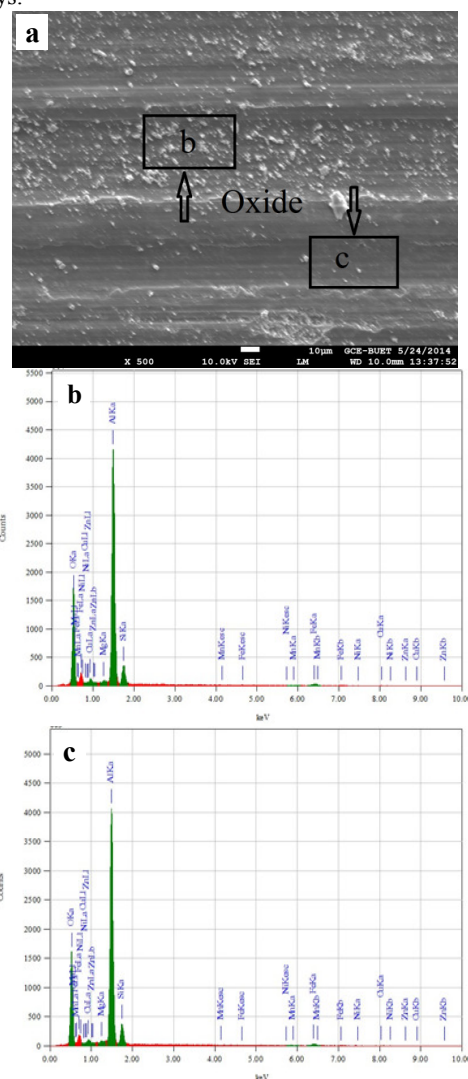
Fig. 9 SEM images of worn surfaces of aluminium engine piston after wear at 1.4 MPa applied pressure and sliding distance of 4200m

The corresponding EDX profile analysis of piston alloy for the selected area of the SEM is shown in Figs. 9 (b) and (c). The weight percentage of elements found in these areas were 33.82% O, 0.12% Mg, 48.00% Al, 5.69% Si, 0.17% Mn, 10.61% Fe, 0.42% Ni, 1.01% Cu, 0.1% Zn and 33.93% O, .15% Mg, 48.45% Al, 5.99% Si, 0.45% Mn, 9.70% Fe, 0.34% Ni,

0.86% Cu, 0.13% Zn respectively. The EDX data clearly reveals the high oxide content in the selected areas which suggest the oxidative wear was the dominant process. In case of block alloy the EDX analysis of the investigated areas reveals that the oxide content is unevenly distributed. Whereas for piston alloy the oxide content is roughly uniform which can be responsible for lower wear rate for the piston alloy. This can be due to the variation of chemical composition of the alloys.
