# Study on Discharge Current Phenomena of Epoxy Resin Insulator Specimen

Waluyo, Ngapuli I. Sinisuka, Suwarno, Maman A. Djauhari

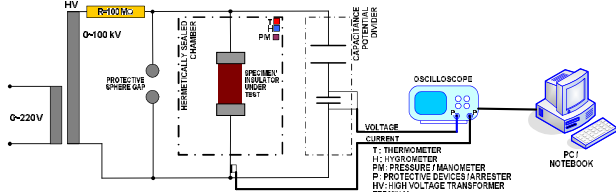
Fig. 1. Schematic diagram of experimental setup

The measurements of discharge current and applied voltage waveforms used a two-channel storage digital oscilloscope. The measured data could be recorded and transferred to a computer with USB and could be saved in softcopy form, read and saved in Excel. The schematic diagram of experimental setup is shown on Figure 1.

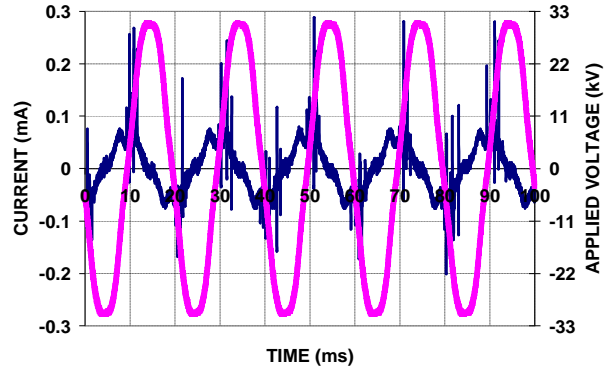
(a) Current & voltage waveforms

Figure 3 shows discharge current phenomenon of epoxy resin specimen on 26.4°C, 99%, 30.6 kV<sub>max</sub> of temperature, humidity and applied voltage amplitude respectively, and without pressure. This is sample of high relative humidity typical condition. Figure 3(a) is discharge current and applied voltage waveforms on such condition. It is seen that the intermittent discharge current was occurrence suddenly and significantly more rather than that on low humidity. It was easier to discharge on high humidity rather than on low humidity condition. Thus, the threshold voltage would be reduced. This case was caused by the existence of grains of water droplet on the surface of epoxy resin specimen. These water droplets raised quantity of discharges. However, the magnitudes of current discharge and applied voltage reduced explicitly. For this condition, the clean

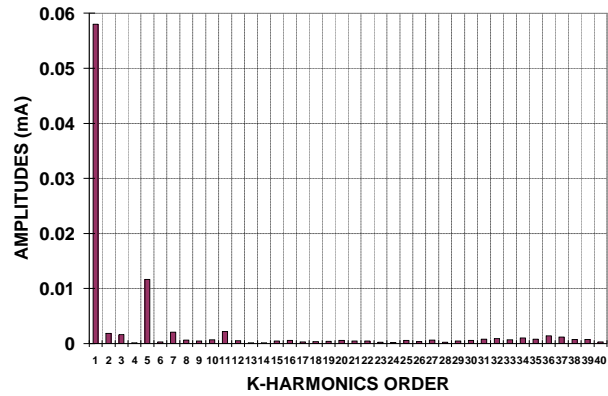
(b) Current harmonics spectrum

epoxy resin specimen still had capacitive property. Thus, the discharge condition did not change the epoxy resin specimen significantly. Figure 3(b) shows harmonics frequency spectrum of discharge current of Figure 3(a). Besides the fundamental frequency, the fifth harmonics was visible explicitly, as second highest of harmonics. Other harmonics were not visible significantly. Figure 3(c) is the characteristics of applied voltage to discharge current of high humidity clean epoxy resin specimen. It is seen that the flash points increased, compared to the flash points on low humidity. This case was caused by some water droplets on the specimen surface.

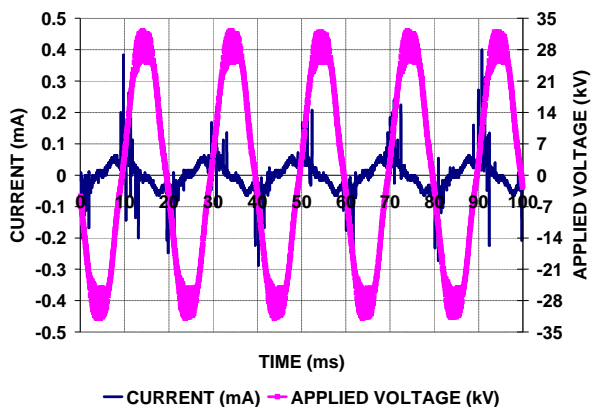
(a) Current & voltage waveforms

Figure 4 shows discharge current phenomenon of epoxy resin specimen on 26°C, 92%, -16 kPa and 30.6 kV<sub>max</sub> of temperature, humidity, pressure and applied voltage amplitude respectively. This is sample of low pressure typical condition. Figure 4(a) is discharge current and applied voltage waveforms on such condition. It is seen that the intermittent discharge current was occurrence suddenly and significantly more rather than that on low humidity. Nevertheless, the peaks of discharge current points were higher than that on high humidity. For this case of low pressure, the highest peak discharge current point was 0.4 mA, whereas for high humidity case, the highest peak discharge current point was 0.288 mA. Thus, the influence of low pressure was higher than the influence of high humidity. It is stated that it was easier to discharge on low pressure rather than on high humidity conditions. Thus, the threshold voltage would be reduced on low pressure. This case was caused supposedly by particle of air surrounding the specimen reduced, and furthermore, they were easier to discharge. Nevertheless, for this condition, the clean epoxy resin specimen still had capacitive property. It had capacitive property, although in a low pressure discharge condition.

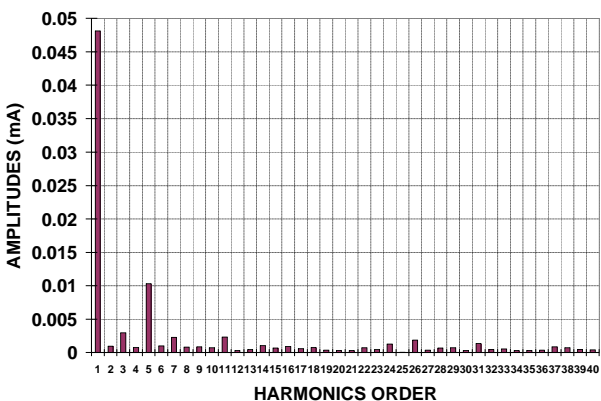
(b) Current harmonics spectrum

Figure 4(b) shows harmonics frequency spectrum of discharge current of Figure 4(a). Besides the fundamental frequency, the fifth harmonics was visible explicitly, as second highest of harmonics. Third harmonics was visible significantly enough, as third highest of harmonics. The lower of pressure, the more visible of third harmonics. Figure 4(c) is the characteristics of applied voltage to discharge current of low pressure clean epoxy resin specimen. It is seen that the flash points increased, compared to the flash points on low humidity or high humidity.

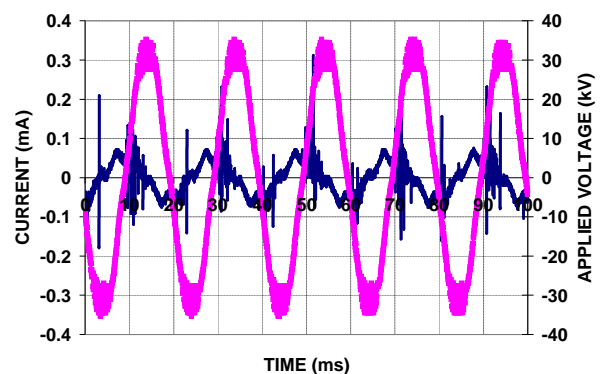
(a) Current & voltage waveforms

Figure 5 shows discharge current phenomenon of epoxy resin specimen on 27.4°C, 99%, +17 kPa and 35.3 kV<sub>max</sub> of temperature, humidity, pressure and applied voltage amplitude respectively. This is sample of high pressure typical condition. Figure 5(a) is discharge current and applied voltage waveforms on such condition. It is seen that the intermittent discharge current was occurred significantly less than that on high pressure. Besides that, the applied voltage amplitude increased to reach a discharge condition. As sample of applied voltage amplitude, for this case, from 30.6 kV<sub>max</sub> on -16 kPa of pressure, became 35.3 kV<sub>max</sub> on +17 kPa of pressure. On other hand, the peak discharge point was lower, from 0.4 mA became 0.312 mA. It is stated that the increasing of pressure, it caused made higher of applied voltage amplitude to make discharge process, and on other word the current discharge point would reduce. It was more difficult to discharge on high pressure rather than that on low pressure. Thus, the threshold voltage would be increased on high pressure. This case was caused supposedly by particle of air surrounding the specimen increased, and furthermore, they were more difficult to discharge, due to be compressed. Nevertheless, for this condition, the clean epoxy resin specimen still had capacitive property.

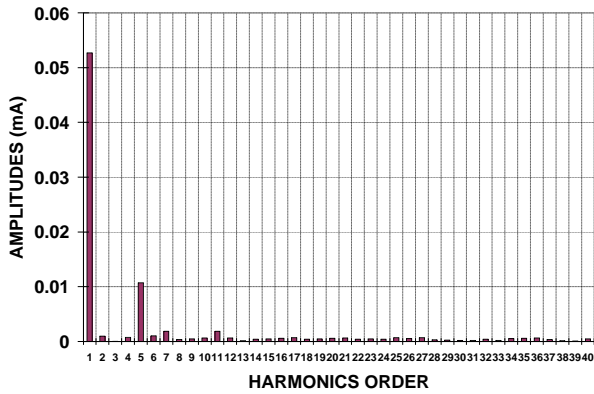
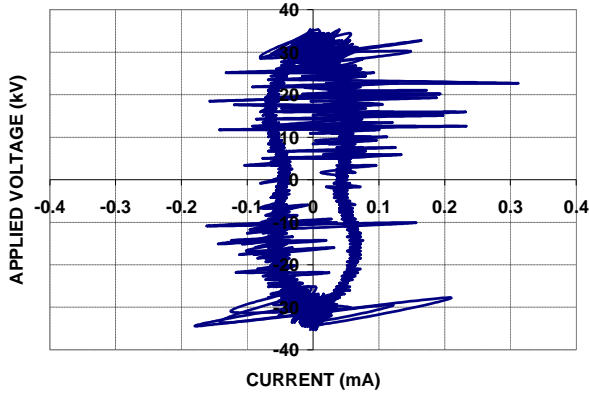
Fig. 5. Typical waveform of high pressure clean specimen

Figure 5(b) shows harmonics frequency spectrum of discharge current of Figure 5(a). Besides the fundamental frequency, the fifth harmonics was visible explicitly. Figure 5(c) is the characteristics of applied voltage to discharge current of high pressure clean epoxy resin specimen. It is seen that the flash points were less compared to that on low pressure.

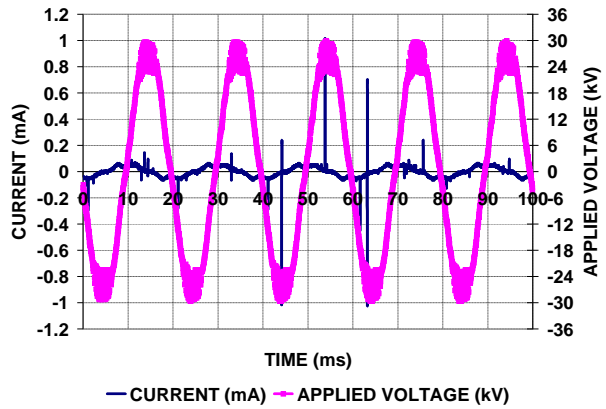
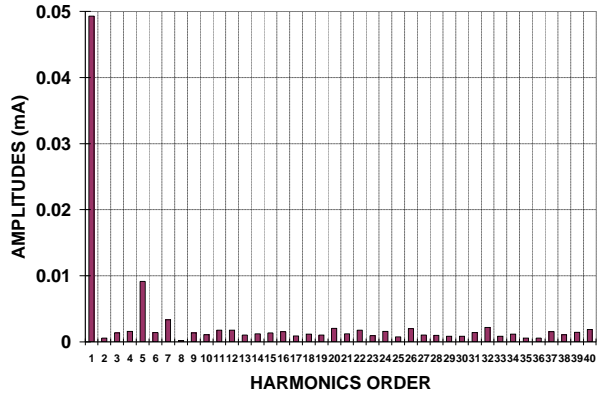
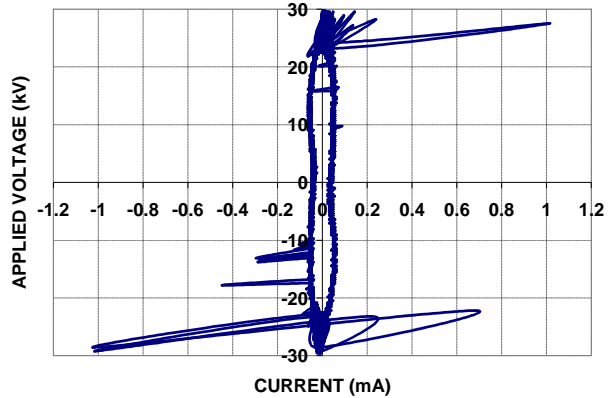
Fig. 6. Typical waveform of low RH lightly polluted specimen

6(c) is the characteristics of applied voltage to discharge current of low humidity for this specimen. It is seen that the flash points were same, but the peak discharge current values were higher compared to that low humidity clean specimen.

Figure 6 shows discharge current phenomenon of lightly artificial contaminated epoxy resin specimen on 26.3°C, 68% and 35.3 kV<sub>max</sub> of temperature, humidity and applied voltage amplitude respectively, and without pressure. This is sample of low humidity typical condition. Figure 6(a) is discharge current and applied voltage waveforms on such condition. It is seen that the intermittent discharge current was occurred slightly to increase compared to that on low humidity of clean specimen. However, the peak discharge current significantly increased, for this applied voltage amplitude, it became +1.01 mA and -1.01 mA for positive and negative peaks. It is stated that the existence of contaminant, it caused made higher of peak discharge current, both for positive and negative values. It was easier to discharge due to existence of contaminant on the specimen. The threshold voltage would be reduced due to existence of contaminant. This case was caused by particle of contaminant on specimen surfaces. Nevertheless, for this condition, the clean epoxy resin specimen still had capacitive property.

Figure 6(b) shows harmonics frequency spectrum of discharge current of Figure 6(a). Besides the fundamental frequency, the fifth harmonics was visible explicitly, and other harmonics were also visible. However, they were far lower than third harmonics. Figure

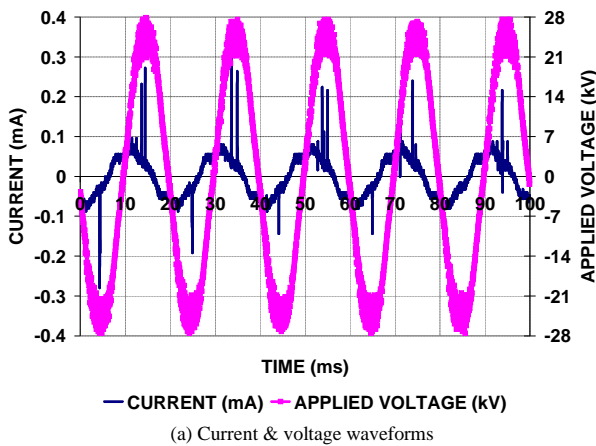
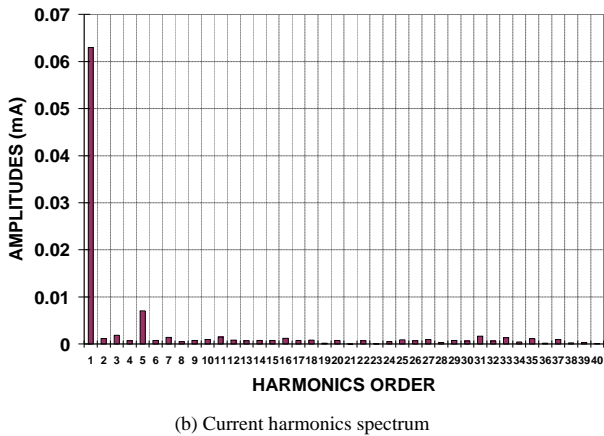
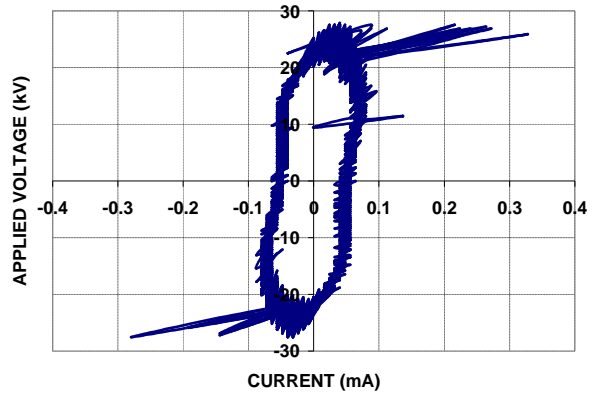
Fig. 7. Typical waveform of high RH lightly polluted specimen

Figure 7 shows discharge current phenomenon of lightly artificial contaminated epoxy resin specimen on 26.3°C, 99% and 27.9 kV<sub>max</sub> of temperature, humidity and applied voltage amplitude respectively, and without pressure. This is sample of high humidity typical condition. Figure 7(a) is discharge current and applied voltage waveforms on such condition. It is seen that the intermittent

discharge current was occurred slightly to increase compared to that on low humidity of slightly contaminated specimen. However, the peak discharge current reduced, became 0.33 mA on this condition compared to previous 1.01 mA. This was also caused the applied voltage was lower than the previous on low humidity. Thus, it was easier to discharge due to high humidity. The threshold voltage would be reduced due to the grains of water droplets. This case was caused by particle of contaminant and water droplets on the specimen surfaces. Nevertheless, for this condition, the specimen still had capacitive property.

Figure 7(b) shows harmonics frequency spectrum of discharge current of Figure 7(a). Besides the fundamental frequency, the fifth harmonics was visible explicitly, and other harmonics were also visible slightly. However, they were far lower than third harmonics. Figure 7(c) is the characteristics of applied voltage to discharge current of high humidity for this specimen. It is seen that the flash points increased slightly, but the peak discharge current values were higher compared to that high humidity clean specimen.

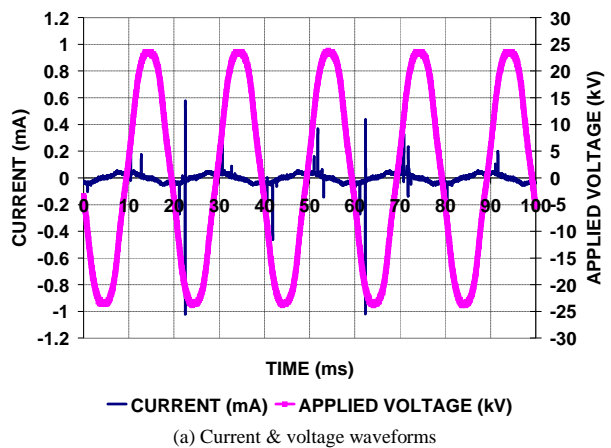
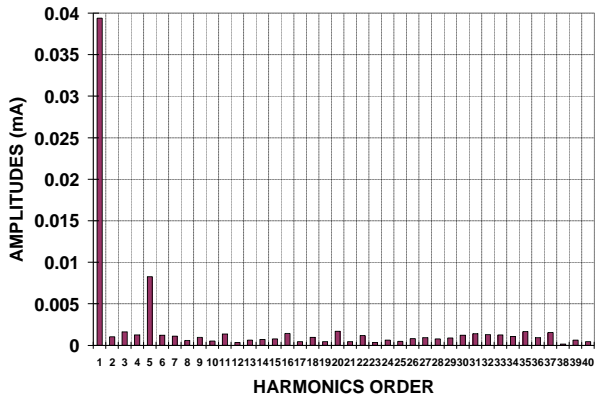
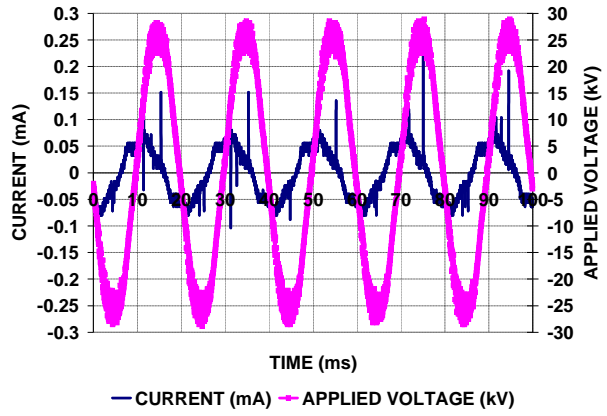
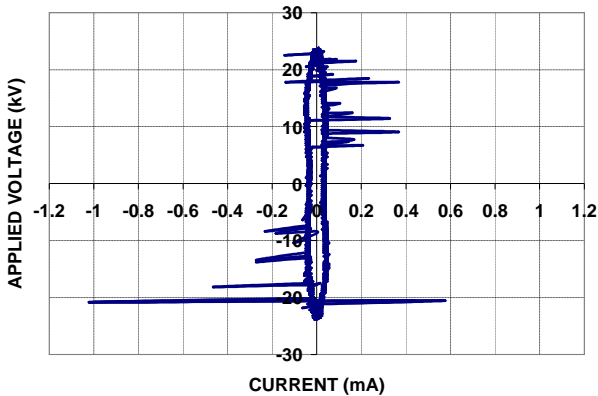
Fig. 8. Typical waveform of low pressure lightly polluted specimen

Figure 8 shows discharge current phenomenon of epoxy resin specimen on 26.5°C, 67%, -18.2 kPa and 34.8 kV<sub>max</sub> of temperature, humidity, pressure and applied voltage amplitude respectively. This is sample of low pressure typical condition. Figure 8(a) is discharge current and applied voltage waveforms on such condition. It is seen that the intermittent discharge current was occurrence suddenly and similar, but the peak discharge current points were lower than that on normal pressure. For this case of low pressure, the highest peak discharge current point was +0.374 mA and -1.01 mA. Thus, the influence of low pressure was significantly high. It was easier to discharge on low pressure rather than on high humidity conditions. Thus, the threshold voltage would be reduced on low pressure. This case was caused supposedly by particle of air surrounding the specimen reduced, and furthermore, they were easier to discharge. Nevertheless, for this condition, the lightly artificially contaminated epoxy resin specimen still had capacitive property. Thus, the discharge condition did not change the epoxy resin specimen significantly. It had capacitive property, although in a low pressure discharge condition.

Figure 8(b) shows harmonics frequency spectrum of discharge current of Figure 8(a). Besides the fundamental frequency, the fifth harmonics was visible explicitly, as second highest of harmonics. Other harmonics were visible slightly enough. Figure 8(c) is the characteristics of applied voltage to discharge current of low pressure lightly artificially contaminated epoxy resin specimen. It is seen that the flash points increased, compared to the flash points on low humidity lightly artificially contaminated specimen.

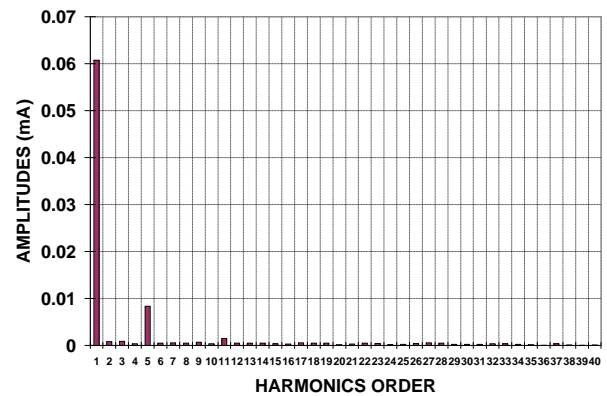
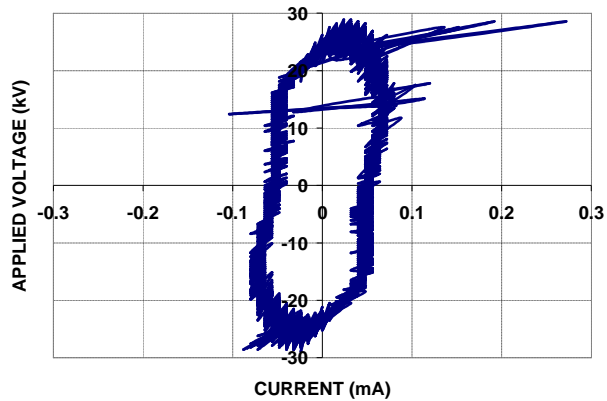
Fig. 9. Typical waveform of high pressure lightly polluted specimen

Figure 9 shows discharge current phenomenon of epoxy resin specimen on 27.5°C, 93%, +19.2 kPa and 28.2 kV<sub>max</sub> of temperature, humidity, pressure and applied voltage amplitude respectively. This is sample of high pressure typical condition. Figure 9(a) is discharge current and applied voltage waveforms on such condition. On this condition, the peak discharge current point was 0.27 mA. It was more difficult to discharge on high pressure rather than that on low pressure. This case was caused supposedly by particle of air surrounding the specimen increased, and furthermore, they were more difficult to discharge, due to be compressed. Nevertheless, for this condition, the specimen still had capacitive property.

Figure 9(b) shows harmonics frequency spectrum of discharge current of Figure 9(a). Besides the fundamental frequency, the fifth harmonics was visible explicitly, and other harmonics were not visible. Figure 9(c) is the characteristics of applied voltage to discharge current of high pressure clean specimen.

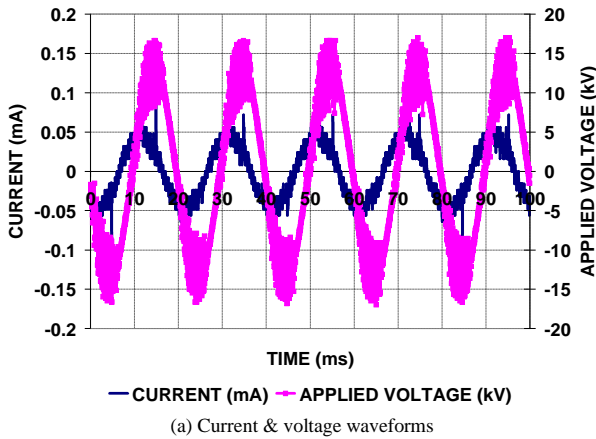
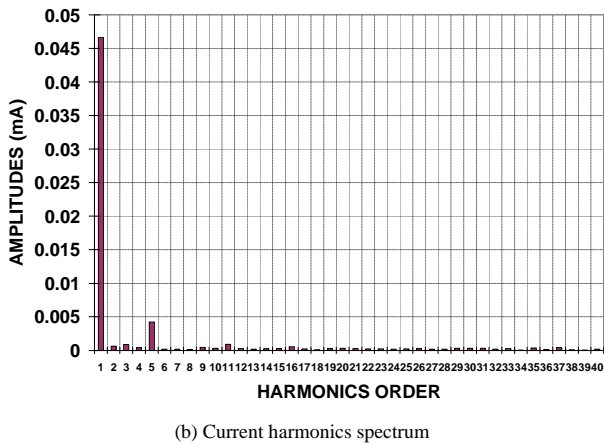
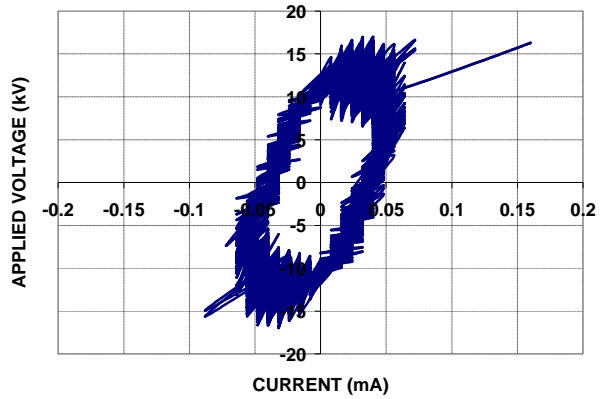
Fig. 10. Typical waveform of low RH heavily polluted specimen

Figure 10 shows discharge current phenomenon of heavily artificial contaminated epoxy resin specimen on 44.2°C, 69% and 16.6 kV<sub>max</sub> of temperature, humidity and applied voltage amplitude respectively, and without pressure. This is sample of low RH typical condition. Figure 10(a) is discharge current and applied voltage

waveforms on such condition. It is seen that the intermittent discharge current was occurred slightly to increase compared to that on low humidity of clean specimen. It is stated that the existence of contaminant, it caused made higher of peak discharge current, both for positive and negative values. Although on this condition, the discharge current points were low, due to the applied voltage was also low. It was easier to discharge due to existence of contaminant on the specimen. Of course, the threshold voltage would be reduced due to existence of contaminant. This case was caused by particle of contaminant on specimen surfaces. Nevertheless, for this condition, the specimen still had capacitive property.

Figure 10(b) shows harmonics frequency spectrum of discharge current of Figure 10(a). Besides the fundamental frequency, the fifth harmonics were not visible significantly. However, they were far lower than fifth harmonics. The third harmonics was visible slightly. Figure 10(c) is the characteristics of applied voltage to discharge current of low humidity heavily artificial contaminated specimen. The peak discharge current values were lower due to the applied voltage was lower too.

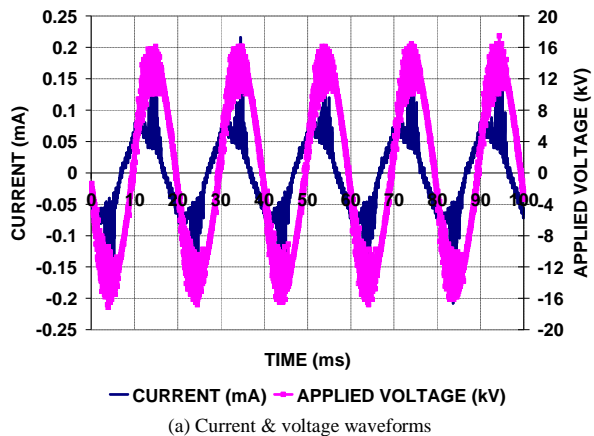
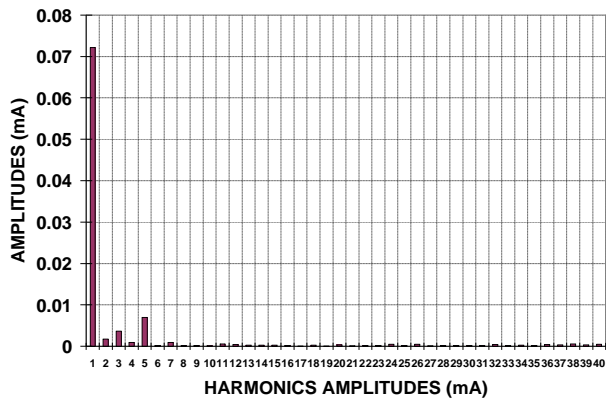
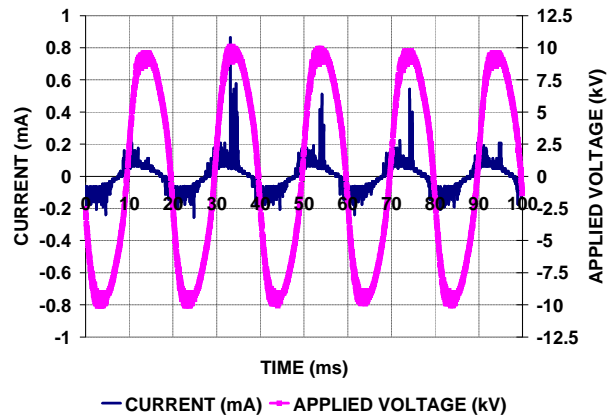
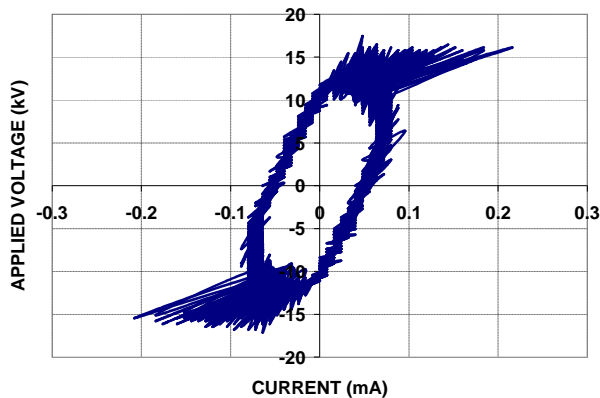
Fig. 11. Typical waveform of high RH heavily polluted specimen

Figure 11 shows discharge current phenomenon of heavily artificial contaminated epoxy resin specimen on 30.2°C, 99% and 16.1 kV<sub>max</sub> of temperature, humidity and applied voltage amplitude respectively, and without pressure. This is sample of high humidity typical condition. Figure 11(a) is discharge current and applied voltage waveforms on such condition. It is seen that the intermittent discharge current was occurred significantly to increase compared to that on low humidity of slightly contaminated specimen. However, the peak discharge current increased, became 0.22 mA on this condition compared to that previous low humidity. This was also caused the applied voltage was lower than the previous on slightly contaminated specimen. Thus, it was easier to discharge due to high humidity. The threshold voltage would be reduced due to the grains of water droplets. This case was caused by particle of contaminant and water droplets on the specimen surfaces. Nevertheless, for this condition, the specimen still had capacitive property.

Figure 11(b) shows harmonics frequency spectrum of discharge current of Figure 11(a). Besides the fundamental frequency, the fifth harmonics was visible explicitly as second highest amplitude. Besides that, the third harmonics was also visible significantly, as third highest harmonics. Figure 11(c) is the characteristics of applied voltage to discharge current of high humidity heavily artificial contaminated epoxy resin specimen. It is seen that the flash points increased significantly.

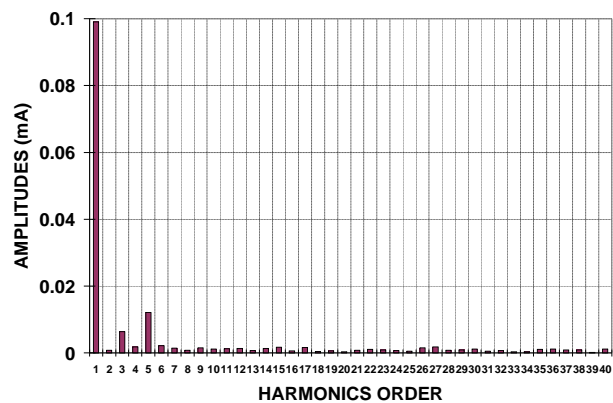
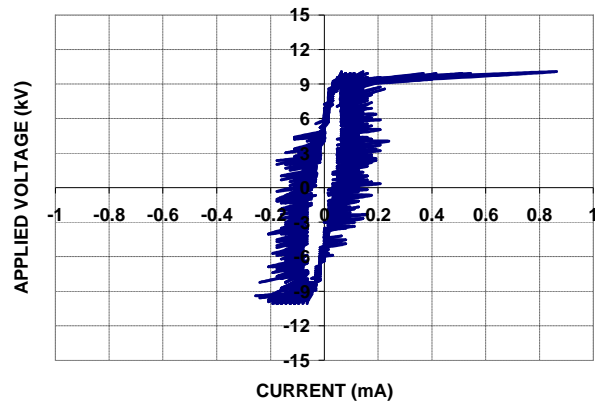
Fig. 12. Typical waveform of low pressure heavily polluted specimen

Figure 12 shows discharge current phenomenon of heavily artificial contaminated low pressure epoxy resin specimen on 26.1°C, 88%, -19.8 kPa and 9.9 kV<sub>max</sub> of temperature, humidity, pressure and applied voltage amplitude respectively. This is sample of low pressure typical condition. Figure 12(a) is discharge current and applied voltage waveforms on such condition. It is seen that the intermittent discharge current was occurrence suddenly and more frequently than the previous. The peak discharge current points could reach 0.864 mA. Thus, the influence of low pressure was significantly high. It was easier to discharge on low pressure rather than on high humidity conditions. Thus, the threshold voltage would be reduced on low pressure. This case was caused supposedly by particle of air surrounding the specimen reduced, and furthermore, they were easier to discharge. Nevertheless, for this condition, the specimen still had capacitive property. Thus, the discharge condition did not change the epoxy resin specimen significantly. It had capacitive property, although in a low pressure discharge condition. Figure 12(b) shows harmonics frequency spectrum of discharge current of Figure 12(a). Besides the fundamental frequency, the fifth harmonics was visible explicitly, as second highest of harmonics. The third harmonics was visible significantly enough. On this condition, the third harmonics was third highest amplitude, after fundamental and fifth harmonics. Figure 12(c) is the characteristics of applied voltage to discharge current of low pressure heavily artificial contaminated epoxy resin specimen. It is seen that the flash points and their amplitudes increased, compared to the flash points on low humidity of specimen.

Figure 12(b) shows harmonics frequency spectrum of discharge current of Figure 12(a). Besides the fundamental frequency, the third harmonics was visible explicitly, and followed by fifth harmonics. This case is different from other spectra, that after fundamental frequency, the second highest amplitude was fifth harmonics. Figure 12(c) is the characteristics of applied voltage to discharge current of high pressure the specimen on this condition. It is seen that the flash points were more compared to the flash points on low pressure.

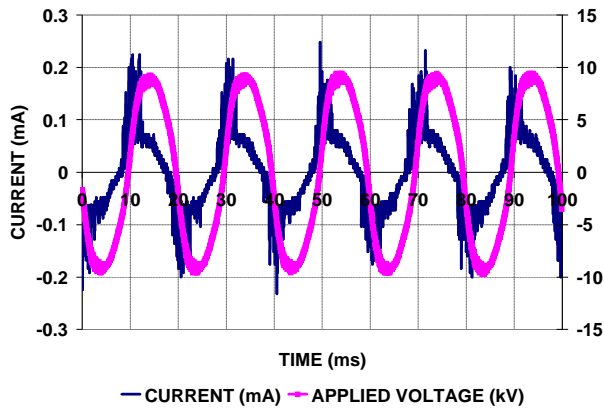
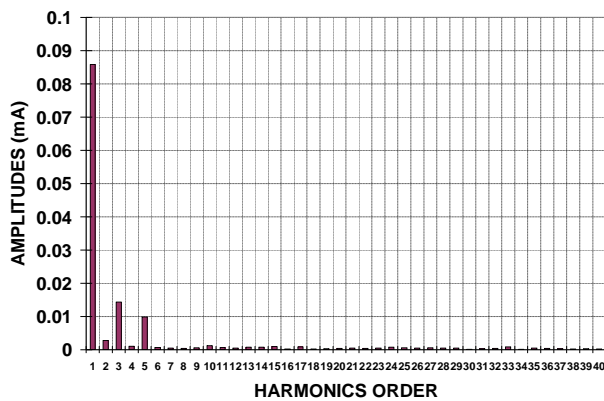
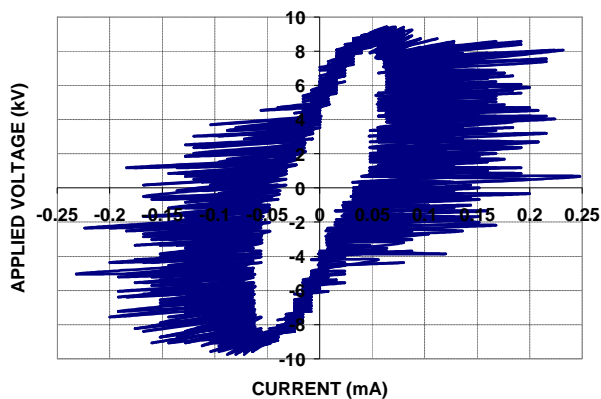
Fig. 13. Typical waveform of high pressure heavily polluted specimen

Figure 13 shows discharge current phenomenon of epoxy resin specimen on 28.4°C, 93%, +19 kPa and 9.4 kV<sub>max</sub> of temperature, humidity, pressure and applied voltage amplitude respectively. This is sample of high pressure typical condition. Figure 13(a) is discharge current and applied voltage waveforms on such condition. It is seen that the intermittent discharge current was occurred significantly less than that on high pressure. On this condition, the peak discharge current point was 0.248 mA. It was more difficult to discharge on high pressure rather than that on low pressure. This case was caused

supposedly by particle of air surrounding the specimen increased, and furthermore, they were more difficult to discharge, due to be compressed. Nevertheless, for this condition, the specimen still had capacitive property.
