Site Inspection and Evaluation Behavior of Qing Shang Concrete Bridge

Keywords—Field investigation, prestressed concrete box girder, maintenance, Qing Shan Bridge

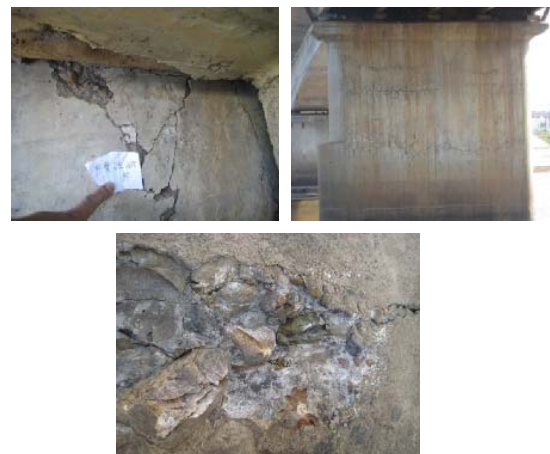
Fig. 4 Damage of concrete bridge abutment #14 and pier No. 5

After checking the abutment joints, the joints were filled with sand and small stones and other debris; the result will be the abutment expansion joints lose functionality. The beams were close to the abutment wall, and the reasons for these

defects include the following :(1) elongation due to heated up beam contract the concrete of back wall. (2). soil pressure behind the abutment makes the abutment move or tilt forward. In other word, the pressure between the beam and the back wall directly causes the damage and defect of concrete as shown in Fig. (4).

The cracked part of the back wall, affecting the durability of the bridge, also if the abutment is damaged to certain degree, the stability of the bridge will be worse.

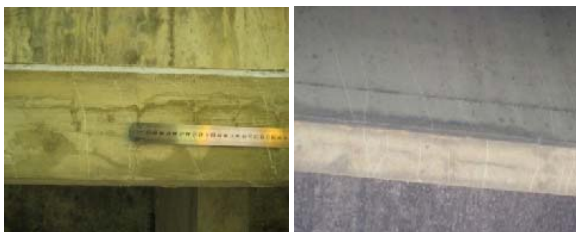
The T beam of all 10 spans were investigated, the occurrence of most T beams have cracking phenomenon occurred. T Beam crack region appears at the bottom under bent beam, crack extended upward along the ribbed T beam, the individual extends to the T beam flange crack, crack width distributed over 0.1mm to 0.4mm, the maximum was about 0.4mm, and crack spacing was about 10 to 15cm. The bridge needs to be improved the flexural bending strength. T beam support region have shear cracks, diagonal cracks were found there, but does not covered large area, crack width about 0.2mm. Cracks generated by the structural force and that

reflect the possible consequences of inadequate carrying capacity of the bridge, which effect on bridge safety and durability. Fig. (9) show the cracks types.

Fig. 9 (c) T beam cross-cracks in the region

- (1) The active implementation of the Qing Shan Bridge, detailed investigation, the static load test, designed must be carried out to provide the necessary technical basis for the maintenance.
- (2) Approach spans of reinforced concrete T-beam should provide design of the implementation reinforcement to increase the carrying capacity of the bridge.
- (3) Replacement of expansion joints. However, in order to improve driving conditions and improve the bridge level of service, while reducing the workload

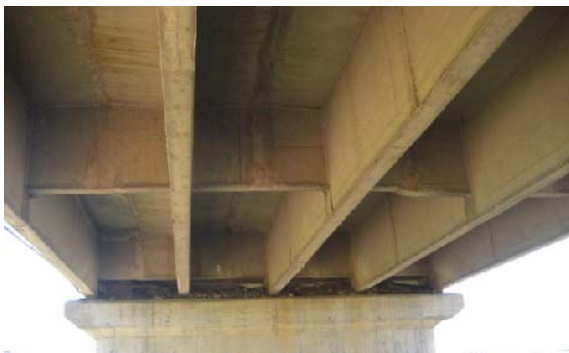
All lateral connections on the bridge observed in detail, simply supported T beam horizontal connections in good condition and the occurrence of cracking was apparent, diaphragm locally have crack, but crack width was small, about 0.1mm.

Fig. 9 (d) T Beam connections is good, no obvious damage (diaphragm)

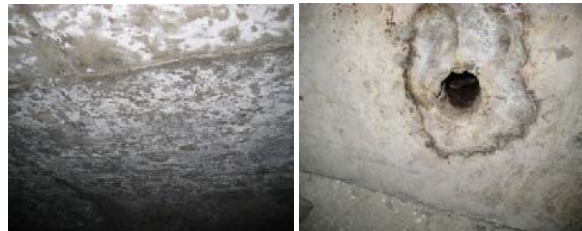
The continuous beam span for the whole box girder and the concrete surface was in a good condition, no obvious damage and cracks. Climb from the box at pier 2 internal inspection of the box found within the surface of structural cracks, top of the local area (especially the original hanging holes of hanging span) the concrete take off, tendons exposed and leaking.

Bridge deck waterproofing was in bad condition, box

leakage, closed hole wasn't dense construction which effect on the durability of the bridge

Fig. 9 (a) the internal box water drainage damage

- (4) Provide appropriate repairs for steel corrosion, concrete cracking and falling concrete parts.
- (5) Completely replace the waterproof layer, re-set the road vent pipe (vent pipe should be guaranteed about 20cm below the main beam);
- (6) Re-laying of pavement, to resolve technical issues such as Bump;

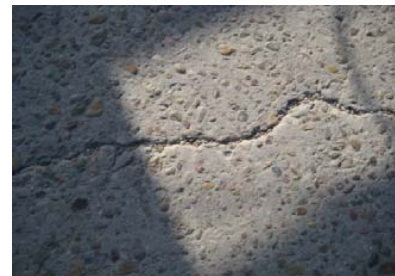
Cement concrete pavement deck with less smoothness, spots potholes, and cracks. Cracking phenomenon effect on carrying capacity of the bridge, functionality, durability,etc, as shown in Fig. (10)

Fig. 10 Deck Damage

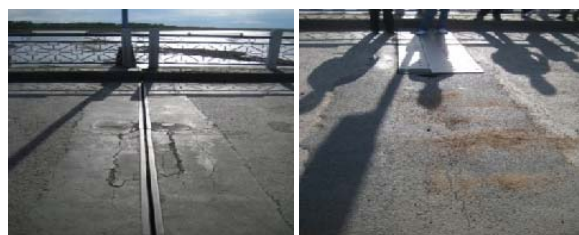
There are severely damaged expansion joints shown in Fig. (11), basically loss of functionality, overloading rolling, improper maintenance witch effect on durability.

Fig. 11 Serious damaged bridge deck expansion joint

of the daily maintenance and management, proposed a continuous deck structure, to minimize the number of joints.

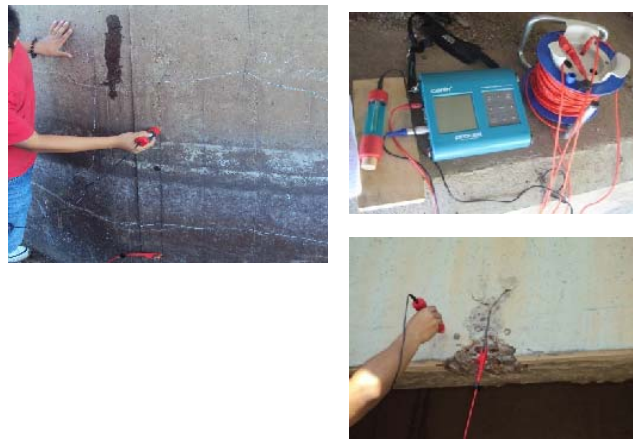
Test results showed that: According to the relationship between steel potential values and the steel corrosion, that the main reinforced concrete cover layer has serious damage, the other side layers had no visual cracks. The damage of concrete layer shows the seriously steel corrosion as shown in Fig. (12).

Fig. (12) Steel corrosion detectors
