Analysis of Highway Slope Failure by an Application of the Stereographic Projection

Chin-Yu Lee and Iau-Teh Wang

Keywords—slope stability analysis, Stereographic Projection, wedge Failure.

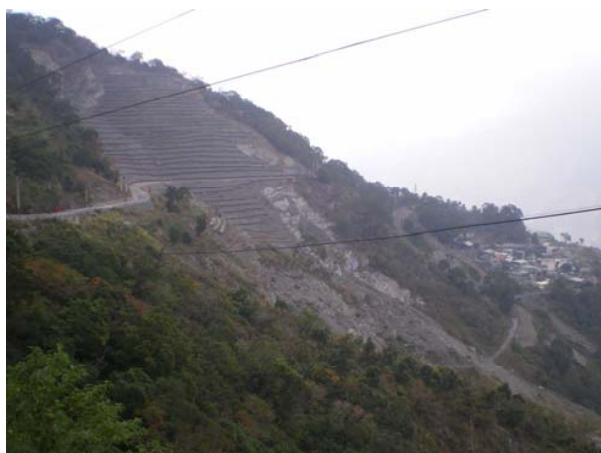
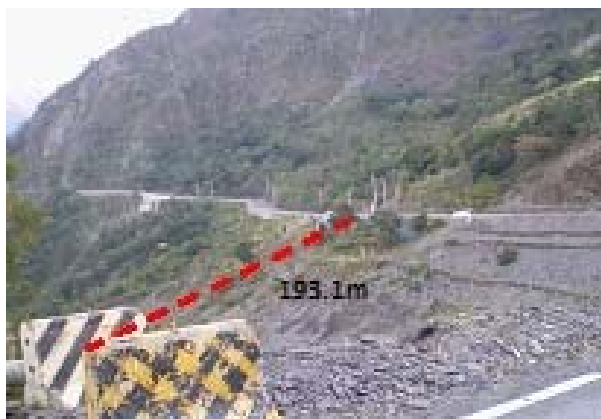
County, along which disasters such as slope collapse and sliding usually occur whenever there are typhoons or heavy rainfalls (Figure 1). Hence, in order to understand the slope collapse features of this sector of road, geological investigations in the collapse area in this research are based on site investigation and the evaluation of remote survey images. By applying this method, we can understand the landscape undulation, geological materials, geological structures, hydrological environment, and other main linear structures. Also, we can conduct slope stability analyses to better understand the sliding failure mechanism of the area of collapse by applying the Stereographic Projection Method, which is based on structural geology.

Fig. 1 Location of slope collapse and sliding

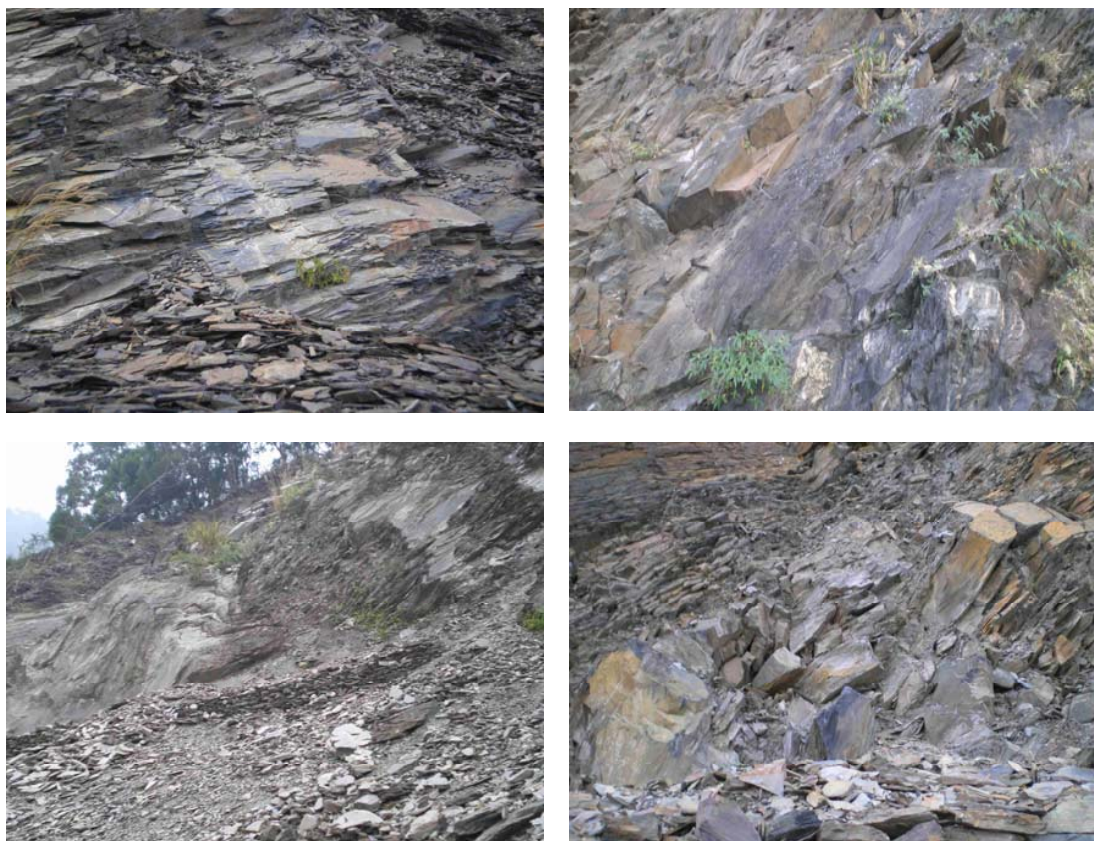
With an average altitude of more than 1,000m, the terrain of Wutai Township is rugged with steep slopes. Ali Village is situated in east Wutai with altitudes ranging between 1,180m-1,300m; the level difference of this village is approximately 120m. The overall terrain descends from the east and southeast to the valleys in the north. Neighbored by Jilou Village on the northwestern side, the overall terrain there descends from the south to the north. The average altitude of Jilou Village is between 1,030m-980m, with a level difference of approximately 50m. Pingtung County is divided into two geological zones: the Central Mountain Range Geological Zone and the Hengchun Peninsula Geological Zone. Rocks there are mainly dark grey and grey-black hard shale, slate or phyllite and belong to the region of Tertiary low-grade metamorphic rock. Located at the south end of the Central Mountain Range, the regional geology of Wutai Township mainly consists of slate, which is one kind of metamorphic rock, due to the high temperature and pressure of the Earth's crust. Slopes along Provincial Road No. 24 in the mountains are closely aligned slates which are easy to break or shell off because of external forces, as shown in Figure 3. The rock stratum of the collapse area is shown in Table 1. The active faults in the adjacent area are as follows. With a distance of 11.8 km, the nearest fault is Chauzhou fault, which is followed by Liouguei fault and Cishan fault with distances of 21.64 km and 31.5 km, respectively.

Fig. 3 Brief geological descriptions

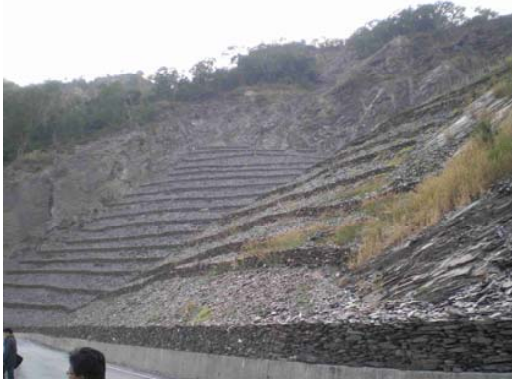
Picture 1

The main disaster location is situated at Point 46.2 km along Provincial Road No. 24 with the X-Y coordinate of (223202, 2515674) on the border between the tribes of Jilou and Ali. An extensive area of slopes is exposed to the air and failures occurred after several typhoons. Beneath the collapsed area is Ailiao North River. After the site investigation, it was found that several disasters such as serious roadbed loss happened along Provincial Road No. 24. A large collapse happened around Jilou Tribe close to the Point 46.4 km along the road. Continuous masonry rock parapets (Picture 1) were built with slate on the rock slopes. Although short retaining walls were built along the toe of the upper slope, collapse and rockfall still occurred. Construction of slope protection was also conducted on the lower slope with slate (Picture 2). However, it seems that some rocky parts were exposed on both sections. The cracking on that section of road is indicated in Picture 3, while undulation of the road surface is shown in Picture 4.

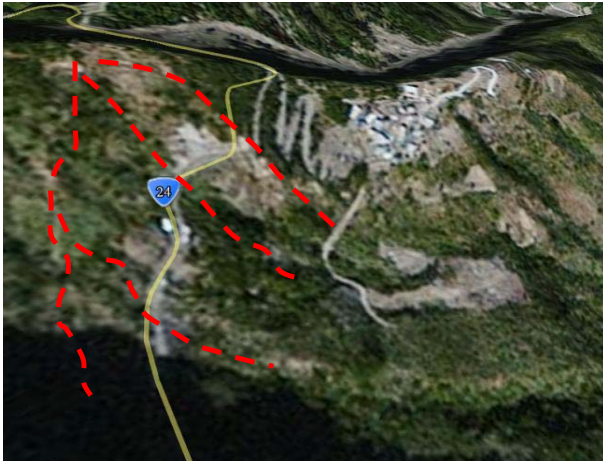
Fig. 13 Collapse Zone of Linear Structure (Google Earth)
