SEM and AFM Investigations of Surface Defects and Tool Wear of Multilayers Coated Carbide Inserts

Ayman M. Alaskari, Samy E. Oraby and Abdulla I. Almazrouee

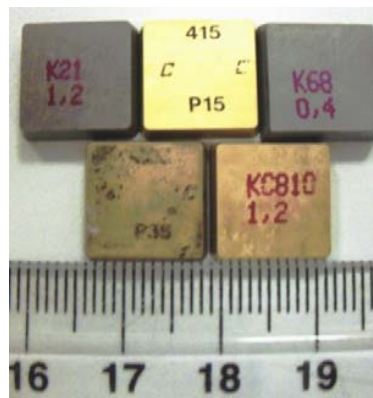
Fig.1 Types of some of the employed coated and uncoated carbide inserts

Five as received different types of tool inserts are tested throughout the different stages of this study; two uncoated and three multilayer coated with a cemented carbide substrate (as shown in Figure 1). The uncoated types are Kennametal K68 and K21 carbide inserts with ISO application range: M10-20 K05-20 (ANSI Range: C3). It consists of a hard, low binder content, unalloyed grade WC/Co fine-grained grade. As claimed by manufacturer, grade K68 has excellent abrasion resistance for machining cast irons, austenitic stainless steels, non-ferrous metals, nonmetals and, it is recommended by manufacturer to be used as a general purpose grade for non-ferrous materials.

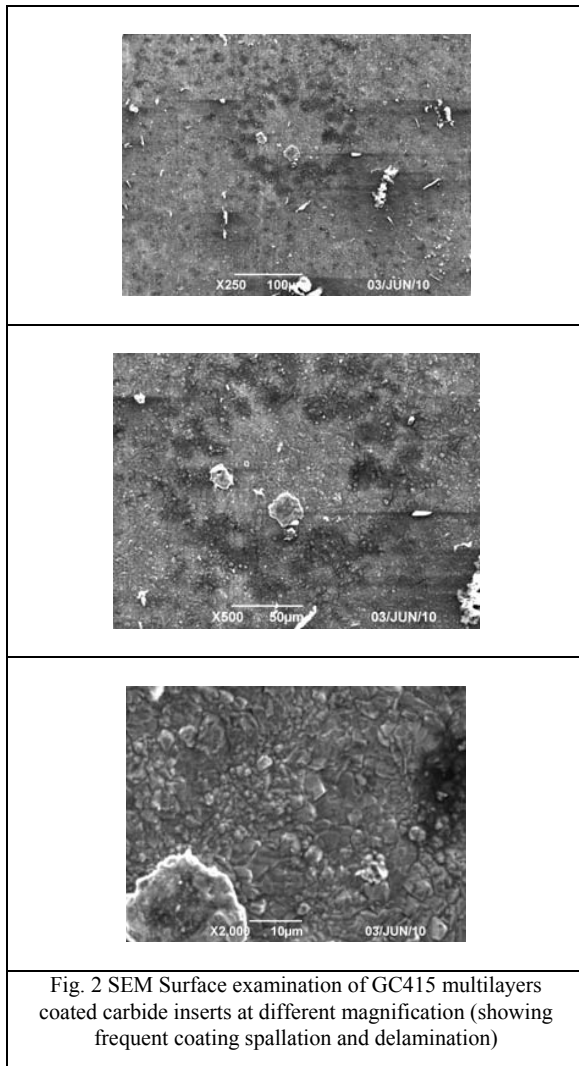
Generally, since SEM can provide a wider area for examinations than AFM, SEM investigations were first carried out for the unused multi-layers coated and uncoated carbide inserts to assess any manufacturing defects. Different defects were found in the unused carbide insert that include spallation, delamination and macro-particles of the coating. Different image magnification was taken to show the overall defected areas. For example, Figure 2 shows the spallation and delamination of coating in different magnifications. Agglomeration of coating particle was also present in some spots of the coated inserts.

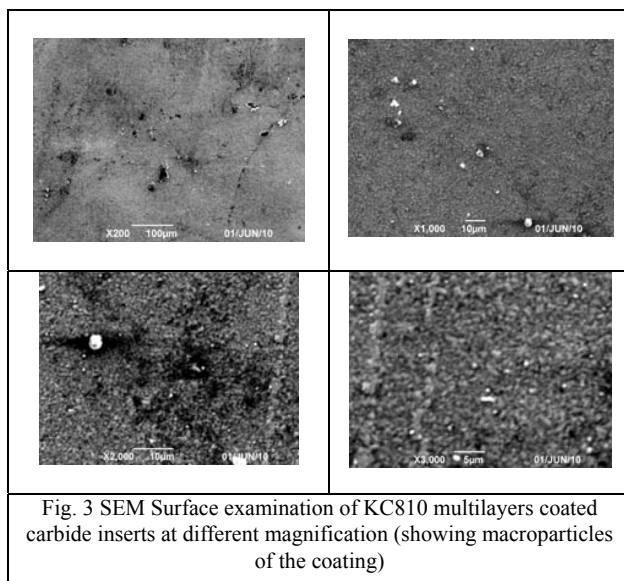
Macroparticle of coating is found in secondary electron image of multilayer coated sample as shown in Figure 3. AFM was then used to investigate the same area of the sample and it gave another set of beneficial data as shown in Figure 4. The quality of surface smoothness can be assessed from the data obtained. The software of AFM provides many topographical aspects including classical roughness values, peak and summit texture data and surface area calculations for the entire image. The roughness of the surface and a coating droplet were found.

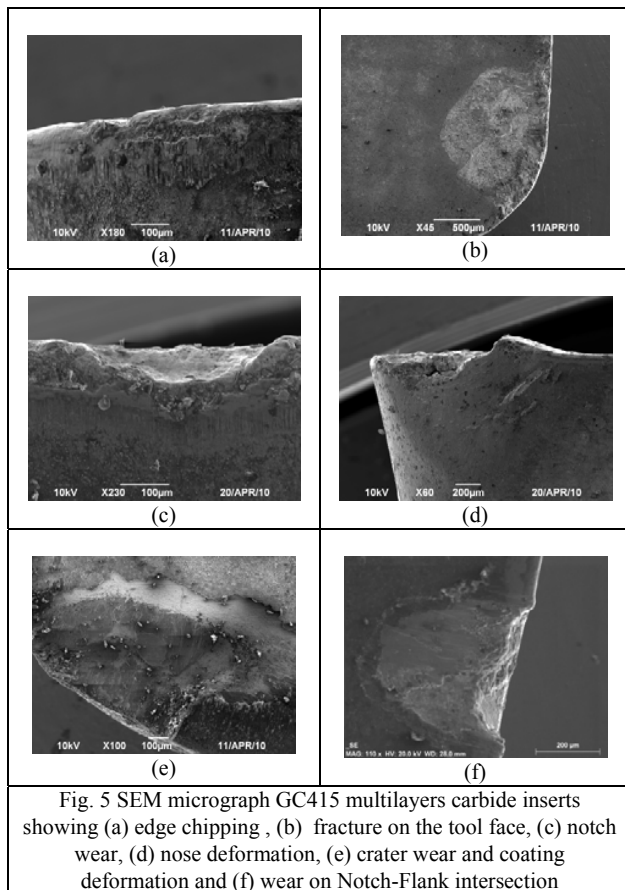
Fig. 5 SEM micrograph GC415 multilayers carbide inserts showing (a) edge chipping, (b) fracture on the tool face, (c) notch wear, (d) nose deformation, (e) crater wear and coating deformation and (f) wear on Notch-Flank intersection

The second stage was to investigate the worn inserts. The same procedure used early was used here namely starting with the SEM then AFM. Low magnification secondary electron images were taken for the flaws and defects of the worn surfaces. Different modes of tool wear and deformation such as edge chipping, fracture on the tool face, notch wear, nose deformation, crater wear and coating deformation are shown in Figure 5.

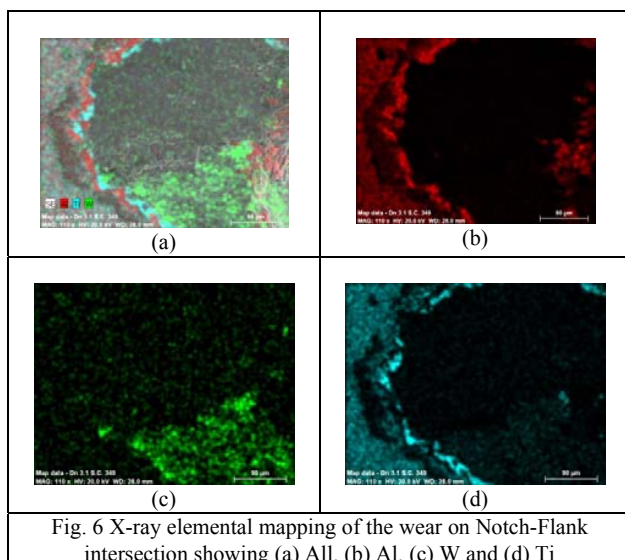
Fig. 6 X-ray elemental mapping of the wear on Notch-Flank intersection showing (a) All, (b) Al, (c) W and (d) Ti

The X-ray elemental mapping attached with SEM allows the user to investigate the elements present in the worn layers of multilayers coating. This was carried out to assess the wear extent in each layer and it is shown in Figure 6.

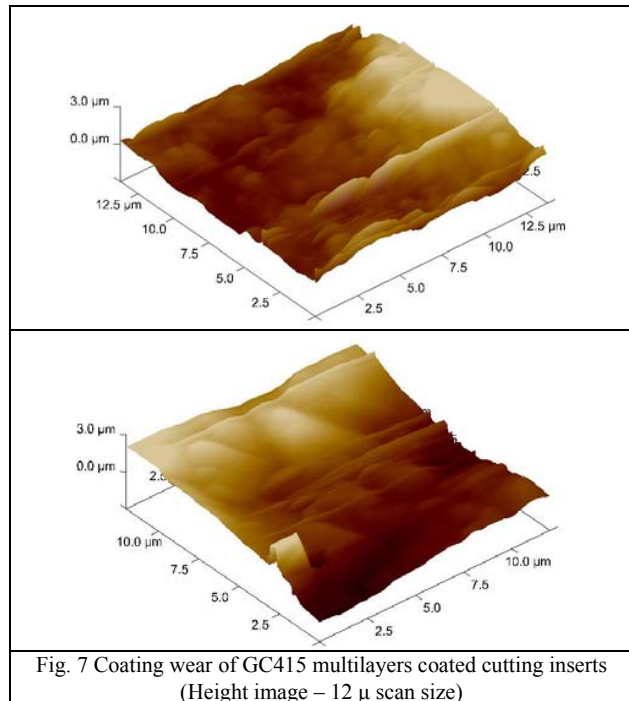
Fig. 7 Coating wear of GC415 multilayers coated cutting inserts (Height image – 12 µ scan size)

EDS was also utilized to check the semi-quantitative chemical composition of certain areas and points. The second stage was to use the AFM in some worn area to measure the different topographical parameters such as horizontal, vertical and surface distances. Two 3D Height images are shown in Figure 7 below.
