Laser Welded Ni-Cr Dental Alloys Inspection

Abstract—Minor problems arising from optimizations by welding of fixed prostheses frameworks can be identified by macroscopic and microscopic visual inspection. The purpose of this study was to highlight the visible discontinuities present in the laser welds of dental Ni-Cr alloys. Ni-Cr base metal alloys designated for fixed prostheses manufacture were selected for the experiments. Using cast plates, preliminary tests were conducted by laser welding. Macroscopic visual inspection was done carefully to assess the defects of the welding rib. Electron microscopy images allowed visualization of small discontinuities, which escapes visual inspection. Making comparison to Ni-Cr alloys taken in the experiment and laser welded, after visual analysis, the best welds appear for Heraenium NA alloy.

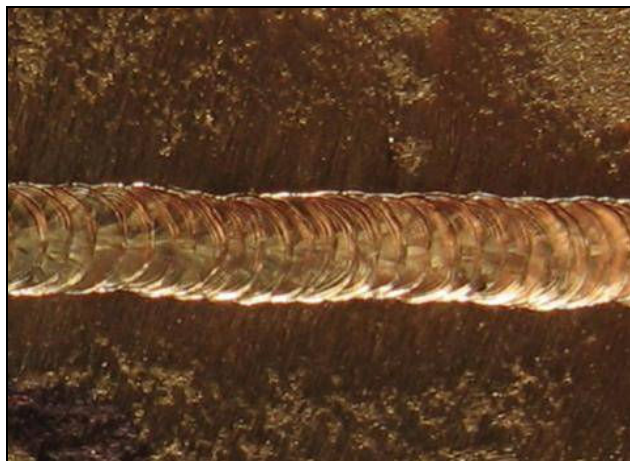
Fig. 1 Aspect of a welded Ni-Cr alloy sample (welding without filler): uniform overlapping of the spots, no visible defects

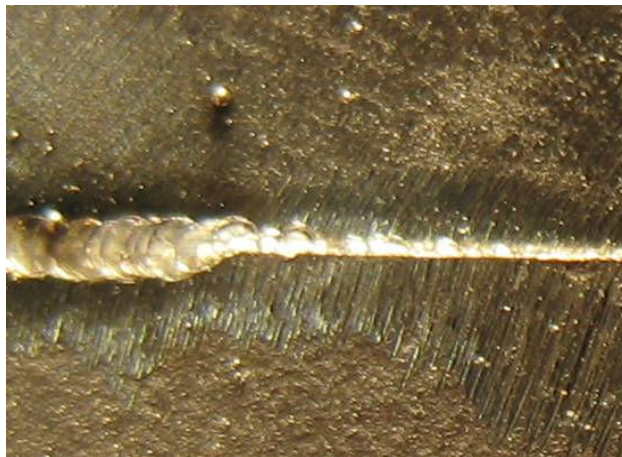
Fig. 4 Aspect of Ni-Cr alloy sample (welding with filler material): poor penetration on the opposite side

In practice metal frameworks have different thicknesses and this have to be also taken into account. Even if the weld penetration at higher power is also high, too strong power produces too much penetration that may induce formation of pores, which implicitly reduces weld strength. A very low penetration may not be able to determine enough strength. It is therefore important to determine the optimal parameters to achieve proper penetration. Welding on both sides could avoid these disadvantages [2].

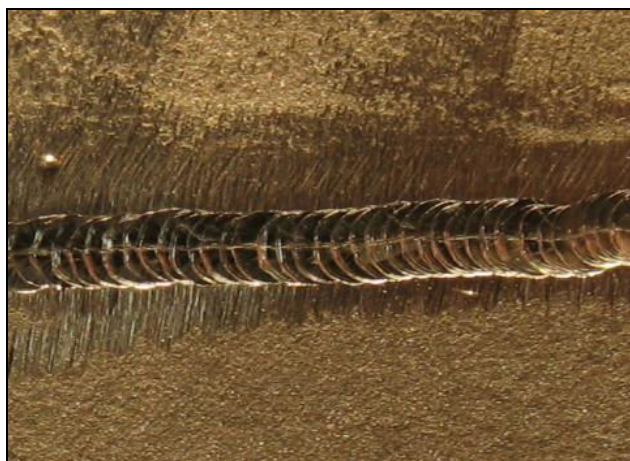
Fig. 2 Aspect of Ni-Cr alloy sample (welding without filler material): uniform width of the weld, continues crack along the joining line

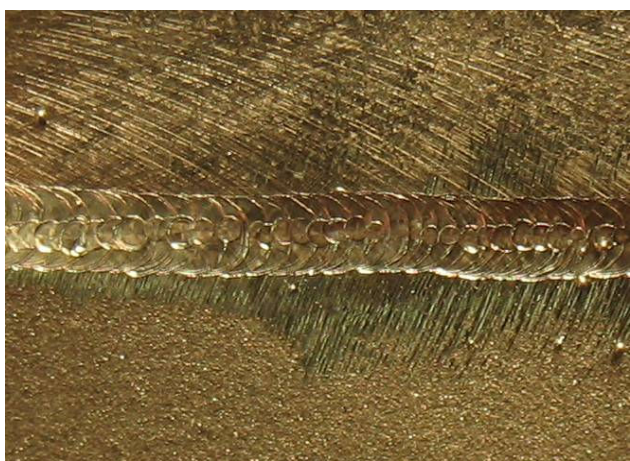
Fig. 3 Aspect of Ni-Cr alloy sample (welding without filler material): good penetration on the opposite side

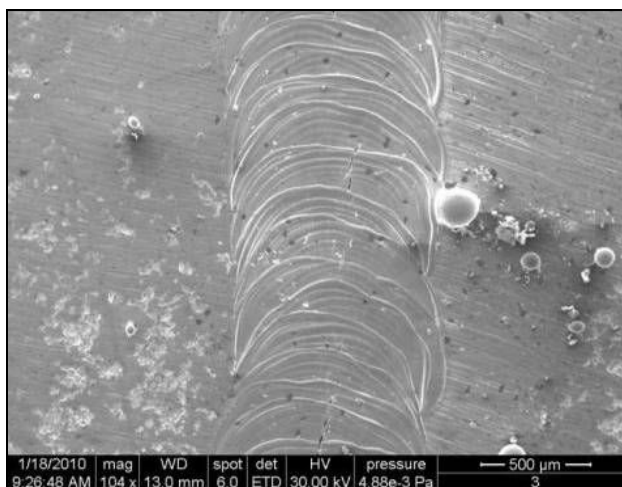
The examined samples revealed some small cracks in the welding rib, both longitudinal and transverse or oblique. Some start from the main longitudinal cracks, some from the middle spot, others are completely isolated.

Fig. 5 Electronomicroscopic image of a Ni-Cr alloy welded joints without filler material: short longitudinal cracks on the welding rib (mag 104x)

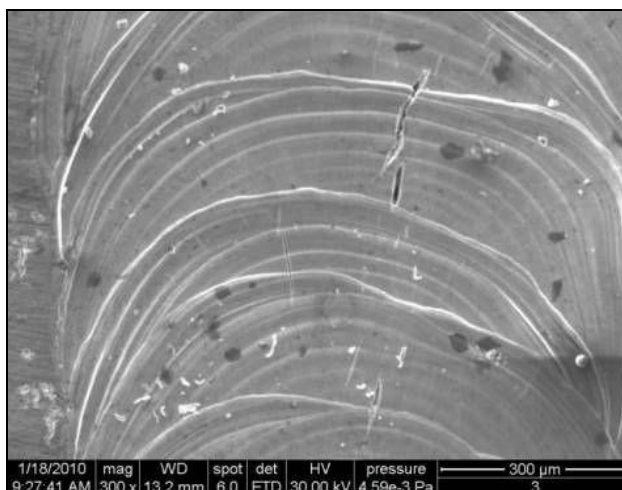
Fig. 6 Electronomicroscopic image of a Ni-Cr alloy welded joints without filler material: short longitudinal cracks on the welding rib (mag 300x)

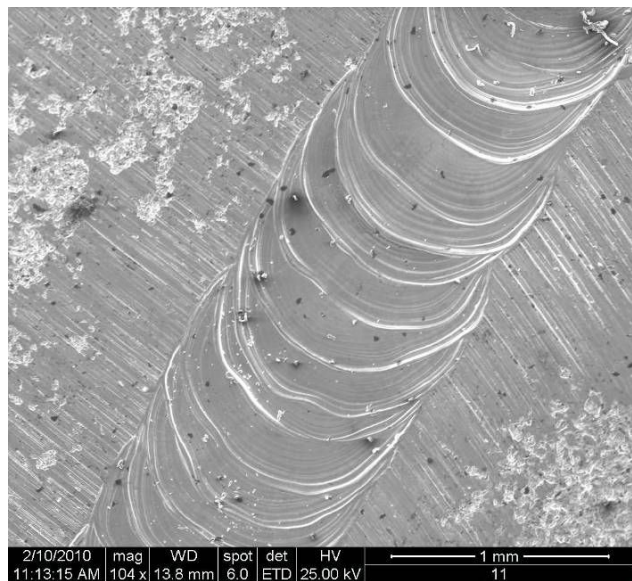
Fig. 7 Electronmicroscopic image of a Ni-Cr alloy welded joints without filler material: no visible defects on the welding rib (mag 104x)

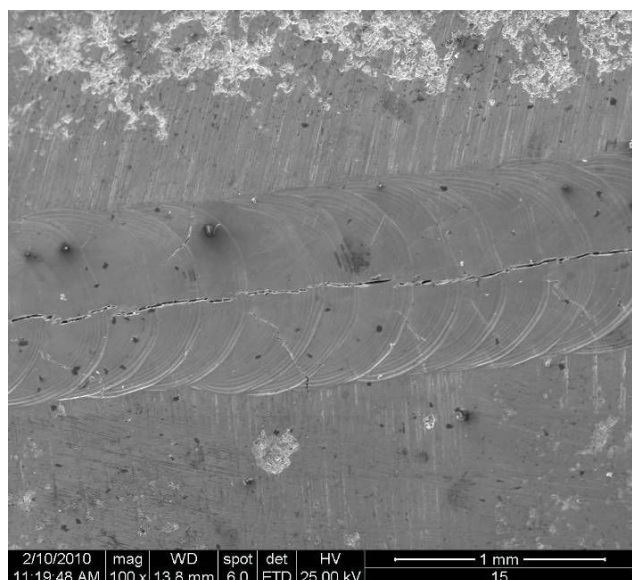
Fig. 8 Electronmicroscopic image of a Ni-Cr alloy welded joints without filler material: continuous longitudinal crack on the welding rib (mag 100x)
