Amine Solution Recovery Package and Controlling Corrosion in Regeneration Tower

Abstract—Sarkhoon gas plant, located in south of Iran, has been installed to removal H₂S contained in a high pressure natural gas stream. The solvent used for the H₂S removal from gaseous stream is 34% by weight (wt%) Di-ethanol amine (DEA) solutions. Due to increasing concentration of heat stable salt (HSS) in solvent, corrosivity of amine solution had been increased. Reports indicated that there was corrosion on the shell of regeneration column. Because source formation of HSS was unknown, we decided to control the amount of HSS at the limit less than 3% wt amine solvent. Therefore, two small columns were filled by strong anionic base and carbon active, and then polluted amine was passed through beds. Finally a temporary amine recovery package on industrial scale was made based on laboratory's results. From economical point of view we could save \$700000 beside corrosion occurrence of the stripping column has been vigorously decreased.

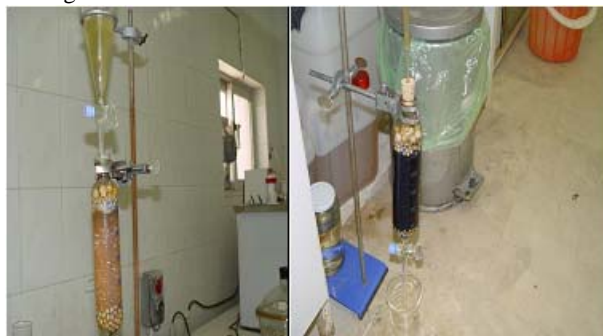
Lean amine solution feed through a bubbler in to an activated column filter and the resin column. The ion exchange resin removes the heat stable salts and the purified amine solution is collected for further analysis. Diluted caustic soda is used to regenerate the resin column.

Fig. 4 Laboratory set up of (Left Resin Bed, Right Carbon Active bed)

Laboratory scale .The HSS in solution were at approximately 3.5 wt% (as DEA) when laboratory test started to removal HSS form the solution .In order to reduce level of HSS to 0.5/wt% which strong ion resin studied an onions strong resin type was selected and all experimental test on it . As shown (figure4) our set up was consist of two 250 glass (decanter) which used as anionic resin column and activated carbon .That scope was removing HSS and fine Particles and color of amine(figure 5) by means of those manipulated column respectively .

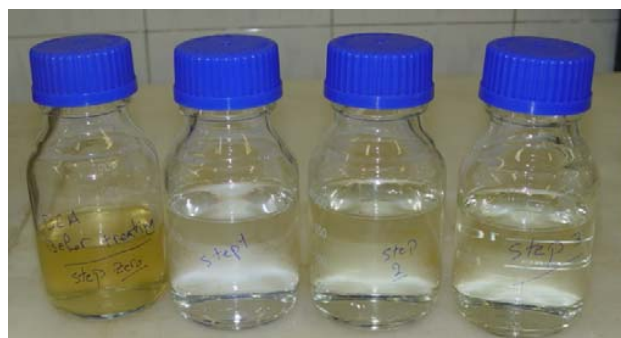
Fig. 5 Quality of sample in inlet and outlet of resin and carbon active beds(left. 1st, polluted amine right, 2st to 4rd batch of outlet bed)

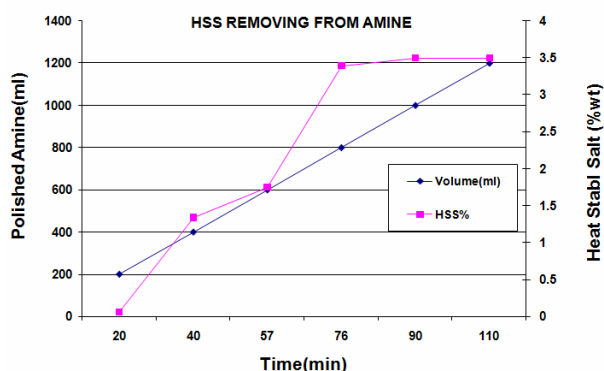
As results is shown figure 6, it is proved that selected resin have capability of remove about 5 times of bed volume. From economical point of view amine purification by resin column is move profitable than "bleed to feed" strategy.

Fig. 6 Evaluation the capacity of resin bed to remove HSS)

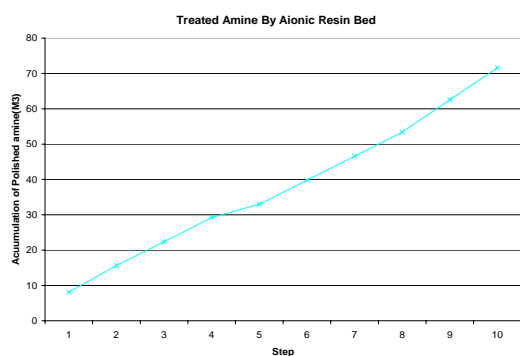
Fig.8 trend of accumulated polished amine

Because the scope of installation of package recovery was to remove HSS form amine solution , the parameter of HSS in inlet and exit of bed was selected to operation of package .In figure 8 and table 1 are shown for Treatment of 71.6 m polluted amine with concentration 30%wt about 7 ton caustic soda , 382 m deionized water were consumed for 10 batches for a long of 3 months .
