Study of Ageing Deterioration of Silicone Rubber Housing Material for Outdoor Polymer Insulators

Abstract— This paper presents the experimental results of salt fog ageing test of silicone rubber housing material for outdoor polymer insulator based on IEC 61109. Four types of HTV silicone rubber sheet with different amount of ATH were tested continuously 1000 hours in salt fog chamber. By visual observation after tested, slightly surface erosion was observed on tested specimen surface near the energized end. Furthermore, increasing in hardness and reduction in hydrophobicity were measured on tested specimen comparing with new specimen. In addition, chemical analysis by ATR-FTIR was conducted in order to elucidate the chemical change of tested specimens comparing with new specimen. Physical and chemical results confirmed the experimental results as well.

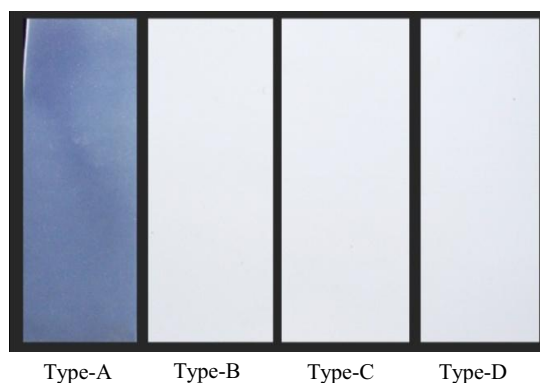
Fig. 1 specimens

Specimens made of high-temperature vulcanized silicone rubber (HTV SiR) with/without alumina trihydrate (ATH: $\text{Al}_2\text{O}_3 \cdot 3\text{H}_2\text{O}$) having content 0%, 50%, 100% and 150% by weight were used in this experimental, as shown in Table I and Fig. 1. Configuration of tested specimen illustrated in Fig. 2. All specimen having 2 mm in thickness, 30 mm in width and 200 mm in length attached with metal electrodes on the both ends of each specimen were hung vertically in test chamber during test.

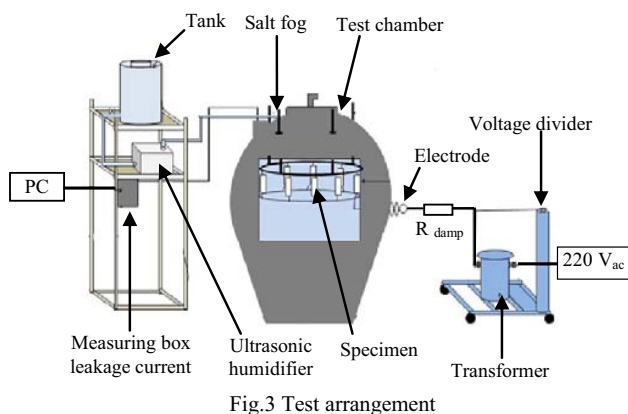
Fig.3 Test arrangement

A polyethylene tank having the volume 4.0 m³ was used as the salt fog test chamber. During salt fog ageing tests, specimens were hung vertically in the test chamber. An ultrasonic humidifier was used as salt fog generation and salt fog was injected from the top of the test chamber. Fig. 3 shows the test arrangement and Fig. 4 shows the actual test chamber.

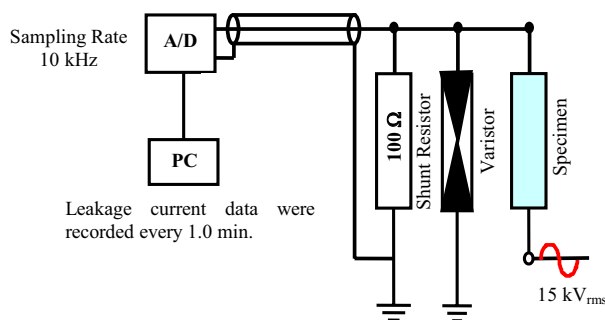
Fig. 5 Diagram of leakage current measuring system

cyclic salt fog ageing test was conducted by injecting salt fog in to the test chamber for 8 hours and stopping it for 16 hours every day under ac high voltage 15 kV. The salt fog having injection 0.5 l/hr/m³ was injected from the top of the chamber as test conditions shown in table II. All specimens were hung vertically in test chamber and were tested together. Leakage current measurement system is shown in Fig. 5. Individual specimens were connected to the leakage current measurement system via the shunt resistors of 100 Ω by means of coaxial cables. Leakage currents were continuously measured for individual specimens during the test. The leakage current was fed to an A/D board and converted to voltage. The leakage current data measured at the sampling rate of 10 kHz were recorded once every 60 s by postulating the data continuing for this period using the computer software developed via LabView.

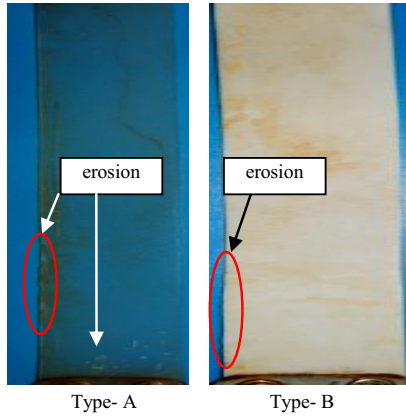
Fig.6 Specimens surface after 1000 hours.

After 1000 hours salt fog ageing test, visual observation was conducted in order to inspect any change on tested specimen surface. Slightly surface erosion near the energized end, as shown in Fig. 5, was observed on specimens type A and type B. This may be caused by discharges on specimens surface during test due to higher electric field stress on such position. No surface erosion was observed on specimen type C and type D. The results confirm that the amount of ATH is effective to improve the anti-erosion performance of silicone rubber.

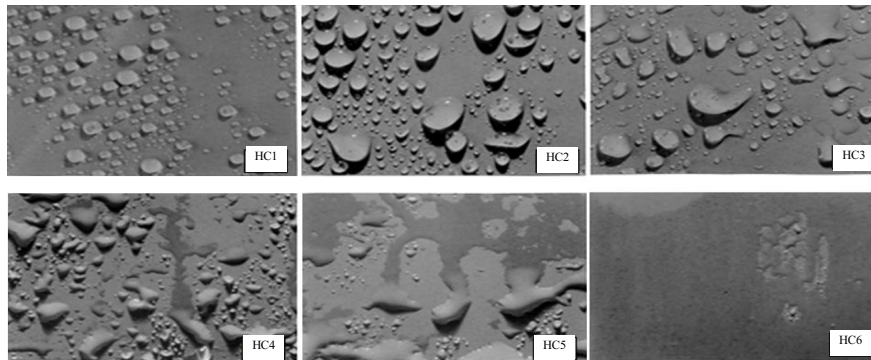
Fig. 7 Characteristics of the sample surface HC1-HC6

reduction in hydrophobicity and/or may be related to the amount of ATH. Reduction in hydrophobicity was evaluated by STRI criteria, as shown in Fig.7 [9,10]. Characteristics of hydrophobicity on tested specimen surface are shown in Fig.8. Hydrophobicity measurement results are shown in Table III.

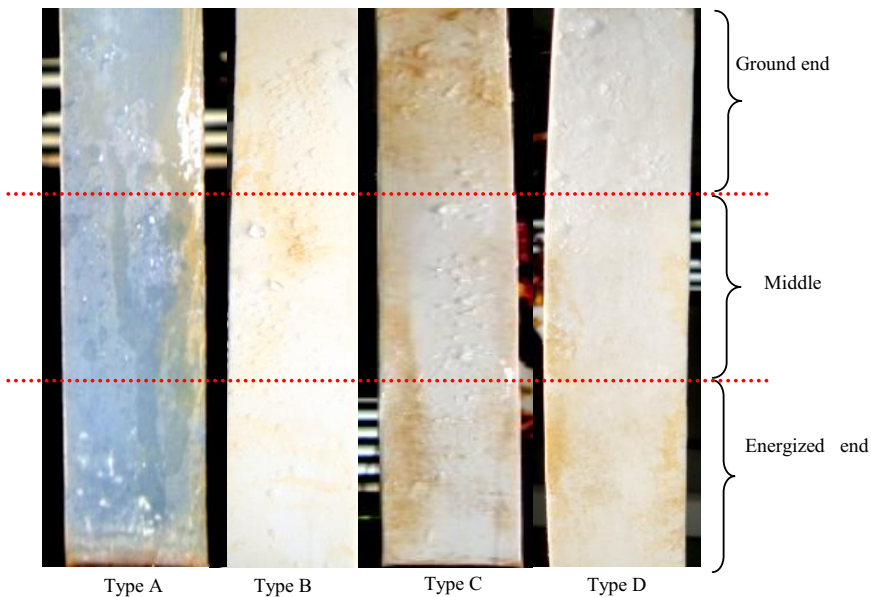
Fig. 8 Characteristics of hydrophobicity on surface

Significant decreasing in hydrophobicity can be observed on thoroughly surface of the specimens. Extremely loss of hydrophobicity (HC 6) was observed on thoroughly surface of specimen type A. In the case of the specimen without ATH and without filler surface treatment, a larger reduction in hydrophobicity can be seen compared with the other specimens having ATH. Such results indicate that ATH filler and filler surface treatment can delay the reduction of hydrophobicity on silicone rubber surface. Also, extremely loss of hydrophobicity (HC 6) at energized end was observed on all specimen surfaces. Such results indicate that high electric field stress can accelerate the reduction of hydrophobicity on the specimen surface.

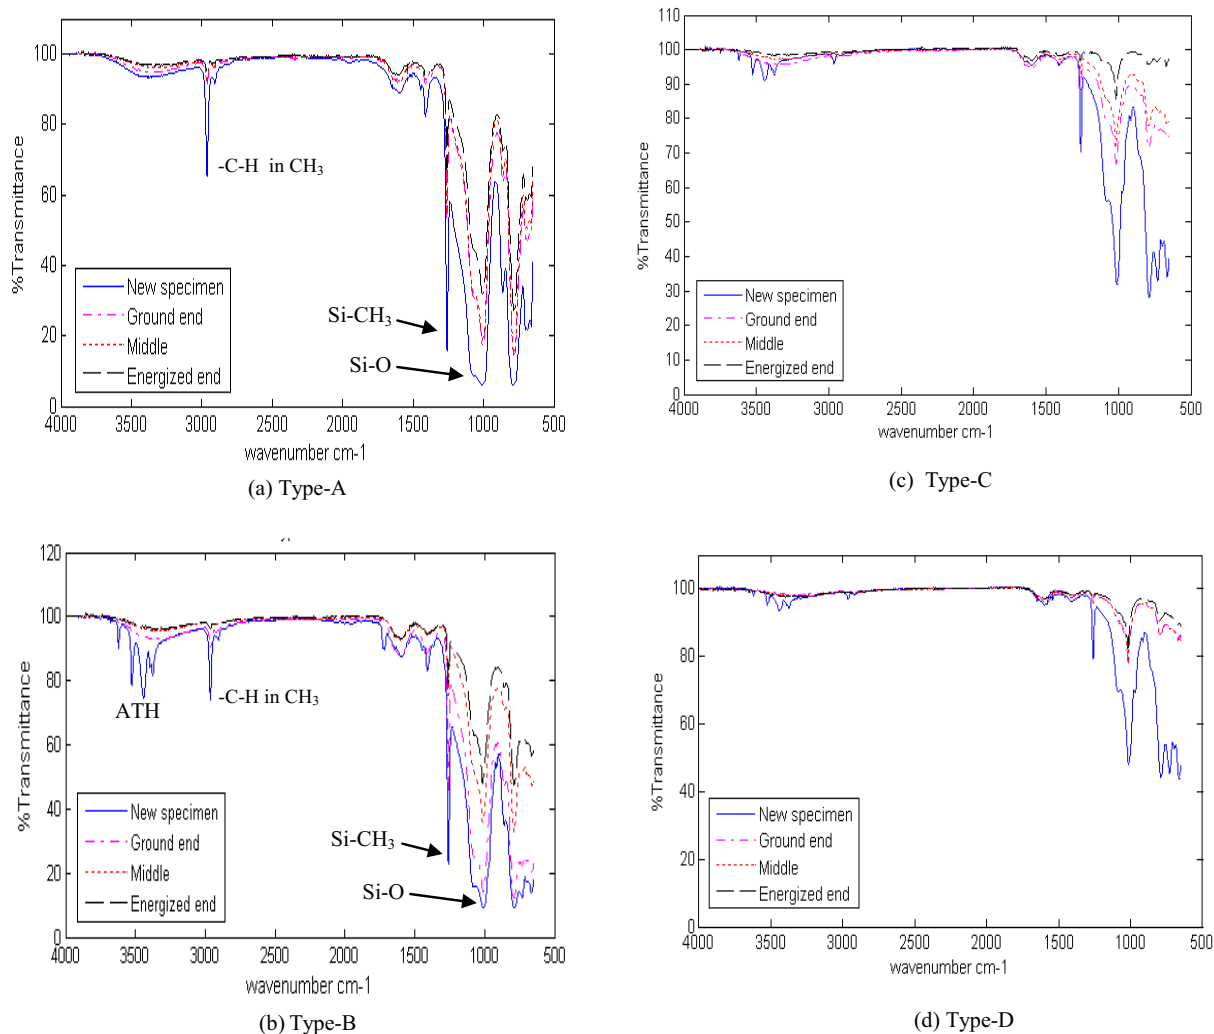
Fig. 9 FTIR spectra of test specimens

The chemical bonds of interested chemical structure are bonding side chain (Si-CH₃) with wave number 1261 cm⁻¹, backbone (Si-O) with wave number 1041 cm⁻¹. Decreasing of Si-CH₃ means separation of side chain and decreasing of Si-O refers to the separation of the back bone of polydimethylsiloxane bonding changes. The changes in the absorption peak of Si-CH₃ and Si-O bonds show degree of specimen surface deterioration. FTIR spectra of specimens and %Transmittance of specimens after 1000 hrs salt fog test are shown in Fig.9 and Table IV.

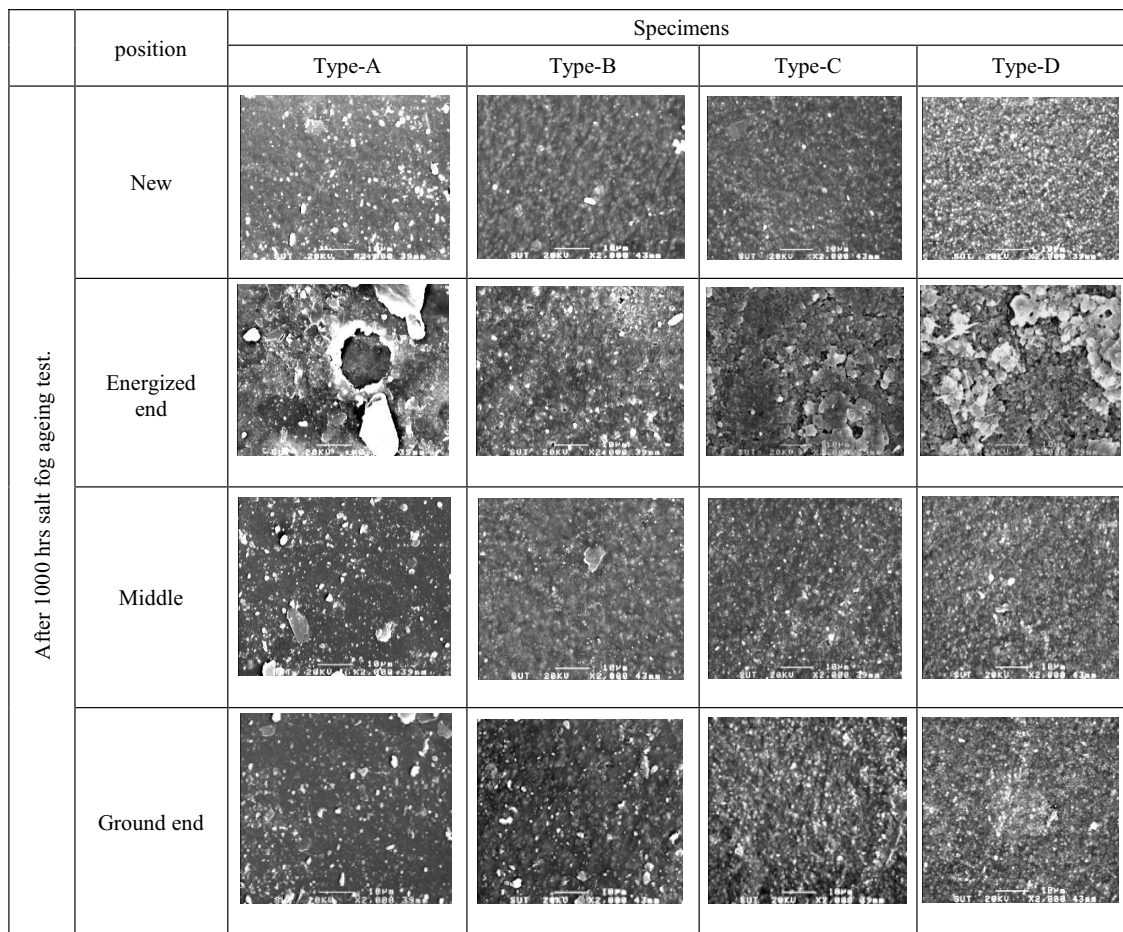
Fig. 10 SEM analyzes of the specimens surface.

A comparison of the photo-micrographs between the aged and new specimen can provide a comparative indication of the surface conditions. Specimens were gold coated prior to examination [11]. Severe micro-erosion was observed on the energized end of tested specimen type-A comparing with the other type, as shown in Fig. 10.

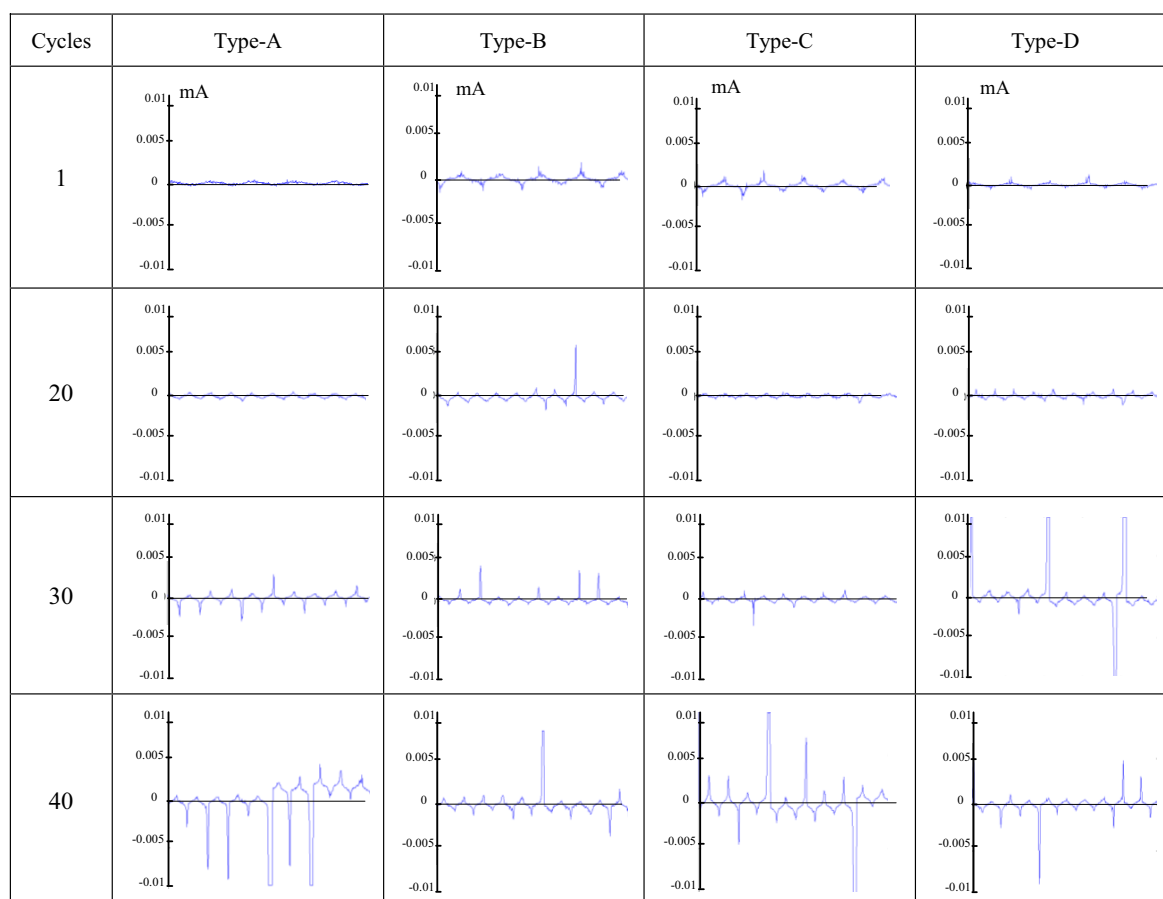
Fig. 11 Leakage current waveform (1 cycle is 24 hrs).

Leakage current flowing along the specimen surface was continuously measured and was recorded every 1 minute by leakage measuring software via LabView. Typical leakage current waveforms in each test cycle during salt fog injection are shown in Fig.11. The magnitudes of the leakage current increased gradually as the number of test cycles increased. The degree of the surface deterioration correlated with magnitudes of the leakage current.
