Study of Ageing Deterioration of Silicone Rubber Housing Material for Outdoor Polymer Insulators

Abstract— This paper presents the experimental results of salt fog ageing test of silicone rubber housing material for outdoor polymer insulator based on IEC 61109. Four types of HTV silicone rubber sheet with different amount of ATH were tested continuously 1000 hours in salt fog chamber. By visual observation after tested, slightly surface erosion was observed on tested specimen surface near the energized end. Furthermore, increasing in hardness and reduction in hydrophobicity were measured on tested specimen comparing with new specimen. In addition, chemical analysis by ATR-FTIR was conducted in order to elucidate the chemical change of tested specimens comparing with new specimen. Physical and chemical results confirmed the experimental results as well.

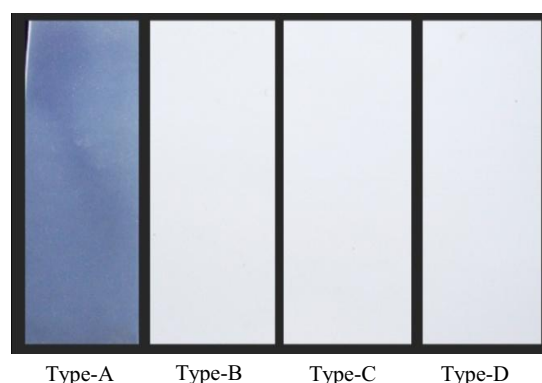
Specimens made of high-temperature vulcanized silicone rubber (HTV SiR) with/without alumina trihydrate (ATH: $\text{Al}_2\text{O}_3 \cdot 3\text{H}_2\text{O}$) having content 0%, 50%, 100% and 150% by weight were used in this experimental, as shown in Table I and Fig. 1. Configuration of tested specimen illustrated in Fig. 2. All specimen having 2 mm in thickness, 30 mm in width and 200 mm in length attached with metal electrodes on the both ends of each specimen were hung vertically in test chamber during test.

Fig. 1 specimens

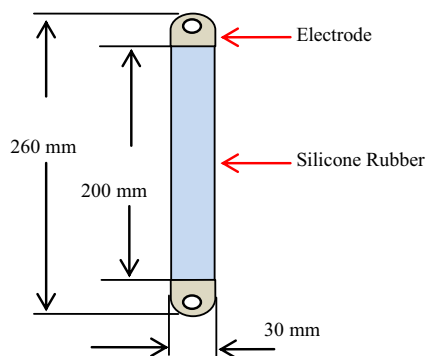
Fig. 2 Specimen configuration

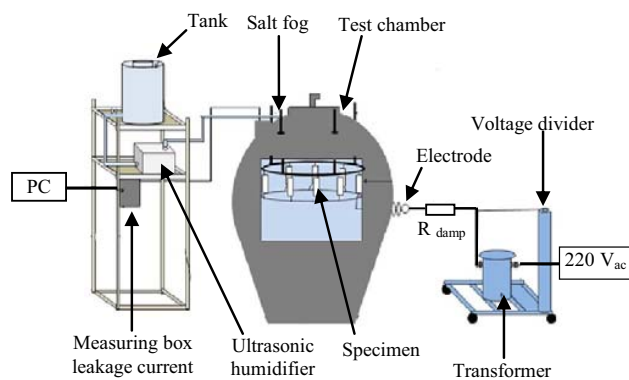
A polyethylene tank having the volume 4.0 m^3 was used as the salt fog test chamber. During salt fog ageing tests, specimens were hung vertically in the test chamber. An ultrasonic humidifier was used as salt fog generation and salt fog was injected from the top of the test chamber. Fig. 3 shows the test arrangement and Fig. 4 shows the actual test chamber.

Fig.3 Test arrangement

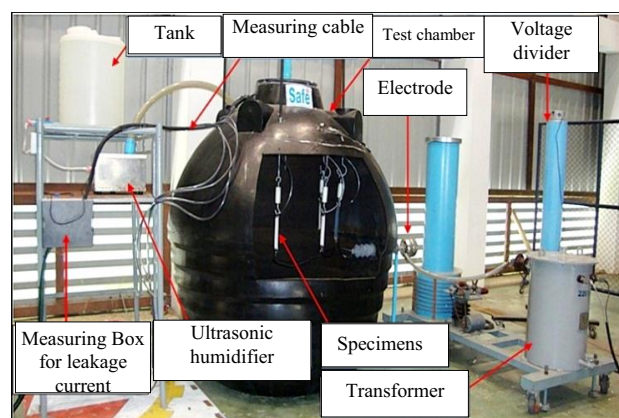
Fig. 4 Test chamber

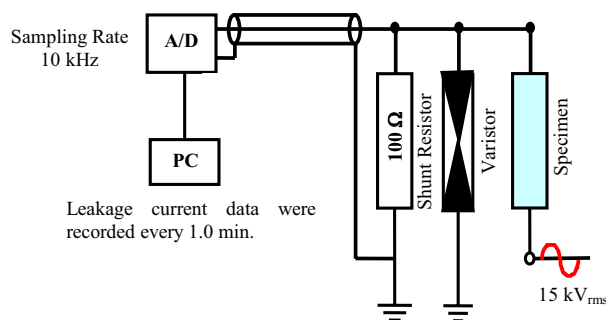
Fig. 5 Diagram of leakage current measuring system

cyclic salt fog ageing test was conducted by injecting salt fog in to the test chamber for 8 hours and stopping it for 16 hours every day under ac high voltage 15 kV. The salt fog having injection 0.5 l/hr/m^3 was injected from the top of the chamber as test conditions shown in table II. All specimens were hung vertically in test chamber and were tested together. Leakage current measurement system is shown in Fig. 5. Individual specimens were connected to the leakage current measurement system via the shunt resistors of 100Ω by means of coaxial cables. Leakage currents were continuously measured for individual specimens during the test. The leakage current was fed to an A/D board and converted to voltage. The leakage current data measured at the sampling rate of 10 kHz were recorded once every 60 s by postulating the data continuing for this period using the computer software developed via LabView.

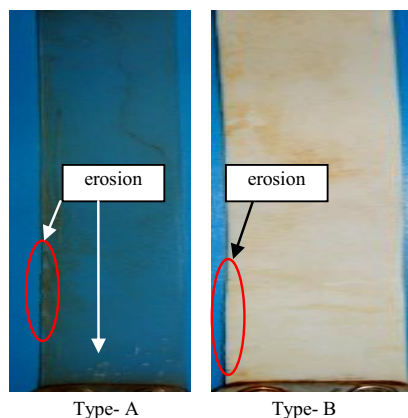
After 1000 hours salt fog ageing test, visual observation was conducted in order to inspect any change on tested specimen surface. Slightly surface erosion near the energized end, as shown in Fig. 5, was observed on specimens type A and type B. This may be caused by discharges on specimens surface during test due to higher electric field stress on such position. No surface erosion was observed on specimen type C and type D. The results confirm that the amount of ATH is effective to improve the anti-erosion performance of silicone rubber.

Fig.6 Specimens surface after 1000 hours.

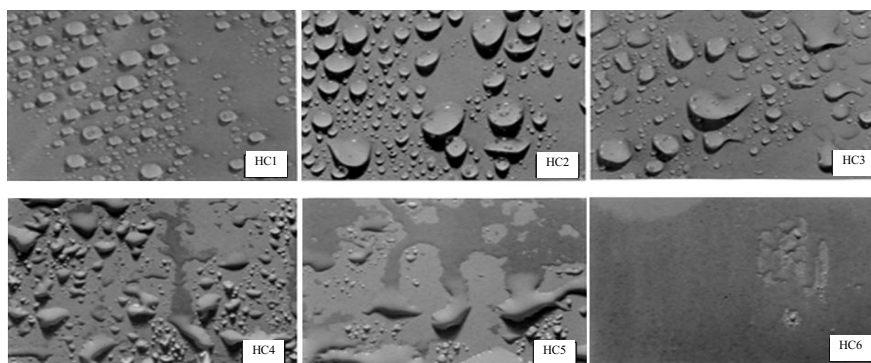
Fig. 7 Characteristics of the sample surface HC1-HC6

reduction in hydrophobicity and/or may be related to the amount of ATH. Reduction in hydrophobicity was evaluated by STRI criteria, as shown in Fig.7 [9,10]. Characteristics of hydrophobicity on tested specimen surface are shown in Fig.8. Hydrophobicity measurement results are shown in Table III.

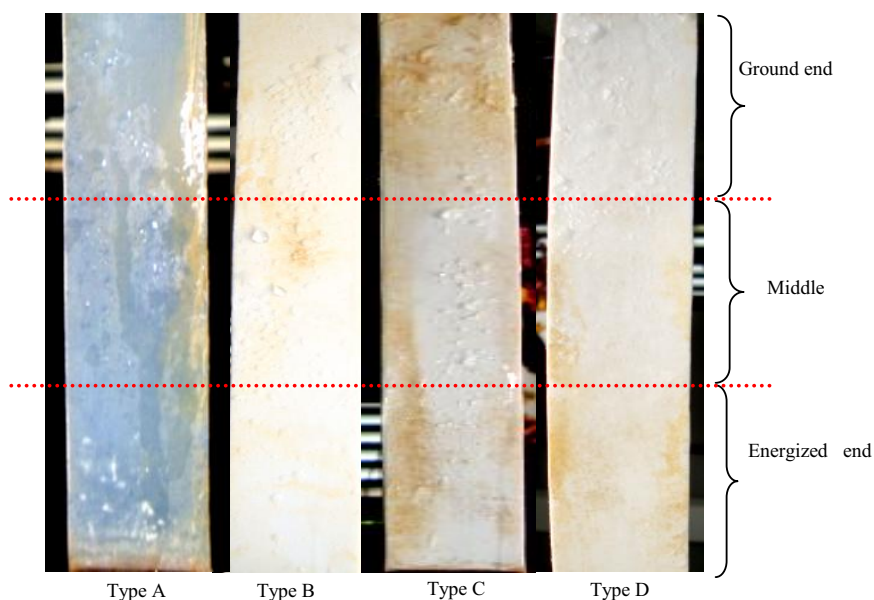
Fig. 8 Characteristics of hydrophobicity on surface

Significant decreasing in hydrophobicity can be observed on thoroughly surface of the specimens. Extremely loss of hydrophobicity (HC 6) was observed on thoroughly surface of specimen type A. In the case of the specimen without ATH and without filler surface treatment, a larger reduction in hydrophobicity can be seen compared with the other specimens having ATH. Such results indicate that ATH filler and filler surface treatment can delay the reduction of hydrophobicity on silicone rubber surface. Also, extremely loss of hydrophobicity (HC 6) at energized end was observed on all specimen surfaces. Such results indicate that high electric field stress can accelerate the reduction of hydrophobicity on the specimen surface.

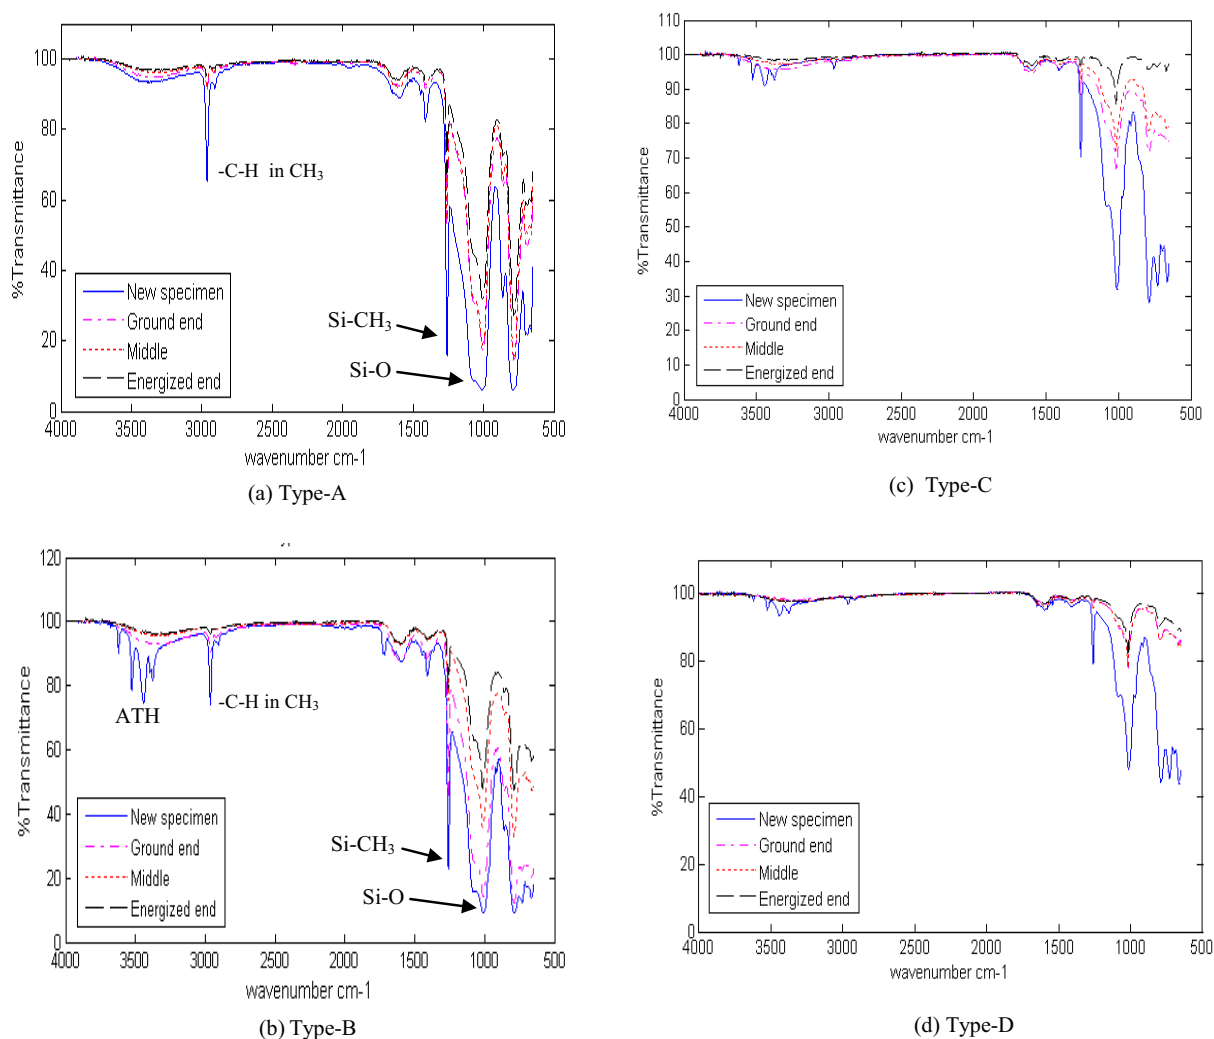
The chemical bonds of interested chemical structure are bonding side chain (Si-CH₃) with wave number 1261 cm⁻¹, backbone (Si-O) with wave number 1041 cm⁻¹. Decreasing of Si-CH₃ means separation of side chain and decreasing of Si-O refers to the separation of the back bone of polydimethylsiloxane bonding changes. The changes in the absorption peak of Si-CH₃ and Si-O bonds show degree of specimen surface deterioration. FTIR spectra of specimens and %Transmittance of specimens after 1000 hrs salt fog test are shown in Fig.9 and Table IV.

Fig. 9 FTIR spectra of test specimens

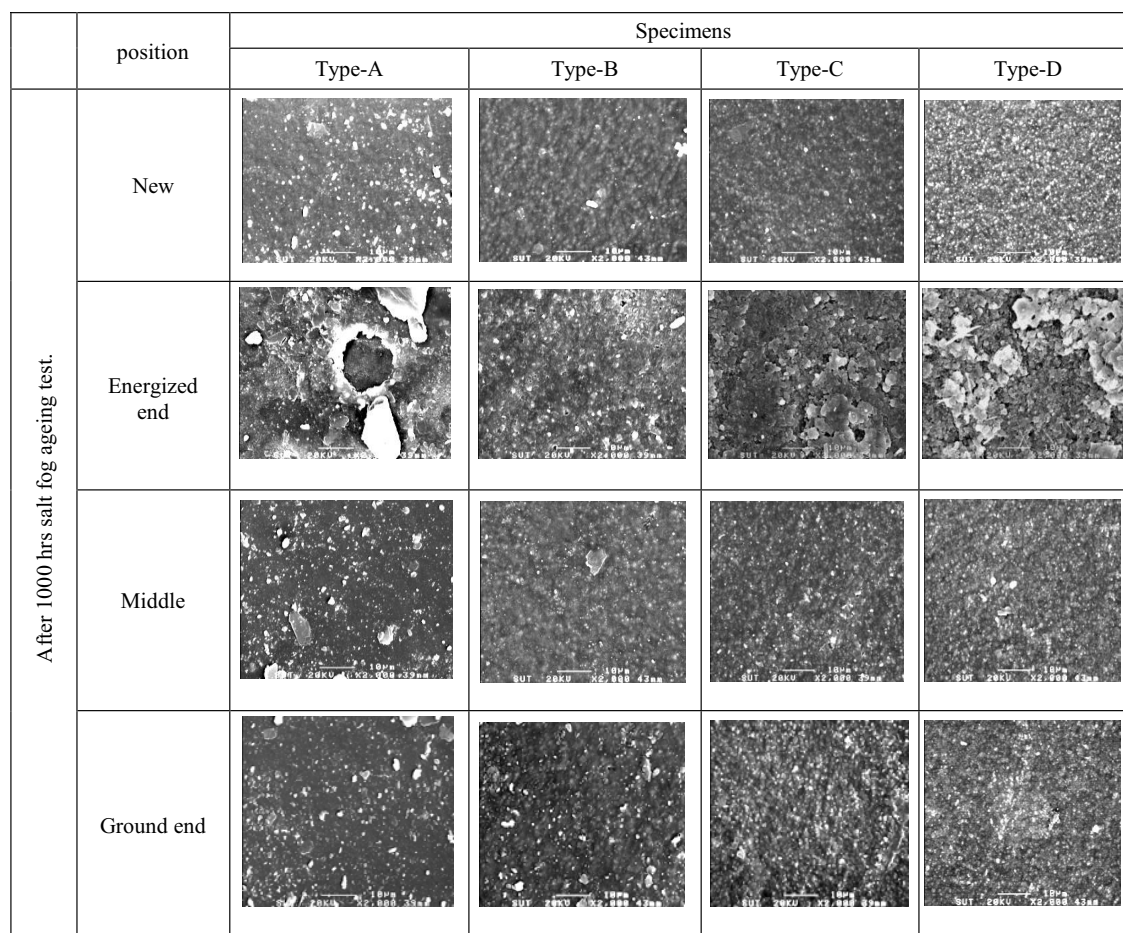
A comparison of the photo-micrographs between the aged and new specimen can provide a comparative indication of the surface conditions. Specimens were gold coated prior to examination [11]. Severe micro-erosion was observed on the energized end of tested specimen type-A comparing with the other type, as shown in Fig. 10.

Fig. 10 SEM analyzes of the specimens surface.

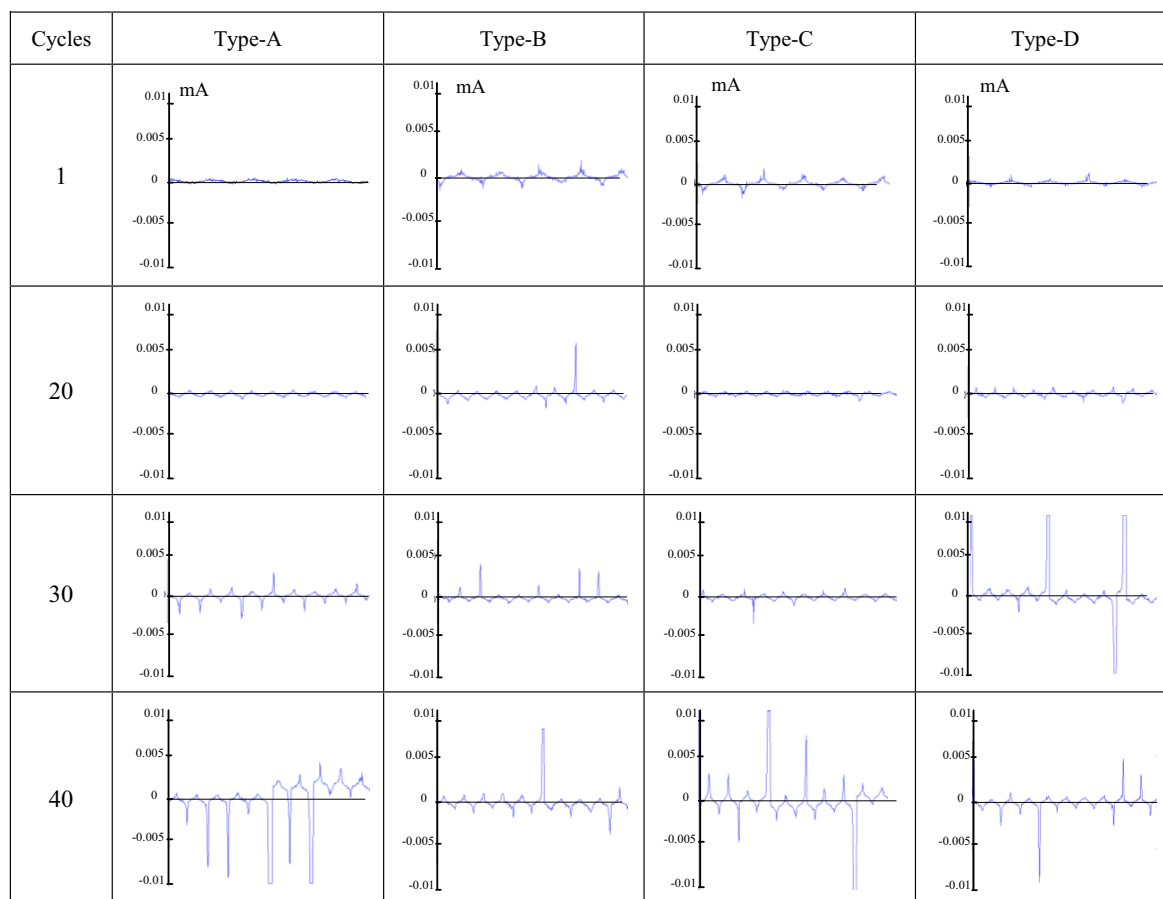
Leakage current flowing along the specimen surface was continuously measured and was recorded every 1 minute by leakage measuring software via LabView. Typical leakage current waveforms in each test cycle during salt fog injection are shown in Fig.11. The magnitudes of the leakage current increased gradually as the number of test cycles increased. The degree of the surface deterioration correlated with magnitudes of the leakage current.

Fig. 11 Leakage current waveform (1 cycle is 24 hrs).
