Energy Systems and Crushing Behavior of Fiber Reinforced Composite Materials

Hakim S. Sultan Aljibori

Abstract—Effect of geometry on crushing behavior, energy absorption and failure mode of woven roving jute fiber/epoxy laminated composite tubes were experimentally studied. Investigations were carried out on three different geometrical types of composite tubes (circular, square and radial corrugated) subjected to axial compressive loading. It was observed in axial crushing study that the load bearing capability is significantly influenced by corrugation geometry. The influence of geometries of specimens was supported by the plotted load – displacement curves of the tests.

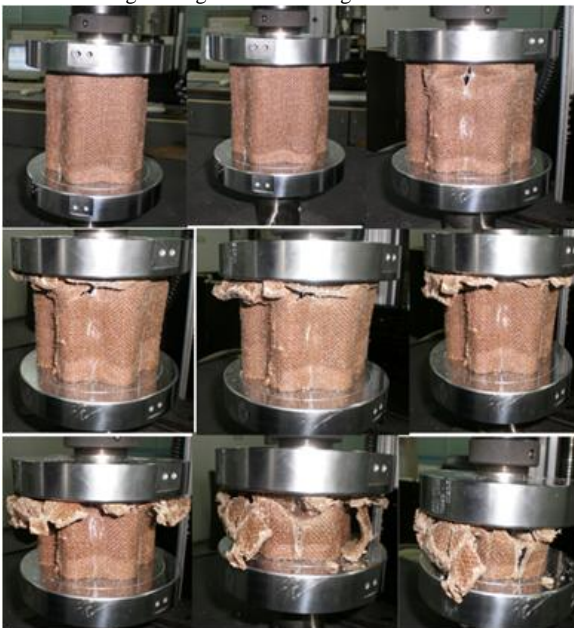
Fig.10 Progress of Crashing Test of RCJFT

The specimens were tested in quasi-static axial compression between two flat steel plates one is static and the other one moving with constant crushing speed. INSTRON 4469 digital testing machine (Figure. 7) with full scale load range of 50kN was used. Three specimens of each type of composite tubes were tested. Load platens were set parallel to each other before testing. All composite tubes were compressed at a loading rate of 15 mm/min until limited crush, which implies complete compaction of the tubes being tested. Load and displacement were recorded by an automatic data acquisition system. Progress and history of triangular crushing test of SJFT, CJFT and RCJFT are shown in Figures 8-10.
