# Evaluation of Drainage Conditions along Selected Roadways in Amman

Zain M. Al-Houri, and Abbas S. Al-Omari

**Abstract**—Roadways in Amman city face many problems consequent upon poor drainage systems. Evaluation tools are necessary to identify those roads needing improvement in their drainage system, and those needing regular maintenance. This work aims at evaluating drainage conditions in selected roadways in Amman city with the intent of identifying the problems encountered in their drainage systems. Three sites in the vicinity of Amman city have been selected and then inspected via several field visits to determine the state of their existing drainage systems and define the major problems encountered in these systems. The evaluation tool used in this study is based on visual inspection supported by photographs that depicted the defined problems. Following the field assessment, the drainage system in each road was rated as excellent, fair, good, or poor. The study reveals that more than 60% of the roadways in the selected sites were in poor drainage conditions, which lead to tremendous environmental problems. This assessment serves as a guide for local decision makers to help

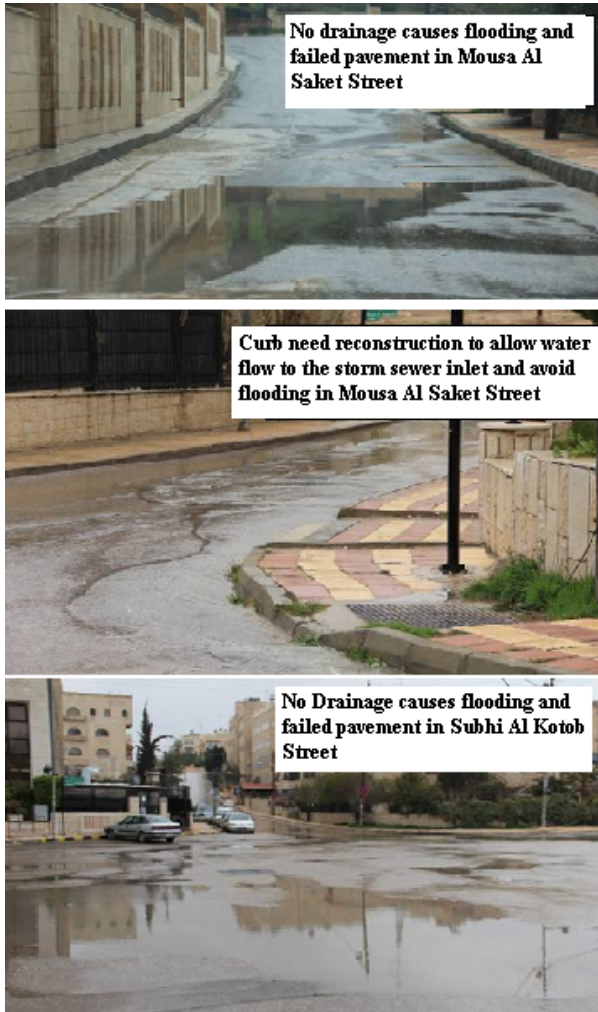
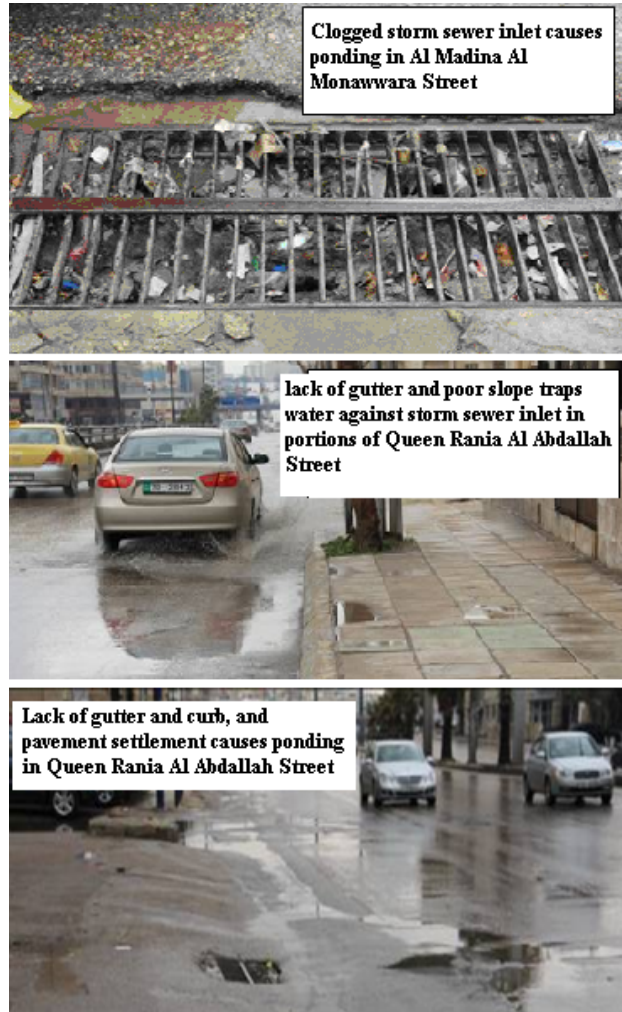
From the inspection process, the study reveals that the poor drainage is caused by a number of problems. These problems are depicted in Figures 3-5 for the three selected sites respectively. These figures are only examples of the observed problems in the streets drainage systems as it is not possible to show all the observed problems in this paper. Among the observed problems are the followings:

- Poor crowns,
- Lack of curbs and gutters,
- Lack of positive gradient,
- The disposal of waste and impermeable materials (clogging) of storm water inlets,
- Poor outlet conditions,
- Insufficient number of storm inlets or capacity, and
- Poor monitoring and maintenance of the sites

Fig. 3 (a) Example Problems of the roadway drainage systems in Site 1

Fig. 3 (b) Example Problems of the roadway drainage systems in Site 1

In summary, this preliminary work points out to the need for a necessary improvement, repair or reconstruction of the drainage systems in these roadways.

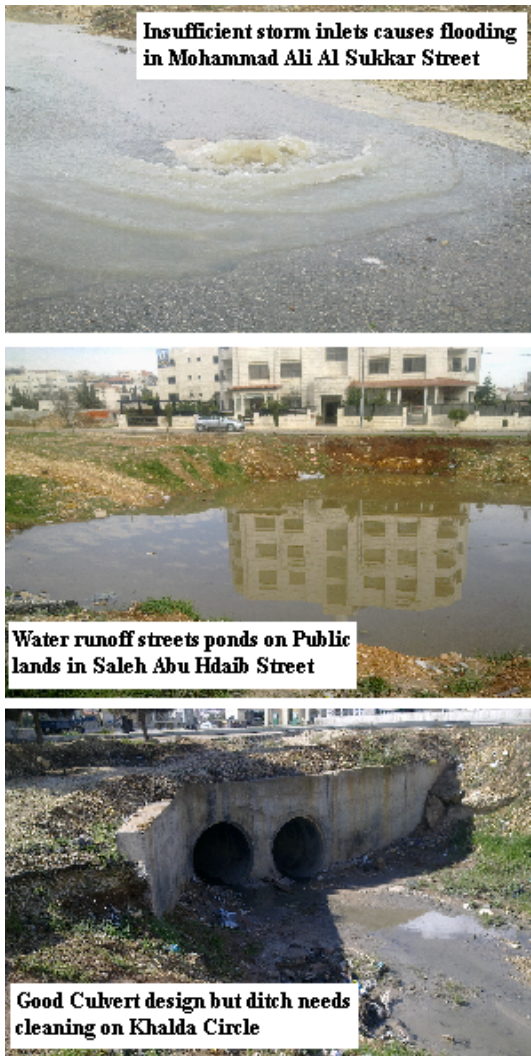
Fig. 4 Example Problems of the roadway drainage systems in Site 2

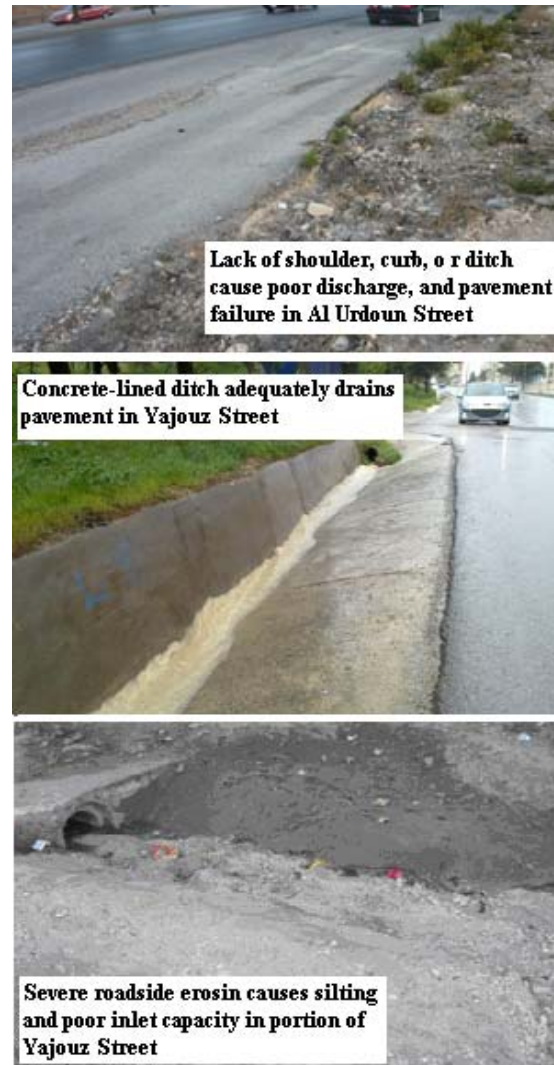
Fig. 5 Example Problems of the roadway drainage systems in Site 3
