Effects of Corrosion on Reinforced Concrete Beams with Silica Fume and Polypropylene Fibre

S.Shanmugam, V.G. Srisanthi, and S.Ramachandran

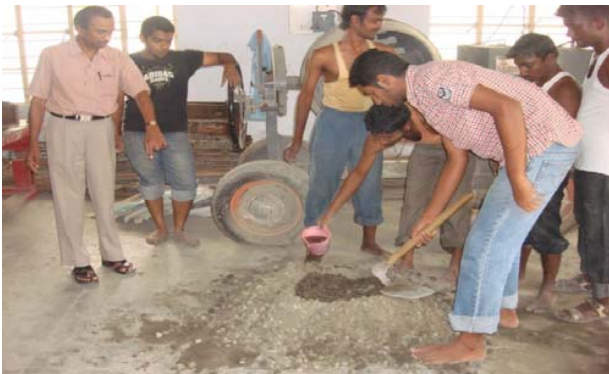
Fig. 1 Mixing of Concrete for Casting of Beam Specimens

1000 mm were selected. Bottom reinforcement of 2 numbers of 10 mm diameter, top reinforcement of 2 numbers of 8 mm diameter and shear reinforcement of 6 mm diameter two legged stirrups were used. The surface of rebars was derusted using wire brush and rust clear solution in order to remove any loose rust particles. The coating material was applied over the surface of the rebars with a brush and was allowed to cure. The initial weight of the rebars was taken and then the rebars were tied together to form the skeleton reinforcement cage. Twenty four numbers of beam specimens were cast using M35 grade of concrete. (Fig. 1). After curing for a period of 28 days, the specimens were transferred to Fibre Reinforced Plastic (FRP) tanks and were subjected to accelerated corrosion process.

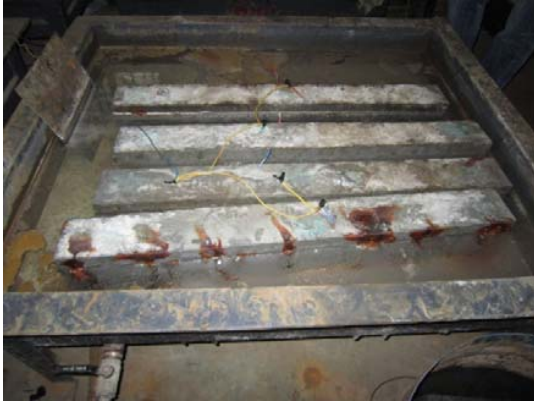
Fig. 3 Accelerated Corrosion Process for Unstressed Condition

Galvanostatic method was used to accelerate the corrosion process. Having the embedded steel as anode and an external stainless steel plate as cathode the beam specimens were impressed a selected current intensity under low voltage conditions for a period of 15 days. The specimens and steel plates were immersed in an electrolyte solution of 3% sodium chloride concentration [2] to simulate the conditions of sea water artificially. The current was applied using a regulated D.C. Rectifier. (Figs. 2 & 3)
