Beating Phenomenon of Multi-Harmonics Defect Frequencies in a Rolling Element Bearing: Case Study from Water Pumping Station

Abstract—Rolling element bearings are widely used in industry, especially where high load capacity is required. The diagnosis of their conditions is essential matter for downtime reduction and saving cost of maintenance. Therefore, an intensive analysis of frequency spectrum of their faults must be carried out in order to determine the main reason of the fault. This paper focus on a beating phenomena observed in the waveform (time domain) of a cylindrical rolling element bearing. The beating frequencies were not related to any sources nearby the machine nor any other malfunctions (unbalance, misalignment ...etc). More investigation on the spike energy and the frequency spectrum indicated a problem with races of the bearing. Multi-harmonics of the fundamental defects frequencies were observed. Two of them were close to each other in magnitude those were the source of the beating phenomena.

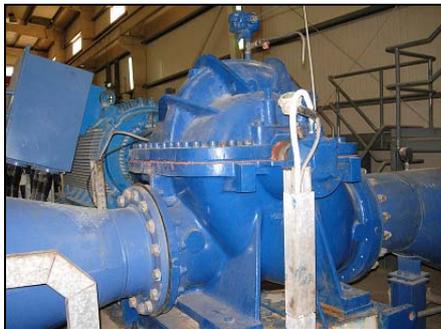
Fig. 2 West Riffa centrifugal pump

A double suction centrifugal pump running at 1480 rpm (24.67 Hz) is installed in West Riffa II water blending station in Bahrain water transmission network as shown in Fig. 2. The main duty of the pump is to pump water from a ground storage tanks to an elevated service reservoir (ESR). The last overhauling of the pump was on May 2008 after which the pump was running smoothly. Fig. 3 shows the vertical frequency spectrum of the Pump-drive end bearing which has an overall vibration of 0.6 mm/s only.

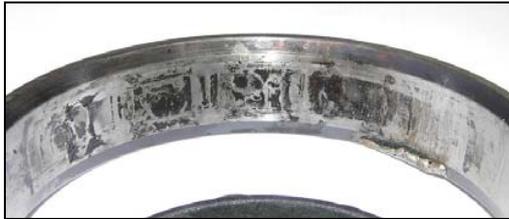
Fig. 14 The defects (dark marks) in the outer race of the bearing

Both outer and inner races were defective as shown in Fig. 14 and Fig. 15. The outer race has a lot of scratches and wear. The same thing could be said about the inner race.
