# Role of Oxide Scale Thickness Measurements in Boiler Conditions Assessment

**Abstract**—Oxide scale thickness measurements are used in assessing the life of different components operating at high temperature environment. Such measurements provide an approximation for the temperature inside components such as reheater and superheater tubes. A number of failures were encountered in one of the boilers in one of Kuwaiti power plants. These failure were mainly in the first row of the primary super heater tubes, therefore, the specialized engineer decide to replace them during the annual shutdown. As a tool for failure analysis, oxide scale thickness measurement were used to investigate the temperature distribution in these tubes. In this paper, the oxide scale thickness of these tubes were measured and used for analysis. The measurements provide an illustration of the distribution of heat transfer of the primary superheater tubes in the boiler system. Remarks and analysis about the design of the boiler are also provided.

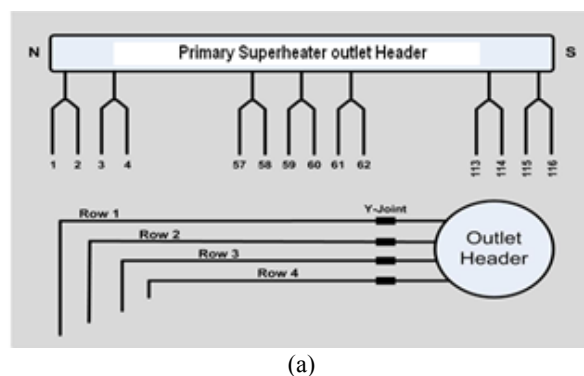
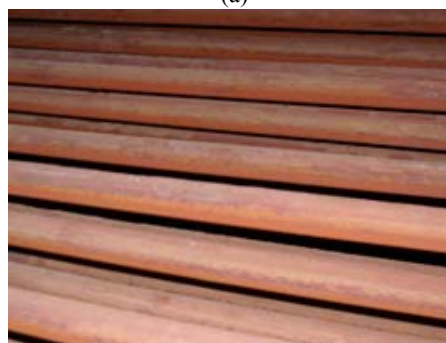
Chromium-molybdenum steels are used extensively in the manufacturing of piping, heat exchangers, pressure vessels and several other high temperature components in process and power plants, due to their creep and oxidation resistance [12-14]. They are used in Kuwaiti power plants in primary and secondary superheaters for long times. However, in one of Kuwaiti power plants, a number of failures were encountered mainly in the first row of the primary superheater tubes. As a results, the specialized engineer decide to replace them during the annual shutdown. The primary superheater, in the studied boiler, consists of four rows of tubes, each row having 116 tubes that are connected to the outlet header (Fig. 1). The design operating temperature for the outlet of the primary superheater is 436 °C.

Fig. 1 (a) Schematic illustration of the primary superheater setup and (b) the tube bank

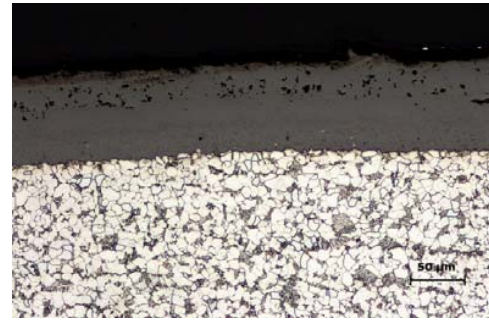
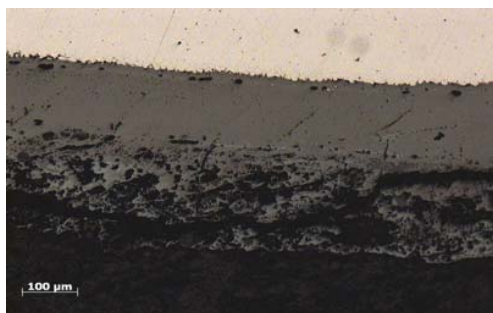
Fig. 2 Optical micrograph of (a) Fireside oxide scale showing thick layer with some spallation and (b) intact steam side oxide scale

The repeated failure in the boiler can be caused by several reasons such as overheating, fireside corrosion, fatigue, and creep. The temperature of the boiler firing and the steam temperature play significant role in these failures. Therefore, the metal temperature which can be approximated by the oxide scale measurements should show whether the design conditions are met or not. The oxide scale were thicker in fireside when compared to steam side. Spallation were noticed in fireside oxide scales and as a result they are not considered in oxide scale measurements.

The temperatures of all tubes are above the design operating temperature by more than 100  $^{\circ}\text{C}$ . This is a clear indication of overheating suffered by these tubes which can explain the repeated failures in this boiler. This overheating can reduce the life of these tubes as a result of creep in less than design time. Also, localized oxidation can be encountered which lead to localized overheating that reduce wall thickness and lead to tube burst. Another interesting remark, is the microstructural degradation that was found in some of these tubes. Some of these tubes suffer from spheroidization as a result of this overheating. Moreover, one of the tubes showed a clear decarburization zone of 150  $\mu\text{m}$ . These microstructural alteration need more analysis to find the root cause of this degradation. However, one clear cause is the long term overheating of as a result of improper boiler firing. The temperature seems to raise gradually as the number of tube increases. This is an indication that a part of the boiler is overheated more than the other. Firing procedure should be reviewed to find out the reason for this overheating and the non-uniformity of the heating for boiler tubes.

Therefore, it is recommend that boiler firing should be checked and adjusted to fit the initial design.
