Analyzing the Historical Ayazma Bath within the Scope of Integrated Preservation and Specifying the Criteria for Reuse

Meryem Elif Çelebi Yakartepe, Ayşe Betül Gökarslan

Keywords—Üsküdar, Ayazma Complex, Ayazma Bath, Conservation, Restoration.

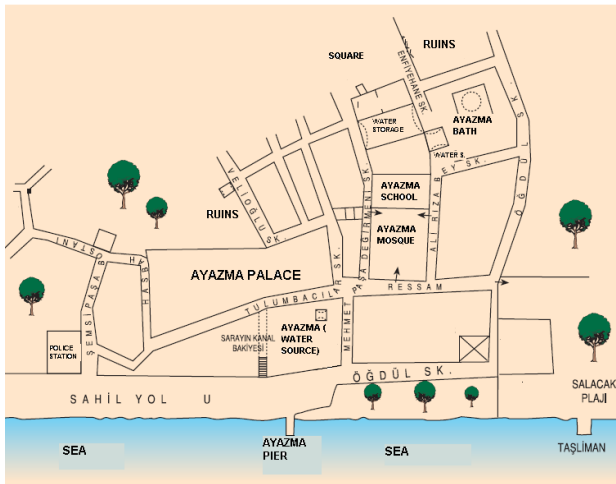
Fig. 1 Ayazma Social Complex Layout [7]

Ayazma Social Complex consists of a mosque in its center and structures around this mosque such as sultan mansion, time assignment center, primary school, stores, bath, and water reservoirs. Mosque, sultan mansion and the water reservoirs survived to today as mostly preserved status. However, time assignment center, primary school and the stores didn't live up today and new structures were built on their plots. The bath was mostly damaged and only the wall residues live up today (Fig. 1).

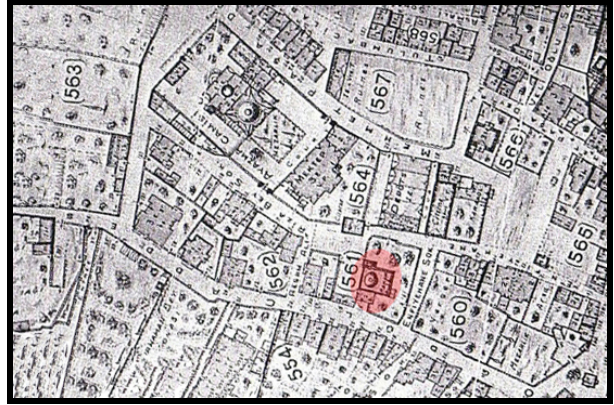
Fig. 2 Ayazma Neighborhood, Complex and Bath [9]

One of the sides of the bath located in Ayazma Neighborhood faces Öğdül Street and the other faces Enfiyehane Street (Fig. 2). There is a water reservoir to the east of the bath (Fig. 3). This reservoir used to be filled with the water from Bulgurlu Village and used to supply water to the bath.

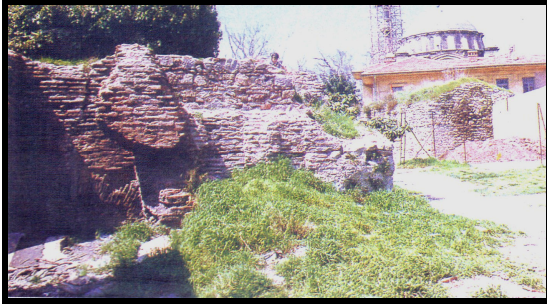
Fig. 5 Ayazma Bath's old photograph from 1987 [10]

The bath, which was abandoned for some time during World War I, started to serve again 1916. In a record dated September 17, 1769; it is claimed that the bath is used as a snuff workshop. Despite being a property of the foundation, it became a private property later with lawful resolution. The date until the bath served under the property of a person and its structural status is not precisely known. Nahide Şimşir (2004) states that the bath was in ruins in 1946 [12]. In 1974, the owner of the bath had stores built on the side of the bath facing Ögdül Street. In 1976, the bath is used as a dump [11] (Fig. 4). It is understood from a photo in the article of Sadi Bayram and Adnan Tüzen (1987) that the top cover of the bath was demolished in 1987 and that only the wall residue remained [10] (Fig. 5). Today, it is desolate.

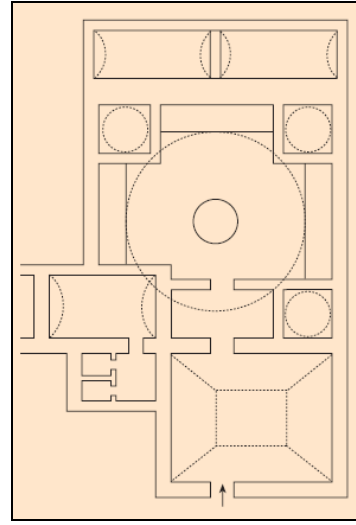
Fig. 6 Ayazma Bath's plan [8]

According to Mehmet Mermi Haskan (2001), Ayazma Bath has "single bath" type (Fig. 6). According to İbrahim Hakkı Konyalı (1976) defines the unique plan of the bath as "...after the display window, the left part of the changing room is

covered by a round and the left is covered by a pendentive dome. From here, one can go to privy and bath sections. It has three private rooms and one navel stone..." [1].

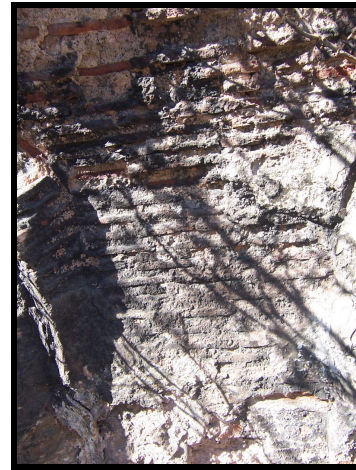
Fig. 7 Bath's material usage and construction technique

The first building of the bath was built out of rubble stones with masonry technique; however, the places added during the repair were made of thin bricks. It can be observed that the top sections of some walls were completed later with stone material (Fig. 7). There are no information concerning the top cover and interior arrangement which didn't live up today.

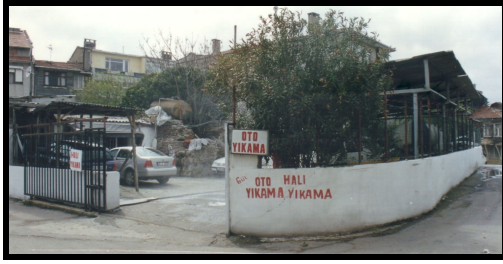
Fig. 8 Ayazma Bath, 2014

The structure is in ruins today. Its domes and furnace is completely destroyed, only the wall residues survived to today. A car and carpet wash service was built in its garden next to the bath. The residues of the structure and its surroundings were closed by new premises built by this enterprise. Water reservoirs were put inside the structure. The water and chemical based leaks used by the enterprise caused

serious deteriorations on the bath. The bath is faced with the danger of collapsing today (Figs. 8, 9).

In order to preserve Ayazma Bath and hand it down to the next generations, it should be purified of the dense structuring surrounding it; it should be saved from the usage type that damages the structure; surveying, restitution and restoration projects should be prepared as soon as possible and the restoration applications should immediately commence.

Firstly, the new additions of the enterprise in the surrounding of Ayazma Bath and the trees and soil dump in the bath should be cleaned. After this, ground excavations should be made and the status of the foundations should be examined. Necessary foundations and the walls should be subjected to strengthening and consolidation works. If there is ground water problem, the water should be kept away from the

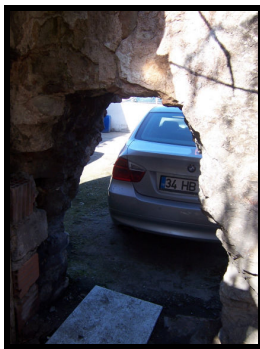
Fig. 10 The gap opened on the body wall of the bath by the enterprise - 2014

It is observed that an entrance gap was opened on the body wall by the Car Wash Service in order to be able to use the interior of the bath (Fig. 10).

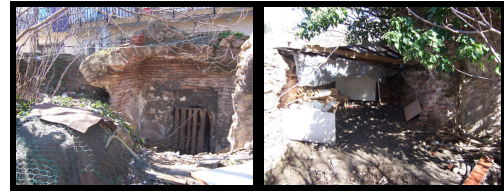
Fig. 12 Bath's interior views - 2014

The interior of the bath became the storage and dump of the Car Wash Service. It is observed that the trees in the interior part of the structure were randomly cut without considering its effects to the structure.

The complete destruction of the upper cover of the structure, the interior being in ruins, vegetation in the wall

residue, darkening and salinization effects, trees and soil dumps in the interior and wrong usage are the important deteriorations in the historical bath (Figs. 11, 12).

structure with drainage system. After the structural liberation, side liberation should be made. The plants, especially on the sides, should be removed from the structure with their roots. Next, the darkening and salinization should be cleaned.

Considering the material losses, the wall residues of the bath should be integrated and should be put to its unique height. Since there isn't any data concerning the unique roof of the bath, the upper cover should be built with today's modern material steel and glass.

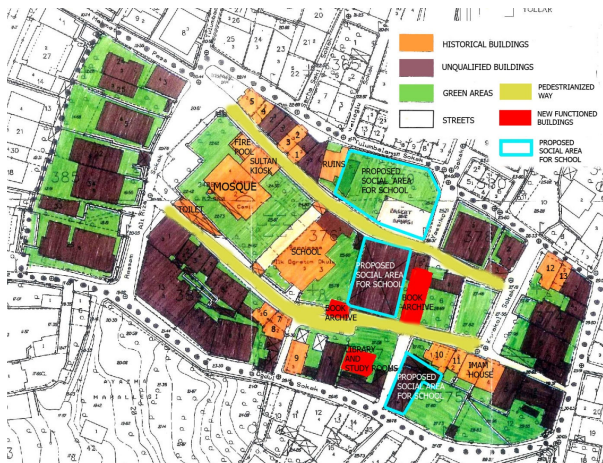
Fig. 14 Ayazma Complex and around buildings proposal analysis

Due to the fact that Ayazma Primary School is an important architectural inheritance of the work space and that the mass of buildings around many houses, it's decided that the buildings to be re-functioned should have "education" purposes.

Since the users are the students around 5-14 ages and in primary education level, it was suggested that Ressam Ali Rıza, Enfiyehane and Değirmen Streets should be pedestrianized. Furthermore, the areas considered to belong to the historical social complex should be evacuated and these areas should be functioned as social - public areas in relation to the school.

Among the Ayazma Social Complex; Ayazma Bath, which survived to today but is not able to maintain its unique function, and the water reservoir that provides the water needs of the bath should be re-functioned. It was considered that the bath should be library and study center and the water reservoirs to be archives. Thus, school - library - study center constructions and the pedestrianized streets connecting these constructions to each other will have created an education island of streets and social areas.
