Preservation of Isparta Yılan Kırkan (Yılan Kıran) Fountain within the Scope of Sustainability

Meryem Elif Çelebi Yakartepe, Ayşe Betül Gökarslan

The restoration decisions of Yılan Kırkan Fountain in Isparta province of Turkey is a good example of the works of sustainable architecture and the preservation of architectural inheritance. It is aimed that Yılan Kırkan Fountain, which is desolate nowadays with no function, to be restored by the local authorities and university, included in the daily life and continue its function.

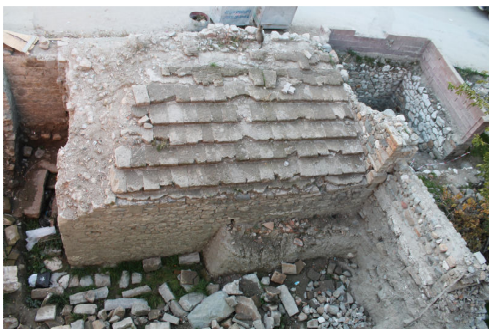
Fig. 4 Yılan Kırkan Fountain, from worksite which located besides fountain

The debris on the immovable was cleaned in 1999 and the fountain was revealed. During the debris cleaning, an inscription of the fountain with the proportions of 0.26 x 1.01 m was found. A cleaning excavation was carried out with the by the decision no. 3087 by Antalya Cultural Heritage Preservation Board dated 30.04.2009 [3] (Fig. 4).
