# Seismic Vulnerability Mitigation of Non-Engineered Buildings

Muhammad Tariq A. Chaudhary

**Keywords**—Kashmir earthquake, non-engineered buildings, seismic hazard, structural details, structural strengthening.

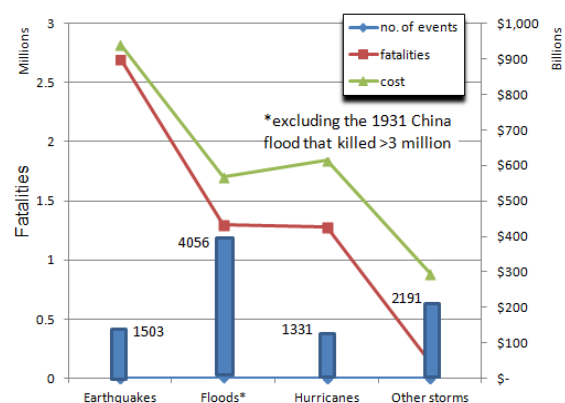
Fig. 1 Fatalities and economic impact of natural disasters (1900 – 2012)

Collapse of buildings and houses during earthquakes are the leading reason for worldwide fatalities caused by natural disasters in the last 110 years followed by floods and hurricanes [3]. Fig. 1 presents a comparison of frequency of

four types of natural disasters and related fatalities and direct economic cost from 1900 to 2012. Earthquakes top both fatalities and economic impact despite lesser occurrence. The numbers are staggering and a reason for concern for policy makers, economists, seismologists and more importantly civil engineers and urban planners who are professionally responsible for ensuring the safety of buildings and cohesion of the urban infrastructure fabric in the aftermath of natural disasters.

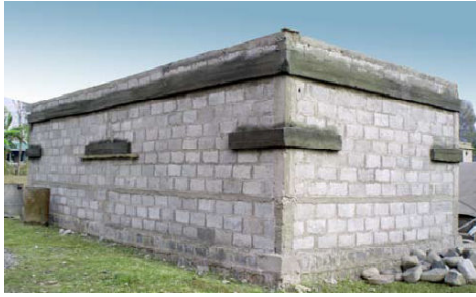
Fig. 7 (a) Roof band beam and wall L-stitches

- 1- Connection of mutually perpendicular walls to enhance building integrity by tying the walls together. The tying is to be done by a material that has good tensile strength and ductility. It includes: (i) wire mesh reinforcing, (ii) use of polypropylene bands, (iii) use of corner stitches (L-stitch) made of reinforced concrete. Refer to Fig. 7 for salient details.
- 2- Install bond beam at roof level to tie together the walls and help to secure the roof with this beam. One example is shown in Fig. 8 for the case of brick masonry walls and reinforced concrete slab.

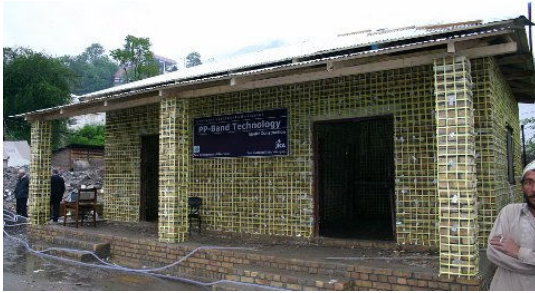
Fig. 7 (b) Polypropylene band reinforcing
