# Relining of Domestic Piping System with Rubber Filled Epoxy and Reinforced Polyester Composites

**Abstract**—Pipe failure and leakage is a problematic issue and the traditional solution of replacing the pipes is costly and time consuming. Rehabilitation by relining materials based on polymer composites is an alternative solution towards the degradation problem of the old piping. This paper provides a brief summary of advances in technology, methods and materials for relining as well as a summary of the degradation analyses of the two main composite materials used for relining, rubber filled epoxy and reinforced polyester baltoflake when they are exposed in deionized water and elevated temperature up to 80°C for a duration of 2-14 months in the laboratory.

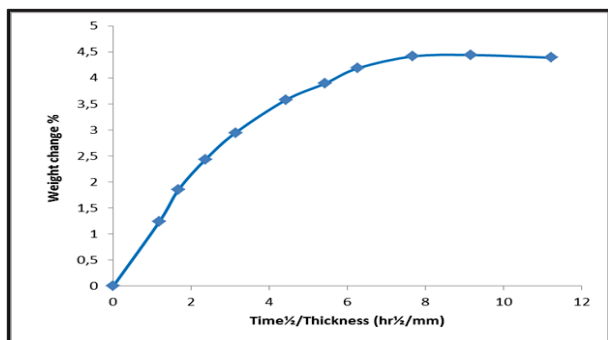
Fig. 5 A typical sorption curve for a coupon of polyester baltoflake immersed in water at 60°C

carried out by immersion of samples with the dimension of 4 X 4cm in deionized water at different temperatures (22°C, 40°C, 60°C and 80°C). A typical sorption curve for a coupon exposed to the water at 60°C is shown below. This sample has reached the equilibrium after the maximum weight change of 4,43% and was taken out for the desorption measurements. The coupons which were exposed to the water at 80°C started to blister and delaminate after 7 weeks so the results for water absorption became different between different coupons exposed to water at 80°C.

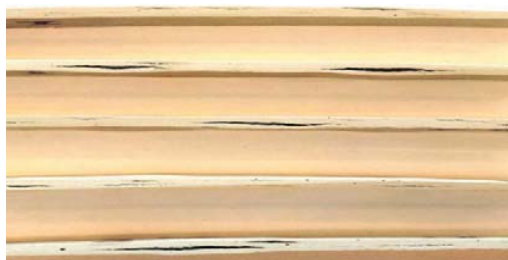
Fig. 12 Specimens prepared from polyester material immersed in water at 80°C for two months and after drying shows how delamination has happened along the edges
