Comparing Repaired and Undamaged Specimens Test Results of Post-Tensioned Beam to Column Connections

Keywords—Precast beam to column connection, moment-resisting connection; post-tensioned connections, repair of precast connections.

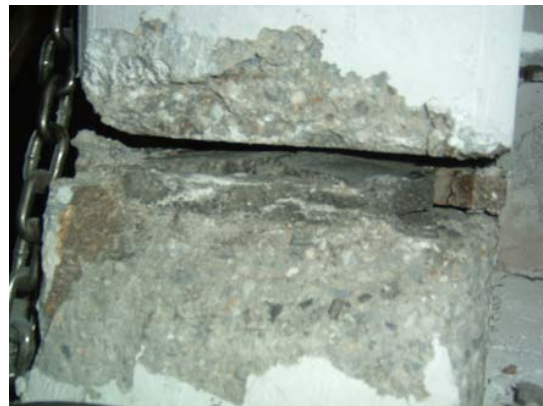
In repetitive loadings, the loading capacity of the AP1R specimen reached average 52 % of the loading capacity of the AP1 when a 1.5 % drift was applied, and a maximum loading capacity of the AP1R specimen reached average 73,50 of the loading capacity of the AP1 specimen. The initial stiffness of the AP1R specimen was seen to be higher than the initial stiffness of the reference specimen. After a load of nearly 7.8 kN the epoxy filling between the column and beam from the surfaces of the column and beam began cracking and this caused a decrease in the stiffness of the specimen. The experimental specimen continued to carry the load during the later cycles at a lower stiffness. Excessive damage was not observed at the concrete side of the specimen during the test (Fig. 1).

Fig. 1 Cracking of the corbel of the AP1R test specimen

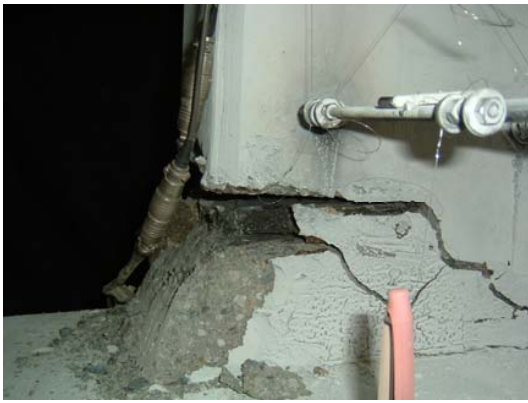
Fig. 3 Fallen state of the parts of the concrete at the upper corner of the corbel of the DP1R specimen

In repetitive loadings, the loading capacity of the DP1U specimen reached average 54 % of the loading capacity of the DP1 when a 1.5 % drift was applied, and a maximum loading capacity of the DP1R specimen reached average 77,00 of the loading capacity of the DP1 specimen. The initial stiffness of the DP1R specimen was seen to be higher than the initial stiffness of the reference specimen. After a nearly 7.5 kN load, the cracking of the epoxy resin caused a decrease in the stiffness of the specimen. The experimental specimen continued to carry the load during the later cycles at a lower stiffness. The bottom edge of the beam touching the corbel at the corbel side was crushed during the backward loading of the last cycle. The cracking of the concrete at the bottom part of the beam caused a 6 kN load loss of the specimen at this loading (Fig. 3).

During the backward loadings of the APIR, and DP1R specimens in the last cycle, crushing was observed at the bottom edge of the beam which resulted in losses in the loading capacities of the specimens.
