Deformation Characteristics of Fire Damaged and Rehabilitated Normal Strength Concrete Beams

Yeo Kyeong Lee, Hae Won Min, Ji Yeon Kang, Hee Sun Kim, Yeong Soo Shin

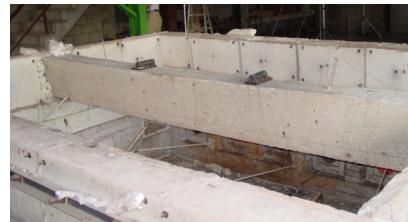
Fig. 2 Specimen installed on the horizontal heating furnace

After 3 months curing, the specimens were installed on the horizontal heating furnace for the fire tests as shown in Fig. 2. The surfaces exposed to heating were 3 faces except the upper face. The fire test was performed according to ISO-834 standard fire curve, Fig. 3, for 1 or 2 hours maintaining 87kN of the initial load corresponding to live load of general office building. Distance from hinge to roller was 4500mm and distance between 2 loading points for four points loading was 1200mm.

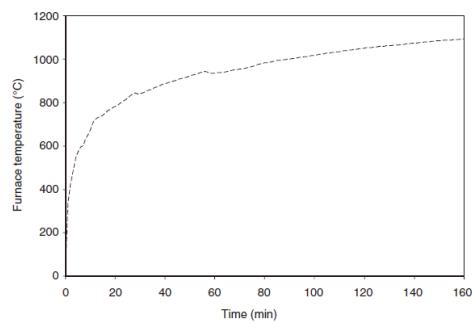
Fig. 3 ISO-834 standard fire curve

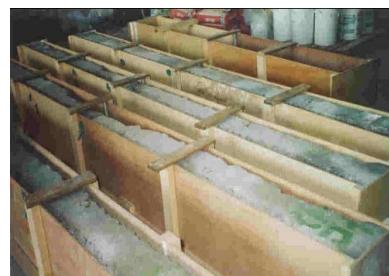
Fig. 5 Curing of rehabilitated beams with polymeric cement mortar

Four specimens were tested after 2 months air-recurring to investigate residual strength of fire damaged RC beams. Other four specimens were rehabilitated with polymeric cement mortar after being removed the fire damaged part of concrete cover as illustrated in Fig. 4. As shown in Fig. 5, these rehabilitated beams were cured for 1 month to get rehabilitation effects enough. The test specimens were tabulated in Table III.

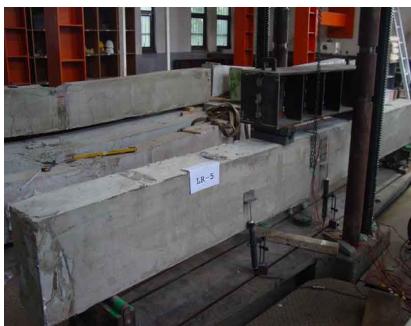
Fig. 6 Four point loading test set up

Four points loading tests were performed in simple support condition for both fire damaged and rehabilitated beams as shown in Fig. 6. Test span was 4000mm and distance between 2 loading points was 1200mm as illustrated in Fig. 7.

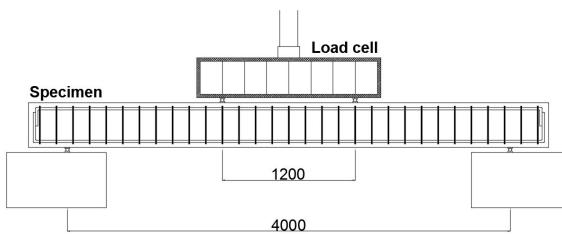
Fig. 7 Details of four points loading system (unit: mm)

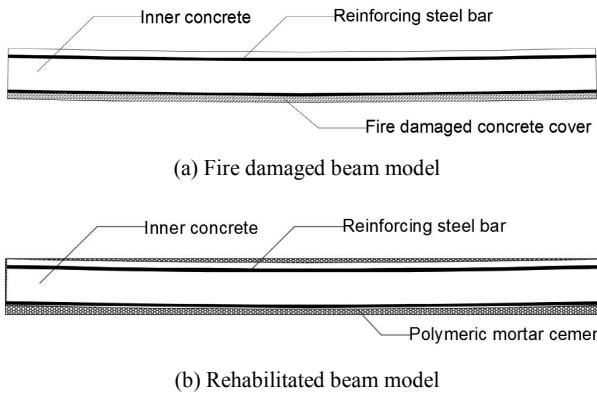
Fig. 8 Details of beam model in analyses

Control beams (40CV, 50CV), fire damaged beams (40CV1H, 40CV2H, 50CV1H, 50CV2H), and rehabilitated beams (40CV1HRH, 40CV2HRH, 50CV1HRH, 50CV2HRH) were structurally analyzed. Based on the deformed geometries from the integrated temperature-structural analyses, fire damaged beam models were generated. These models consisted of three parts; inner concrete, reinforcing steel bar, and fire damaged cover as shown in Fig. 8 (a). The parts were assumed as perfectly bonded each other. As illustrated in Fig. 8 (b), rehabilitated beams had also three parts; inner concrete, reinforcing bar, and rehabilitating part. These three parts were also assumed as perfectly bonded to each other. The rehabilitated beams were modeled in straight configuration by adding rehabilitation part to the location of removed concrete cover.

The element type of inner/fire damaged concrete part and the part for rehabilitation was 4-node tetrahedral element, while reinforcing steel bar part had 8-node linear brick element type. Inner concrete and reinforcing steel bars included 90% of the original elastic modulus and compressive/tensile strength as listed in Table V. Lee [1] and Ahn [4] had been reported that material properties decreased to 90% of the original properties when temperature of inner concrete after heating was lower than 500°C. Fire damaged concrete cover, which was air-recurred for 2 months after heating, had 31% of the original material properties since its temperature of inner concrete was higher than 800°C as Poon et al. [6]. The material properties of polymeric cement mortar referred to available reports of existing material. Non-linear geometrical analyses were performed to investigate deformation characteristics of the beam models.

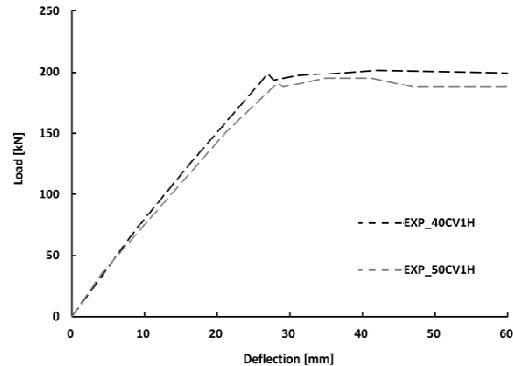
Fig. 9 Load-deflection curves of test specimens heated for 1 hour

Fig. 9 illustrates load-deflection curves of RC beam specimens having cover thickness with 40mm and 50mm heated for 1 hour. As shown, maximum load and slope of 40CV1H specimen are higher than those of 50CV1H specimen because 40CV1H has lower temperature distributions and larger beam depth compared to 50CV1H. The same tendencies are also shown in the load-deflection curves from results of RC beams heated for 2 hours as illustrated in Fig. 10.

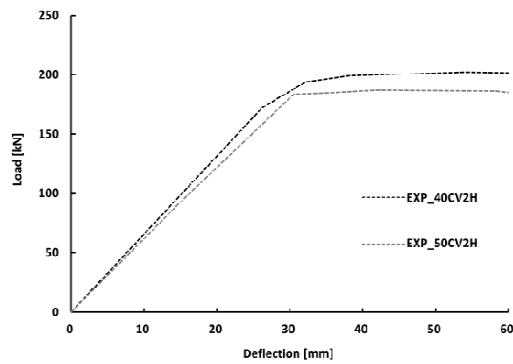
Fig. 10 Load-deflection curves of test specimens heated for 2 hours

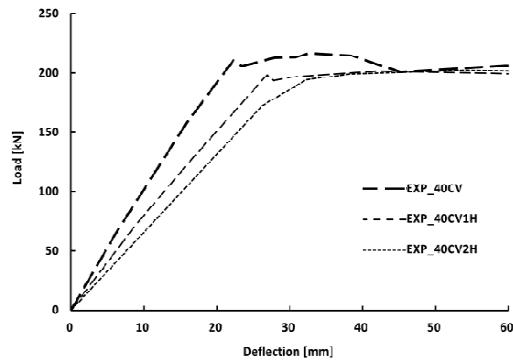
Fig. 11 Load-deflection curves according to heating time difference

Fig. 11 illustrates load-deflection curves of RC beams having 40mm of cover thickness heated for 0, 1 or 2 hours. As seen, the longer specimens are heated, the lower maximum loads and slopes of specimens are. The slopes of 40CV1H and 40CV2H decrease to around 74% and 66% of the slope of 40CV, respectively. All beams, however, show similar structural behaviors such as load beyond 40mm deflection.

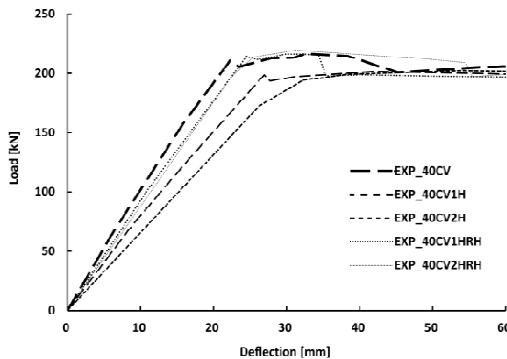
Fig. 12 Load-deflection curves of test specimens having cover thickness 40mm

Fig. 12 shows load-deflection curves of both fire damaged specimens (40CV1H, 40CV2H) and rehabilitated specimens (40CV1HRH, 40CV2HRH) compared with control specimen (40CV). As mentioned in Fig. 11, maximum loads and slopes of 40CV1H and 40CV2H specimens are lower than those of 40CV specimen. However, the load-deflection curves of rehabilitated beam; 40CV1HRH and 40CV2HRH show that the rehabilitation recovers load carrying capacity of the fire damaged concrete beams. Maximum loads of these two specimens reach that of control beam. Similar tendencies are

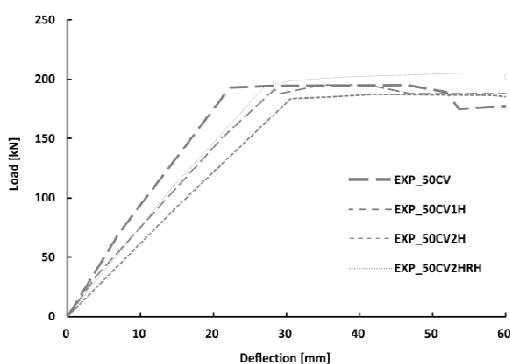
Fig. 13 Load-deflection curves of test specimens having cover thickness 50mm

shown in the load-deflection curves from results of RC beams having 50mm of cover thickness, as illustrated in Fig. 13.

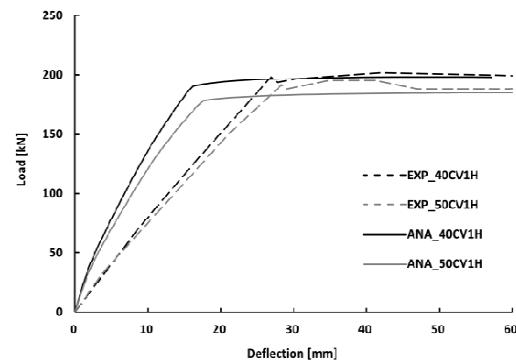
Fig. 14 Load-deflection curves from experiment and analysis of RC beams heated for 1 hour

Fig. 14 illustrates load-deflection curves of RC beams having 40mm and 50mm of cover thickness heated for 1 hour and analytical results are compared with experimental results. As shown in the load-deflection curves, maximum predicted loads matches well with experimental results, but the slopes obtained from analyses are larger than experimental results. Two primary reasons would be able to explain the difference of slopes. First of all, inner concrete's inside cracks occurred by fire are not exactly reflected in analytical models although the decreased material properties are included. In addition, the RC beam models in analyses have larger heights than specimens of experiments, so polymeric cement mortar would affect to structural behaviors more. Between 40CV1H and 50CV1H, both analytical and experimental results show similar tendency. The specimens that have cover thickness of 40 mm have larger stiffness than the specimens that have cover thickness of 50mm because of the larger beam depth.

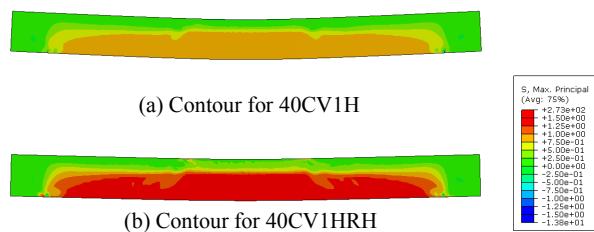
Fig. 15 Maximum principal stress contour predicted from FE models

The rehabilitation effects can be illustrated in Figs. 15~17. Comparing Figs. 15 (a) and (b), rehabilitated beam model, 40CV1HRH, has larger maximum principal stress than fire damaged beam model, 40CV1H. As seen in Figs. 16 and 17, analytical and experimental results are in good agreements.

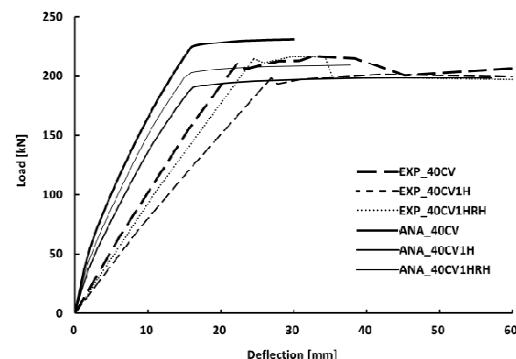
Fig. 16 Load-deflection curves from experiment and analysis of RC beams having cover thickness 40mm

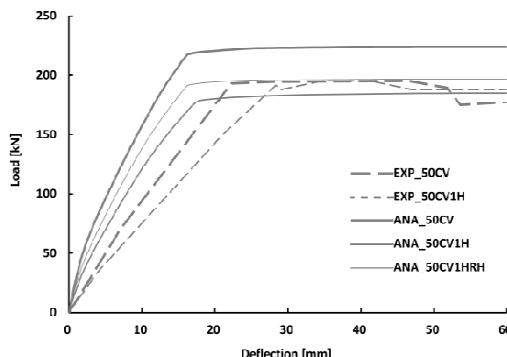
Fig. 17 Load-deflection curves from experiment and analysis of RC beams having cover thickness 50mm
