# Investigation of Rehabilitation Effects on Fire Damaged High Strength Concrete Beams

Eun Mi Ryu, Ah Young An, Ji Yeon Kang, Yeong Soo Shin, Hee Sun Kim

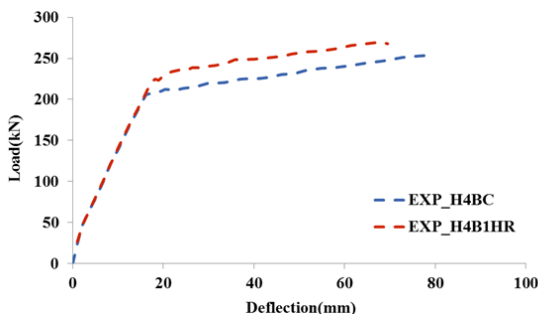
Fig. 9 Experimental load-deflection curves for specimen having cover thickness of 40 mm

After fire test, the ultimate loads of damaged beams such as H4B1H and H5B1H are 13.4% and 28.6% lower than those of control beams respectively. But as shown in Figs. 9 and 10, the ultimate loads of rehabilitated beams are higher than those of control beams. The ultimate loads of H4B1HR and H5B1HR are 5.4% and 0.7% higher than those of H4BC and H5BC respectively. And structural behaviors are analogous between specimen having cover thickness 40mm and 50mm. The ultimate loads from experiments are listed in Table IV.

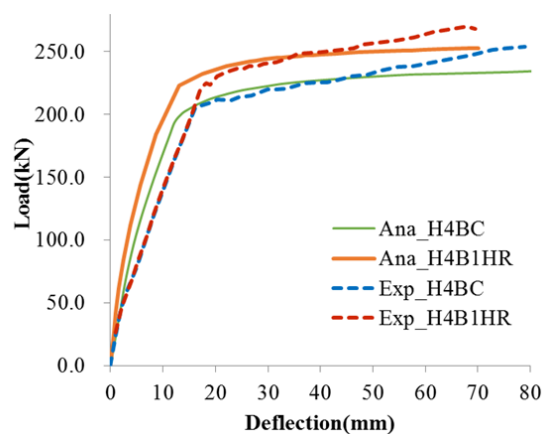
Fig. 11 Experimental and analytical load-deflection curves for beams having cover thickness of 40mm

The analytical results of load-deflection curves are shown in Figs. 11 and 12. The ultimate loads of rehabilitated beams are higher than those of control beams. And the ultimate loads of damaged beams are lower than those of control beams. Such tendencies between experimental and analytical results are in good agreements.

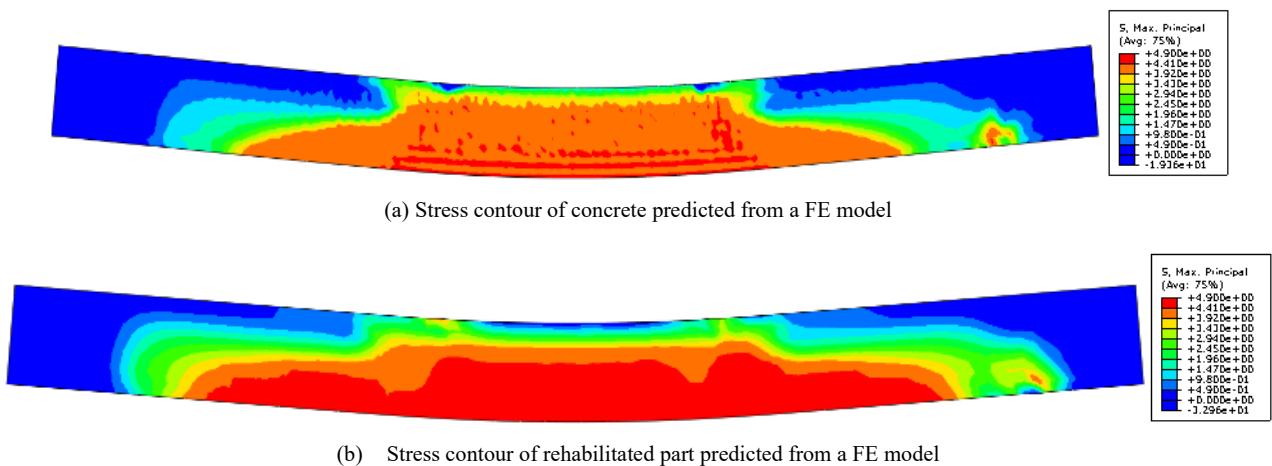
Fig. 13 Stress contour of a FE models for beam having cover thickness of 40mm

Analytical results of deformed shape and stress contours predicted from a FE model of rehabilitated beam are illustrated in Fig. 13. For the rehabilitated FE model, high stresses are distributed in rehabilitated part with polymeric cement mortar while low stresses are found in damaged concrete part.

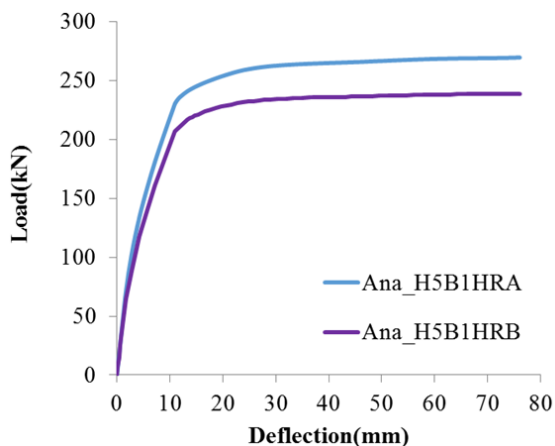
Fig. 14 Analytical load-deflection curves for beams having cover thickness of 40mm according to polymeric cement mortar

It is seen that ultimate loads of beams rehabilitated with polymeric cement mortar type A are higher than those of beams rehabilitated with polymeric mortar type B. As shown in Figs. 14 and 15, the ultimate loads of H4B1HRA and H5B1HRA are 281.5kN and 269.9kN while the ultimate loads of H4B1HRB and H5B1HRB are 252.6kN and 238.3kN. The ultimate loads of FE models are listed in Table VIII. The slopes of beams rehabilitated with mortar type A are stiffer than those of beams rehabilitated with polymeric mortar type B.
