Investigation of Rehabilitation Effects on Fire Damaged High Strength Concrete Beams

Eun Mi Ryu, Ah Young An, Ji Yeon Kang, Yeong Soo Shin, Hee Sun Kim

Keywords—Fire, High strength concrete, Rehabilitation, Reinforced concrete beam.

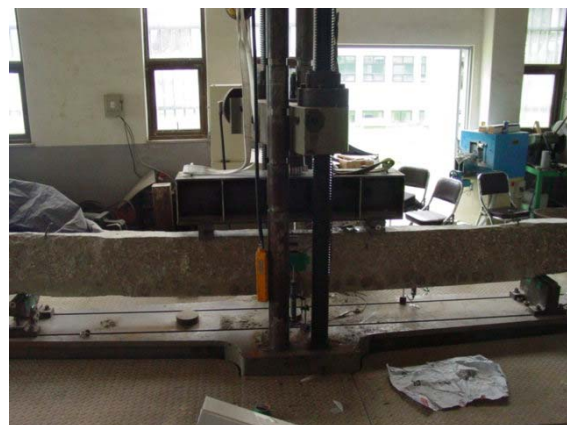
Fig. 5 Four-point loading test of rehabilitated beam

Specimens are simply supported with an effective span of 3750mm and subject to four-point loading. The vertical deflection of the specimen is measured at midspan using a linear variable displacement transducer (LVDT). And the load increases with a gradual rate and is recorded through a data logger. Figs. 3 and 5 illustrate the instrumentation used for the test.

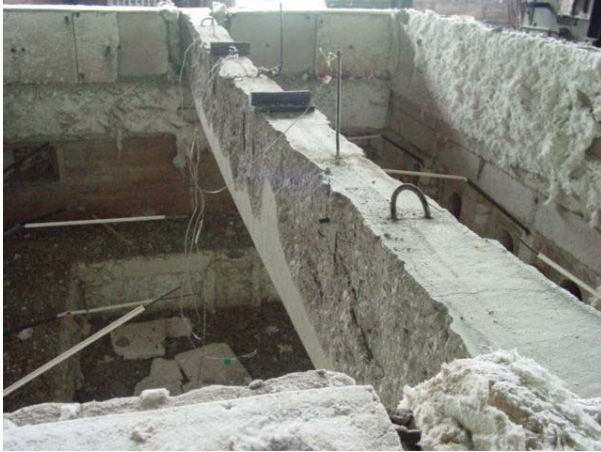
Fig. 6 Specimen on the horizontal heating furnace after fire test

After fire test, the specimens are damaged as shown in Fig. 6 and are left during one month. For comparing residual strength and strength of rehabilitated beam, rehabilitation is performed. Fire damaged U-shaped concrete cover is removed. And, removed part is filled with polymeric cement mortar.
