Tool Damage and Adhesion Effects in Turning and Drilling of Hardened Steels

Chris M. Taylor, Ian Cook, Raul Alegre, Pedro Arrazola, Phil Spiers

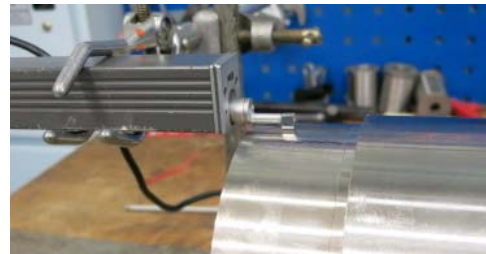
Fig. 1 Measuring roughness on turned bar surface

A standard toolmaker's microscope was used to gather images of the rake and flank faces of each tool for wear measurement and analysis. A Mitutoyo SJ-301 device was used to measure surface roughness in the direction of the bar's axis, applying a fixed cutoff wavelength of 0.8 mm (refer to Fig. 1 for a picture of the roughness measurement arrangement). InfiniteFocus G4 and SL devices from Alicona were used to create high resolution 3D scans of the turned surface and of damaged cutting tools.

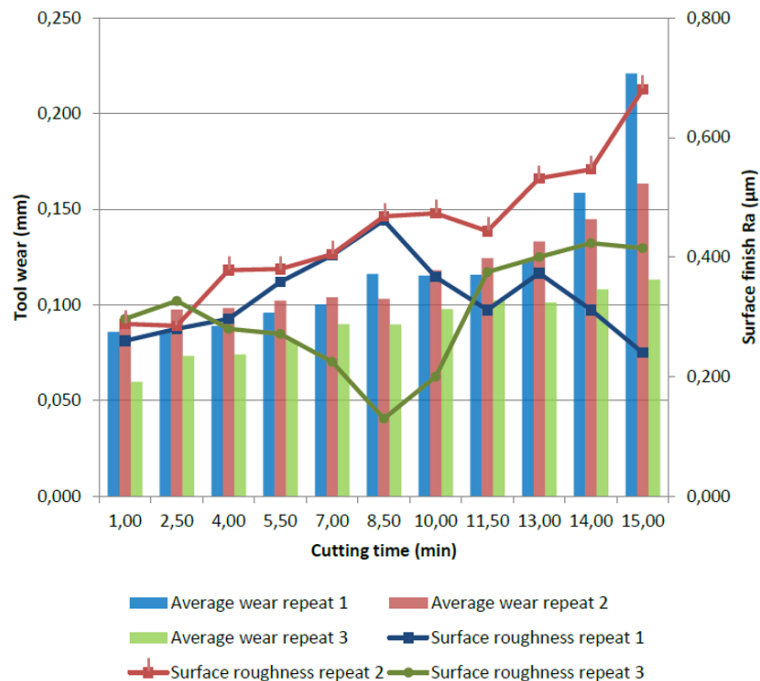
Fig. 2 Tool flank wear and surface roughness progression against time for repeat finish turning cuts. Surface finish in micrometres

For the results which are relevant to the following discussion see Figs. 2-4. Referring to Fig. 2 first, turning tool wear tests were run in an identical fashion three times over. Each repeat test began with a brand new cutting edge: the edge progressively wore during the cutting process. The measured average surface roughness (R_a) is seen to increase and decrease over time. In repeat 2, there is an almost-monotonic upward trend in surface roughness from 0 to 15 minutes of insert cutting time, in repeat 3 there is an overall upward trend in roughness over time with large fluctuation, whilst in repeat 1 the roughness returns to very near the starting value after 15 minutes of cutting. However, over the same time period, the

measured average tool flank wear increases monotonically in all three cases.

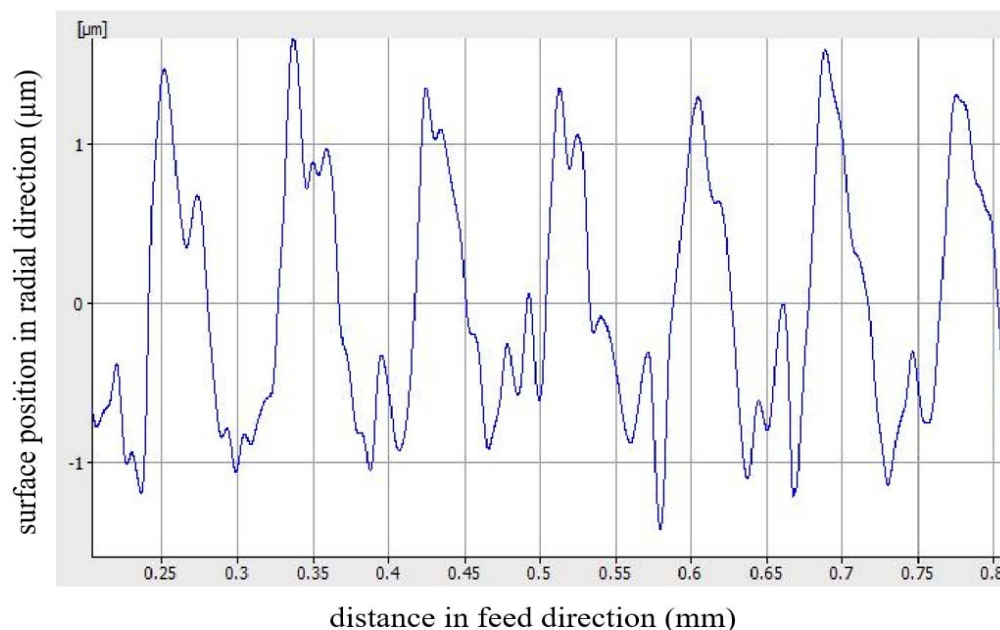
Fig. 3 Turned surface profile, in plane perpendicular to cutting speed direction

The hypothesis to explain this behaviour is that the geometrical effect of adhered workpiece material superimposed onto wear on the cutting edge is what is creating the variable profile cut into the bar's surface and causing the variation in surface roughness. This is borne out by the way in which surface roughness fluctuates independently of the size of the wear scar (Fig. 2), and by the cross-sectional profile measured on the turned surface (Fig. 3). Adhesion causes short-term fluctuations in the surface roughness, whilst tool wear leads to a long-term upward trend in surface roughness (only seen in 2 out of 3 repeat tests). From examination of the turned surface data in Fig. 3, the cross-sectional profile of the surface in the direction of tool feed can be observed to have a cyclic wave-type pattern with a wavelength of 0.088 mm. Note that the tool feed and workpiece rotation combine to create a helical cutting pattern. 0.088mm is the feed per revolution of the turning operation, equivalent to the pitch of the cut helix. However, the exact appearance of each wave profile varies noticeably at each revolution of the bar. Fig. 3 is a scan of the surface created at the end of repeat wear test number 2, where the highest surface roughness was measured. The cut wave profile corresponds to the true profile (shape) of the cutting edge, similar to the case of a serrated knife moving through butter. The nominal shape of the cutting edge is a circle arc, as the tool insert was created with a 1.6 mm radius nose, but the true profile cut into the workpiece surface is far from a circle arc. The profile of the cutting edge has been modified by the joint effects of adhesion and wear. Each revolution of the bar occurs in less than one second, the tool wear occurring in this time period is minimal so the rapid change of profile observable from wave to wave in Fig. 3

cannot be explained by tool wear. The proposal is that adhesion or BUE on the tool cutting edge has a large effect on the instantaneous surface finish of the turned bar.

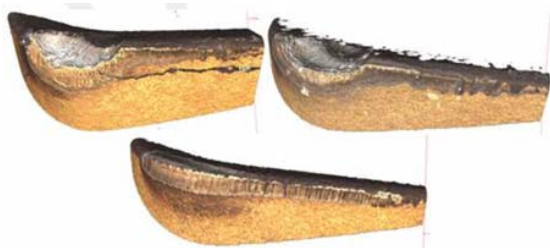
Fig. 4 High resolution 3D scans of tools after 15 minutes' turning

Fig. 4 displays high-resolution scans of the three turning inserts used in these trials. Moving clockwise from the top left, the inserts are from repeat trials 1, 2, and 3 as discussed. The rake face coating is black in colour; the insert flank coating is lighter in colour. The thin edges between the black surfaces and lighter-coloured surfaces are the cutting edges. The reflective silvery material visible in damaged areas along the cutting edges is adhered workpiece material. The uncoated tungsten carbide and cobalt substrate would appear as matt grey, but any areas where the coating has been removed are now covered in adhered material. Many thin “track” or “groove” damage features can be seen on the tool flanks, particularly visible for insert 3. These are orientated perpendicular to the cutting edges, and are the result of abrasive flank wear. Additionally, crater wear can be seen on the rake face in the case of inserts 1 and 2, this is due to the motion and heat resulting from cut chips (swarf) flowing over the rake face.

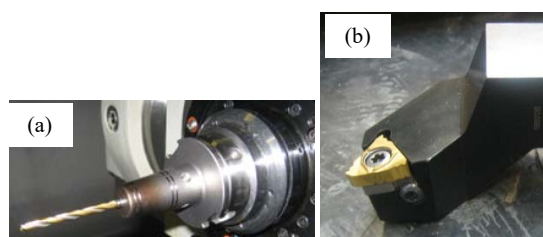
Fig. 6 Tool holding arrangements for (a) drilling and (b) thread turning

In the thread turning process, ISO standard threads were created with a 60-degree form and a pitch of 1.5 mm, equal to the programmed feed per revolution (refer to Fig. 7 for a picture of a finished thread). A shank tool was used to hold coated tungsten carbide based threading inserts as shown in Fig. 6 (b). The Hawk CNC lathe was used for thread turning, the same machine as described in Section II. Threads were

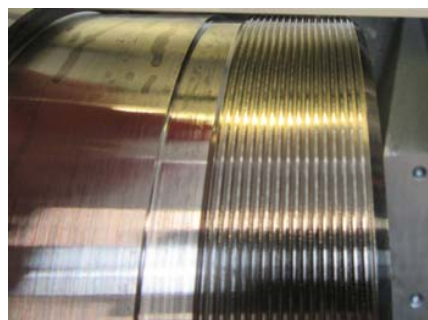
Fig. 7 Turned thread on cylindrical test piece

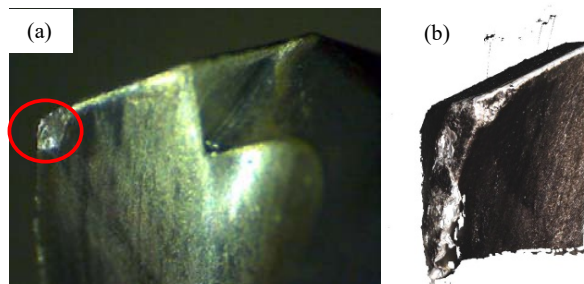
Fig. 8 Drilling failure images (a) microscope image of the end of flute 1; and (b) high-resolution 3D scan of failed drill corner, flute 2

The most common failure mode for drills was as shown in Fig. 8, involving loss of the corner region. This was the failure mode in around 70% of cases. In the remaining 30% of cases, fractures at the chisel edge (drill point) or fractures of the flutes (i.e. the drill broke into two or more large pieces) occurred. In threading, from 12 tests on various insert designs the worn-out cutting edges looked similar to Fig. 9 in every case.

Examining the drill images first: the appearance of the damage in Fig. 8 (a) suggests a “chip” or fracture on the drill corner, but from inspection of Fig. 8 (b), there is a great deal of adhesion around the area of missing tool material. There is no evidence of abrasion in this case. Three possible explanations are that: the drill corner fractured due to excessive cutting stresses imparted into the substrate; or that

adhesion wear plucked away the drill corners as observed by Nomani et al. [13]; or that the flow of cut material (swarf) has caused damage in the corner region, by jamming or abrasion. Both flutes had suffered the same type of damage simultaneously. An argument against stress-related fracture is made in a separate paragraph below. It is worth noting that the effective cutting speed on the end of the drill increases with distance from the centre point. At the centre point (also known as the chisel edge), fractures can occur due to high thrust and near-zero surface speed. The corner of each flute is a weak point structurally, meanwhile the surface speed is at its maximum value at the corner and periphery of the drill, which makes thermally-driven wear mechanisms more likely.
