# Tool Damage and Adhesion Effects in Turning and Drilling of Hardened Steels

**Keywords**—Turning, drilling, adhesion, wear, hard steels.

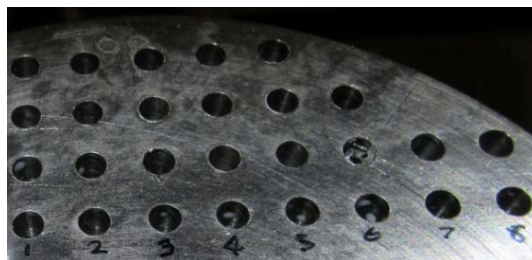
Fig. 5 Array of blind drilled holes in test piece surface

Drilling trials took place on a Starrag ZT1000 5-axis machining centre, which was chosen for its structurally-rigid machining head and a spindle speed of up to 24000 revolutions per minute. Blind holes were drilled to a depth of 50 mm with 4.5 mm diameter coated solid carbide 2-fluted drills. The hole depth is therefore 11 times the diameter. Fig. 5 shows an image of the drilled test holes. A shrink fit tool holder was used for all 4.5 mm drilling as shown in Fig. 6 (a). This holder provided a high grip force and low tool runout (or eccentricity), being less than 10 micrometres in all cases. The cutting fluid was a water-based emulsion supplied at 6-8% concentration. All 4.5 mm drills featured through-tool coolant holes, coolant was supplied through the machine spindle to the tool with 70 bar supply pressure.

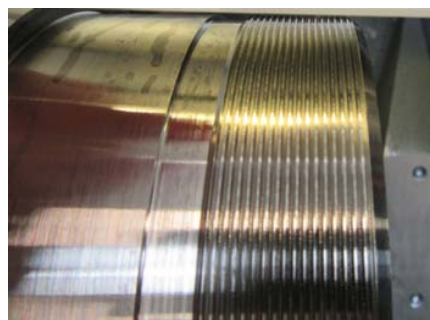
Fig. 7 Turned thread on cylindrical test piece

In the thread turning process, ISO standard threads were created with a 60-degree form and a pitch of 1.5 mm, equal to the programmed feed per revolution (refer to Fig. 7 for a picture of a finished thread). A shank tool was used to hold coated tungsten carbide based threading inserts as shown in Fig. 6 (b). The Hawk CNC lathe was used for thread turning, the same machine as described in Section II. Threads were
