Use of Short Piles for Stabilizing the Side Slope of the Road Embankment along the Canal

Abstract—This research presents the behavior of slope of the road along the canal stabilized by short piles. In this investigation, the centrifuge machine was used, modelling the condition of the water levels in the canal. The centrifuge tests were performed at 35 g. To observe the movement of the soil, visual analysis was performed to evaluate the failure behavior. Conclusively, the use of short piles to stabilize the canal slope proved to be an effective solution. However, the certain amount of settlement was found behind the short pile rows.

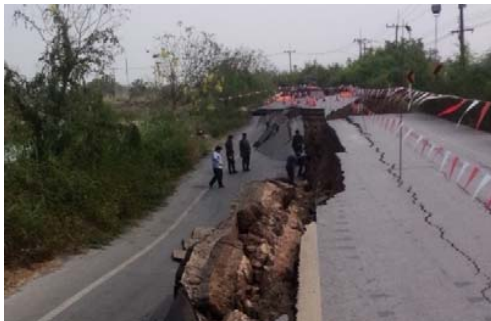
Fig. 1 Road along the canal no.13 collapsed

On the 2nd of March 2016, the road embankment along Canal no.13 (Klong 13) collapsed (Fig. 1) for approximately 100 m long. The canal at the failure area was found to be nearly dry, and a large water pond was found to be located near the failure section (Fig. 2).

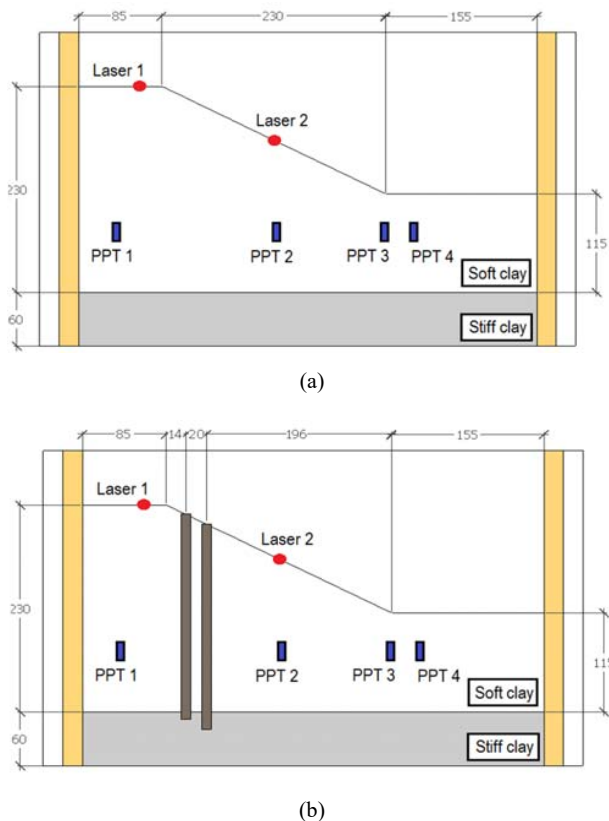
Fig. 3 The setup of instrumentations in both boxes (a) The box without reinforced piles (b) The box with reinforced piles

- PIV Camera: Located in front of the box to record the direction of soil movement.
- Laser: Record the settlement data.
- Pore Pressure water (PPT): Record the changes of water pressure.
- Water Tanks with flow control valve: Control the head of water while testing and the flow rate.

Fig. 3 illustrates the setup of instrumentations of both boxes.

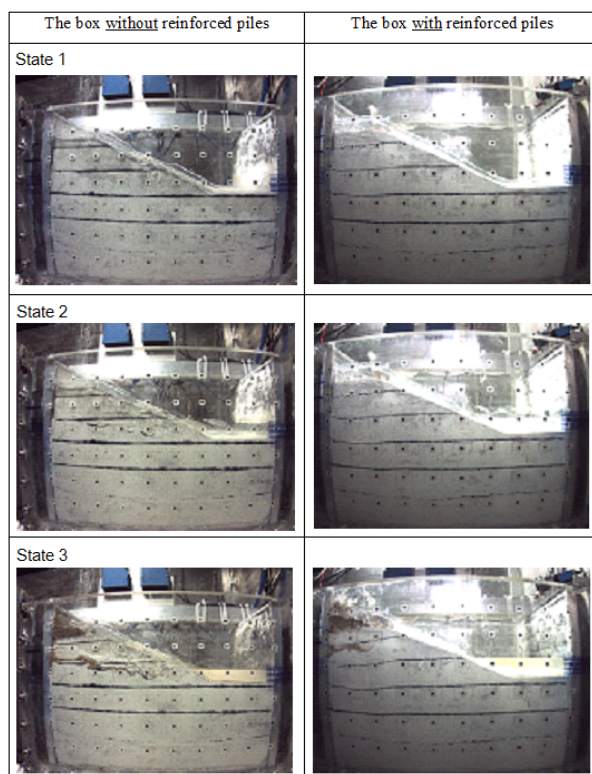
Fig. 6 The results of testing

The results of the centrifuge test can be classified into three states as (Fig. 6):

- State 1: Initial state, after soil preparation but before being spinned up to 35 g.
- State 2: Water level changes according to test plan but before CDG was added:
 1. In the box without reinforced piles, the soil moved down the slope, and the failure plane was found.
 2. In the box with reinforced piles, the soil behind short pile rows moved vertically, but no failure plane was observed.
- State 3: The final step, CDG was added to represent the embankment road:
 1. In the box without reinforced pile, the slope failure was clearly shown (Fig. 7).
 2. In the box with reinforced pile, the soil behind short pile rows moved vertically. Although, more settlement was found and the piles moved slightly, failure plane was not found (Fig. 8).

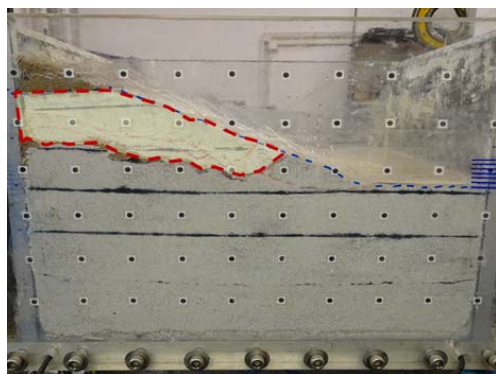
Fig. 7 Failure plane in the box without reinforced piles

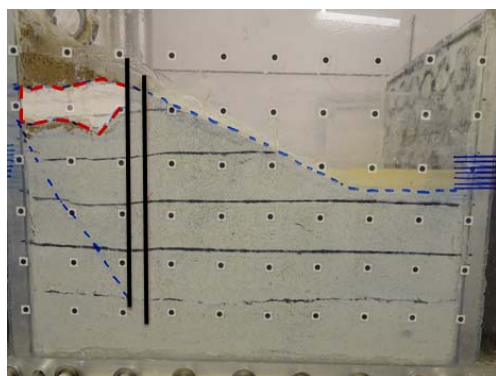
Fig. 8 The vertical settlement area in the box with reinforced piles
